## DOCUMENT CONTROL SHEET

**Project Name:** Mill Moor Road  
**Project Number:** B21957  
**Client:** Vogue Homes  
**Report Title:** Verification Report  
**Reference:** B21957 Verification

## **Analytical Report Number : 19-36899**

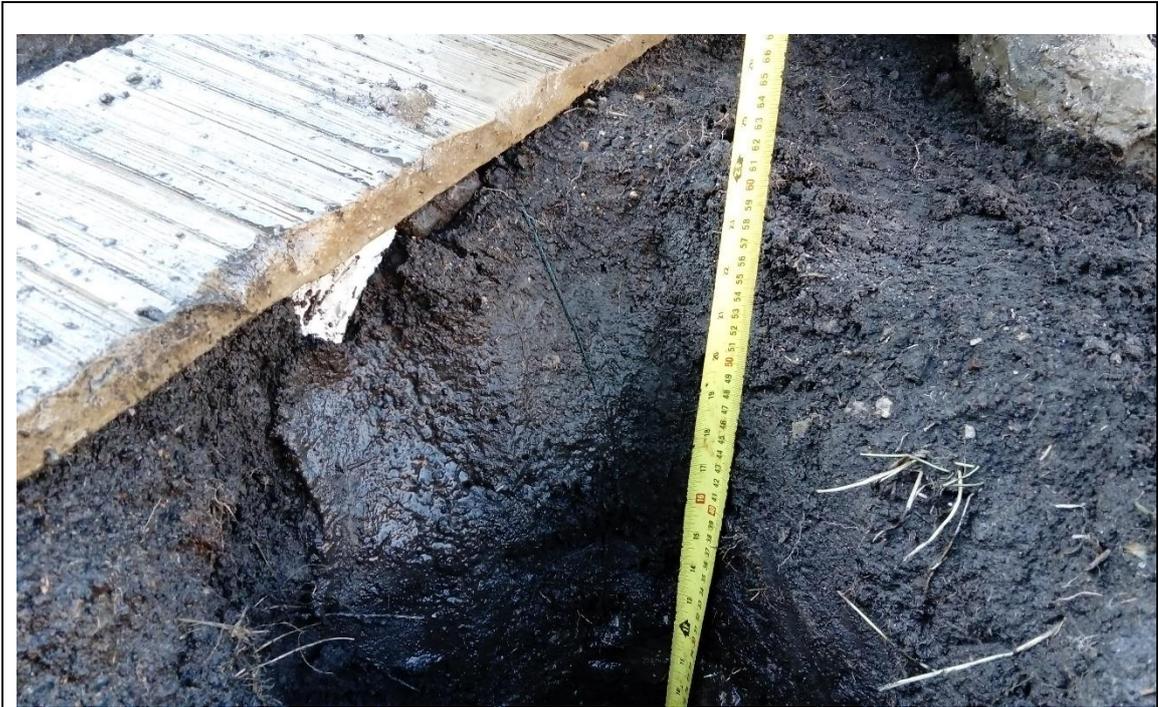
Plot 05 Pit 1

2.2.1 A representative from **jnp group** visited the site and oversaw the excavation of hand dug pits (two in each rear garden) to verify that the thickness of topsoil within the gardens of Plot 5 and 6 was at least 600 mm thick.
