COAL MINING RISK ASSESSMENT REPORT

job number	C3473/23/E/5263	date	04/04/2023
site address	Northfield Lane Highburton Huddersfield HD8 0QT		
written by	J.Finch	checked by	R.Palmer
issued by	J.Finch

Report on a Coal Mining Risk Assessment

Location: **Northfield Lane,**
Highburton, Huddersfield, West Yorkshire, HD8 0QT

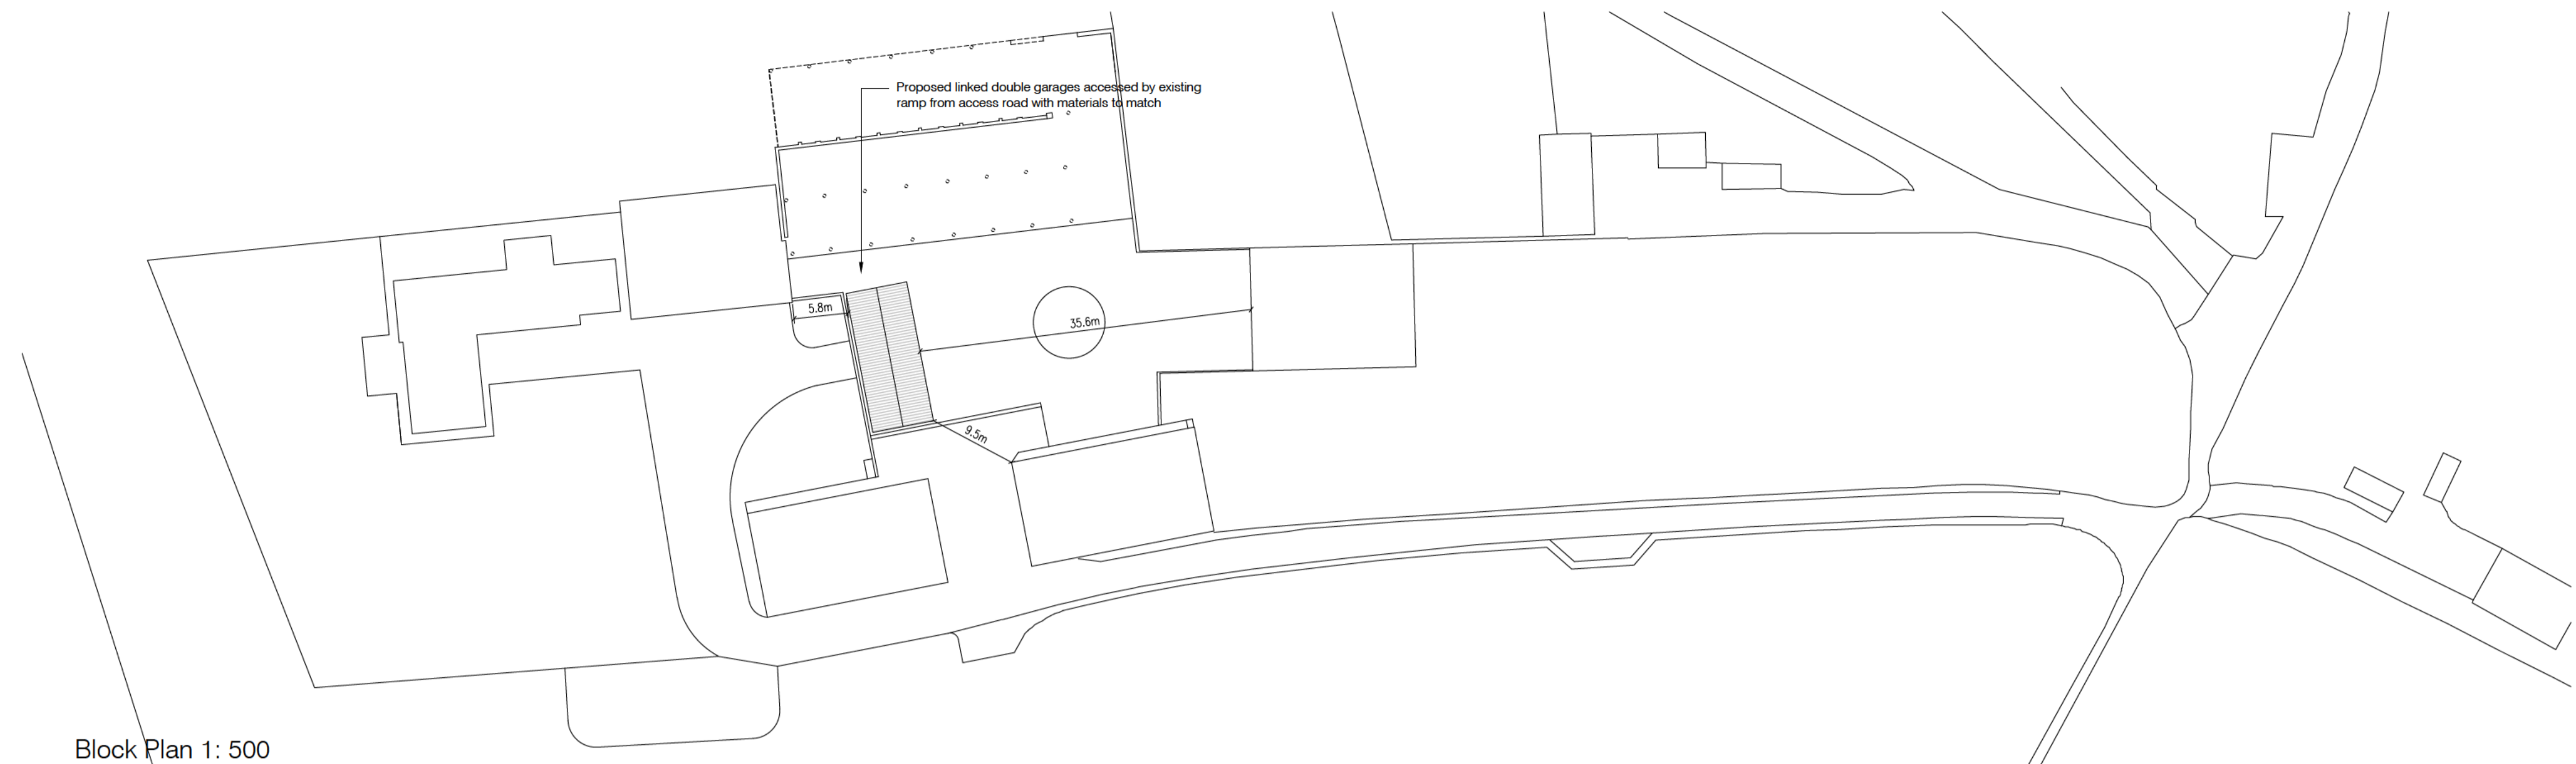
Project	Proposed Garage at Busk Farm, Northfield Lane, Highburton
Client	Mr R Andrews, Busk Farm, Northfield Lane, Highburton
Dwg Title	(23133)2_Scheme proposals
Scale	1: 100 @ A1
Date	Feb 23

It is understood that the site is to be developed by the construction of a garage, as per drawing (23133)2_Scheme proposals, which is presented in Appendix 1. As part of the planning application at the site, a Coal Mining Risk Assessment has been requested by the planning authority. Consequently, a desktop study was commissioned in order to assess the risk to the development from coal mining. This report presents the findings of the study.
