**ARBORICULTURAL REPORT
AND
ARBORICULTURAL IMPACT ASSESSMENT
to BS 5837:2012
at
Former Petrol Station
North Road
Kirkburton
Huddersfield
West Yorkshire
HD8 0RL**

Client:
Walters Architects

JCA Ref:
21554/AJB

**Appendix 5:
Tree Constraints Plan**

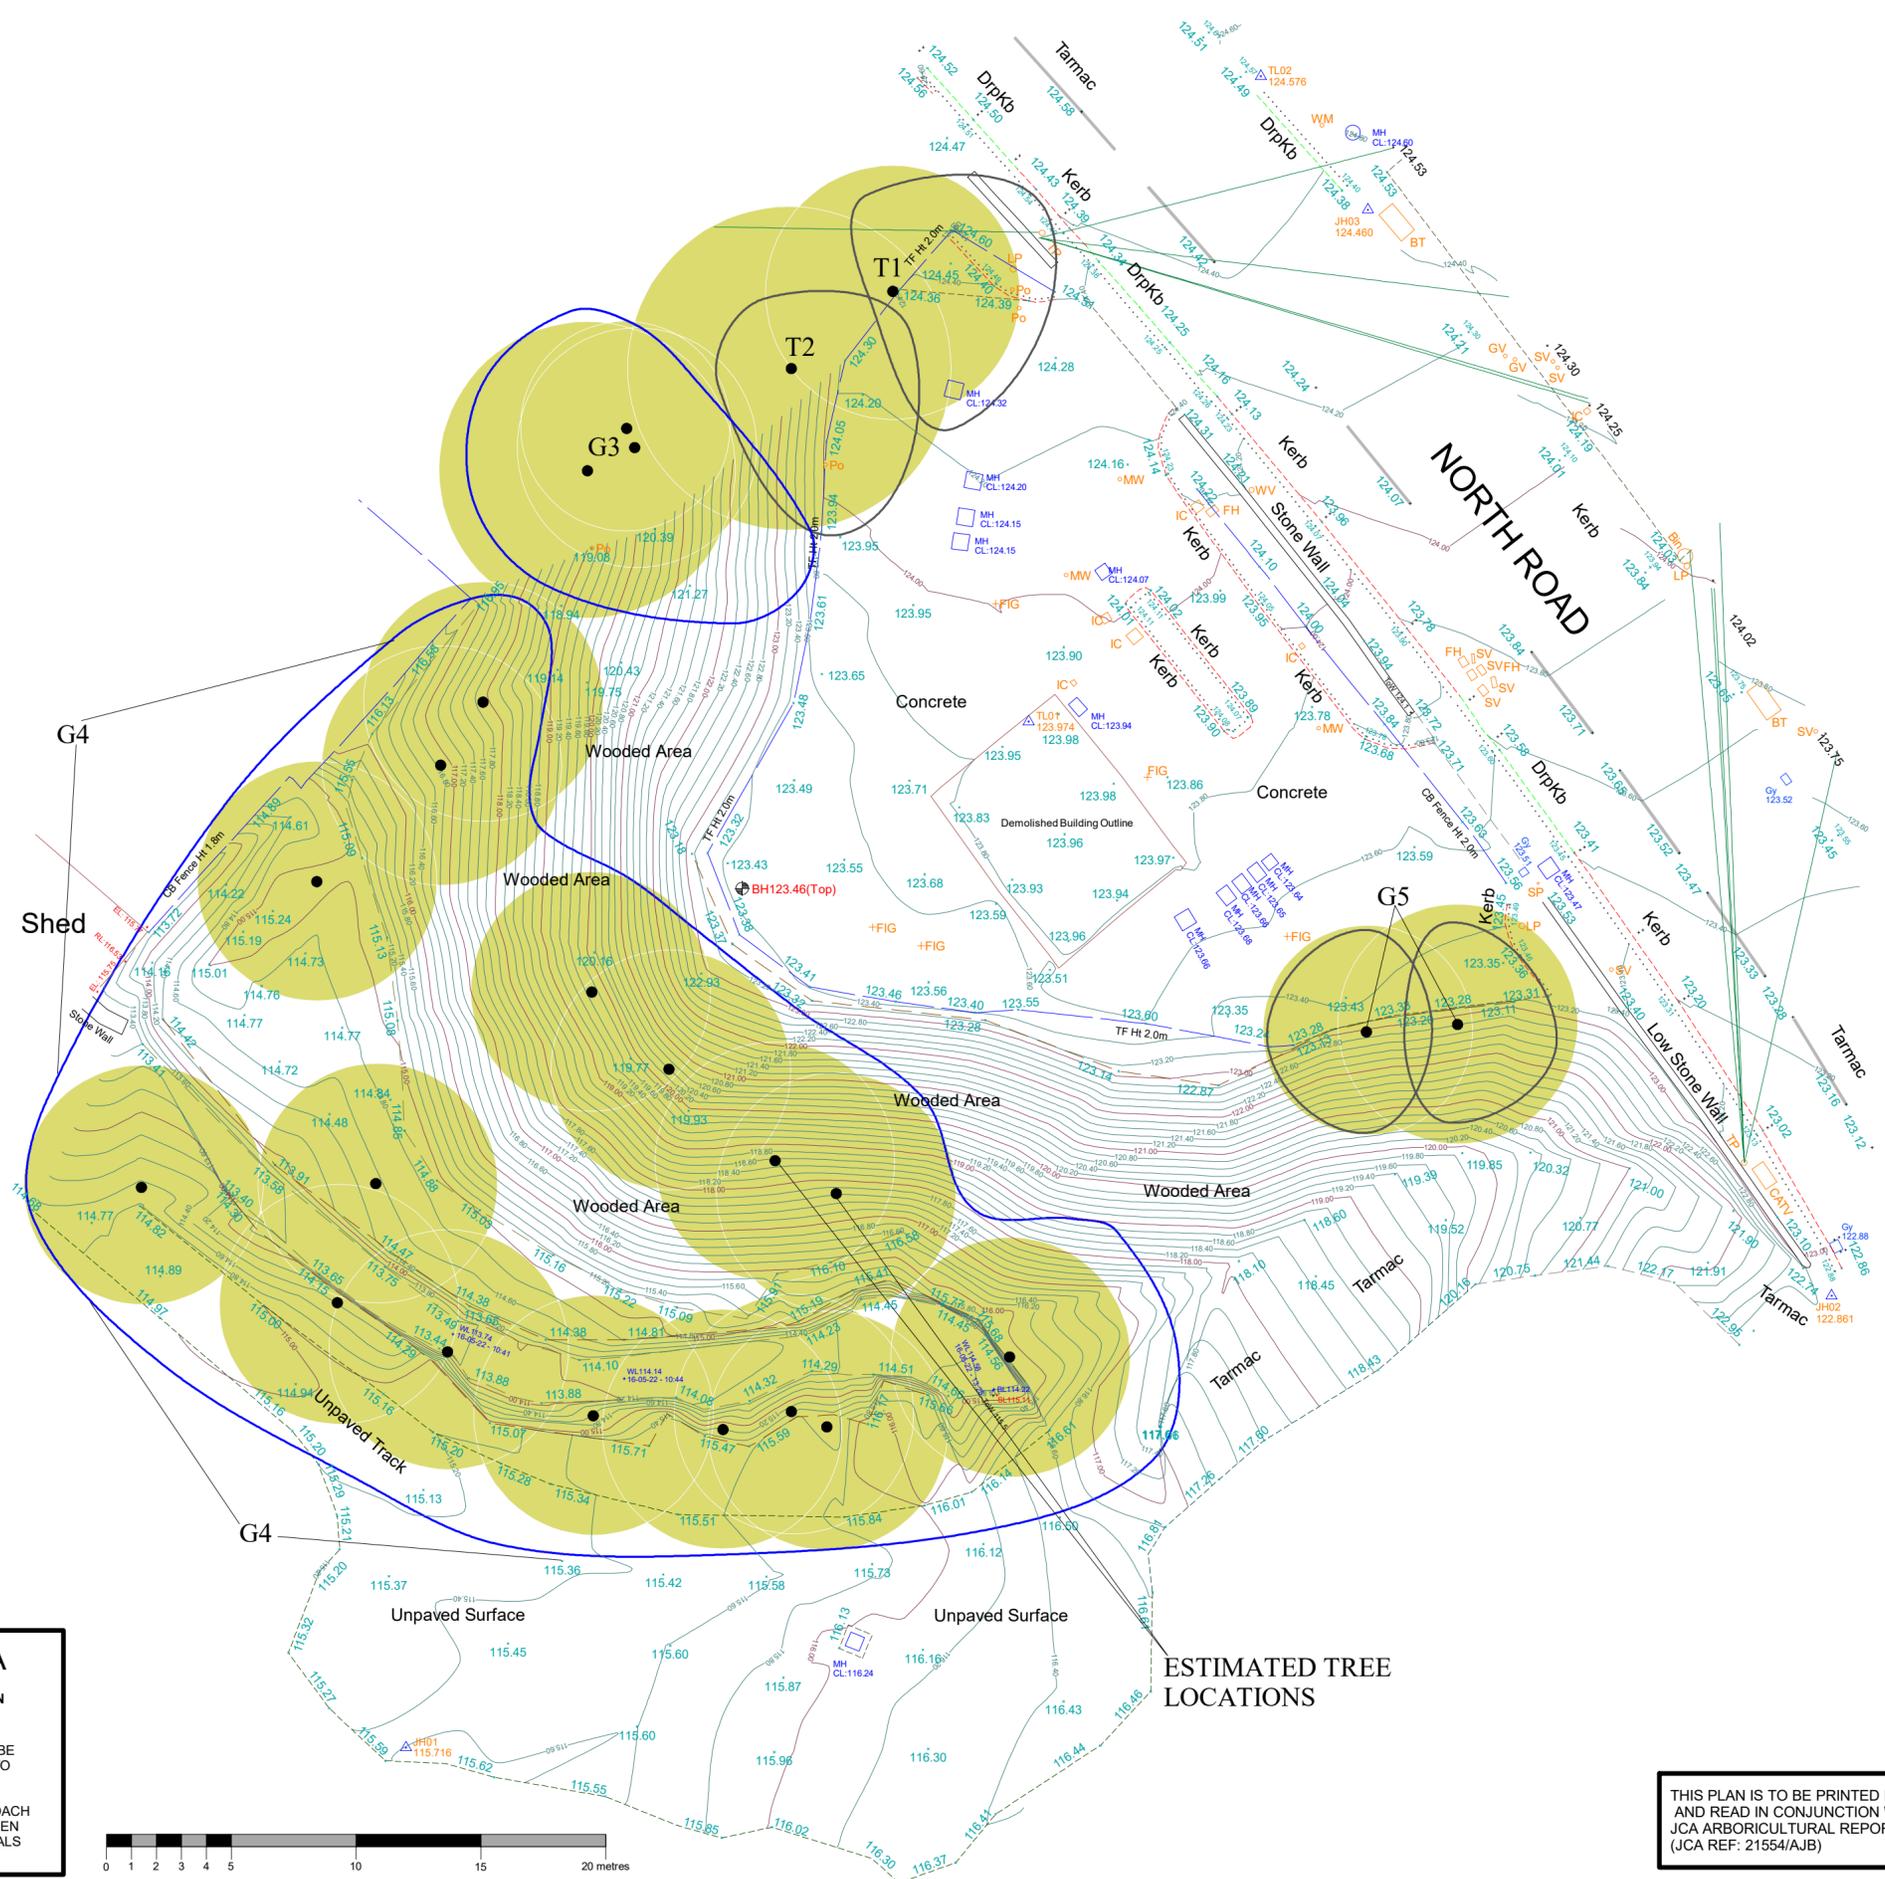
Root Protection Area: RPA

THE ROOT PROTECTION AREA SHOULD IDEALLY REMAIN UNDISTURBED IF THE TREE IS TO BE RETAINED.

THE DEVELOPMENT PROPOSALS SHOULD THEREFORE BE DESIGNED TO AVOID THE RPA OF ANY TREE WHICH IS TO BE RETAINED.

IF IT IS NECESSARY FOR THE DEVELOPMENT TO ENCRANCH INTO THE RPA OF A TREE WHICH IS TO BE RETAINED THEN SPECIALIST CONSTRUCTION TECHNIQUES AND MATERIALS MUST BE CONSIDERED.

ESTIMATED TREE LOCATIONS

THIS PLAN IS TO BE PRINTED IN COLOUR AND READ IN CONJUNCTION WITH THE JCA ARBORICULTURAL REPORT (JCA REF: 21554/AJB)

- 1.2.1 For this purpose, a topographical survey (**Ref: 5445_Former Petrol Station, Kirkburton_Topo_2D**) has been supplied, which forms the basis for the Tree Constraints Plan at **Appendix 5**. The topographical survey, along with all other documents supplied to JCA, is assumed to be correct. No checking of such documents will be undertaken and JCA cannot be held responsible for incorrect data supplied by other parties.

4.5.4.1 The footprint of raised platform required for the proposed retail store incurs the RPA of two trees within **G4**, as shown in blue shade on the plan at **Appendix 6**. Due to this, a specialist foundation design must be implemented to reduce excavation and the detrimental impact this can have on tree roots.
