**ARBORICULTURAL METHOD STATEMENT  
to BS 5837:2012  
at  
Lingards Road  
Huddersfield  
Slaithwaite  
West Yorkshire  
HD7 5HY**

**Client:**  
SB Homes Limited

**JCA Ref:**  
20427/AJB

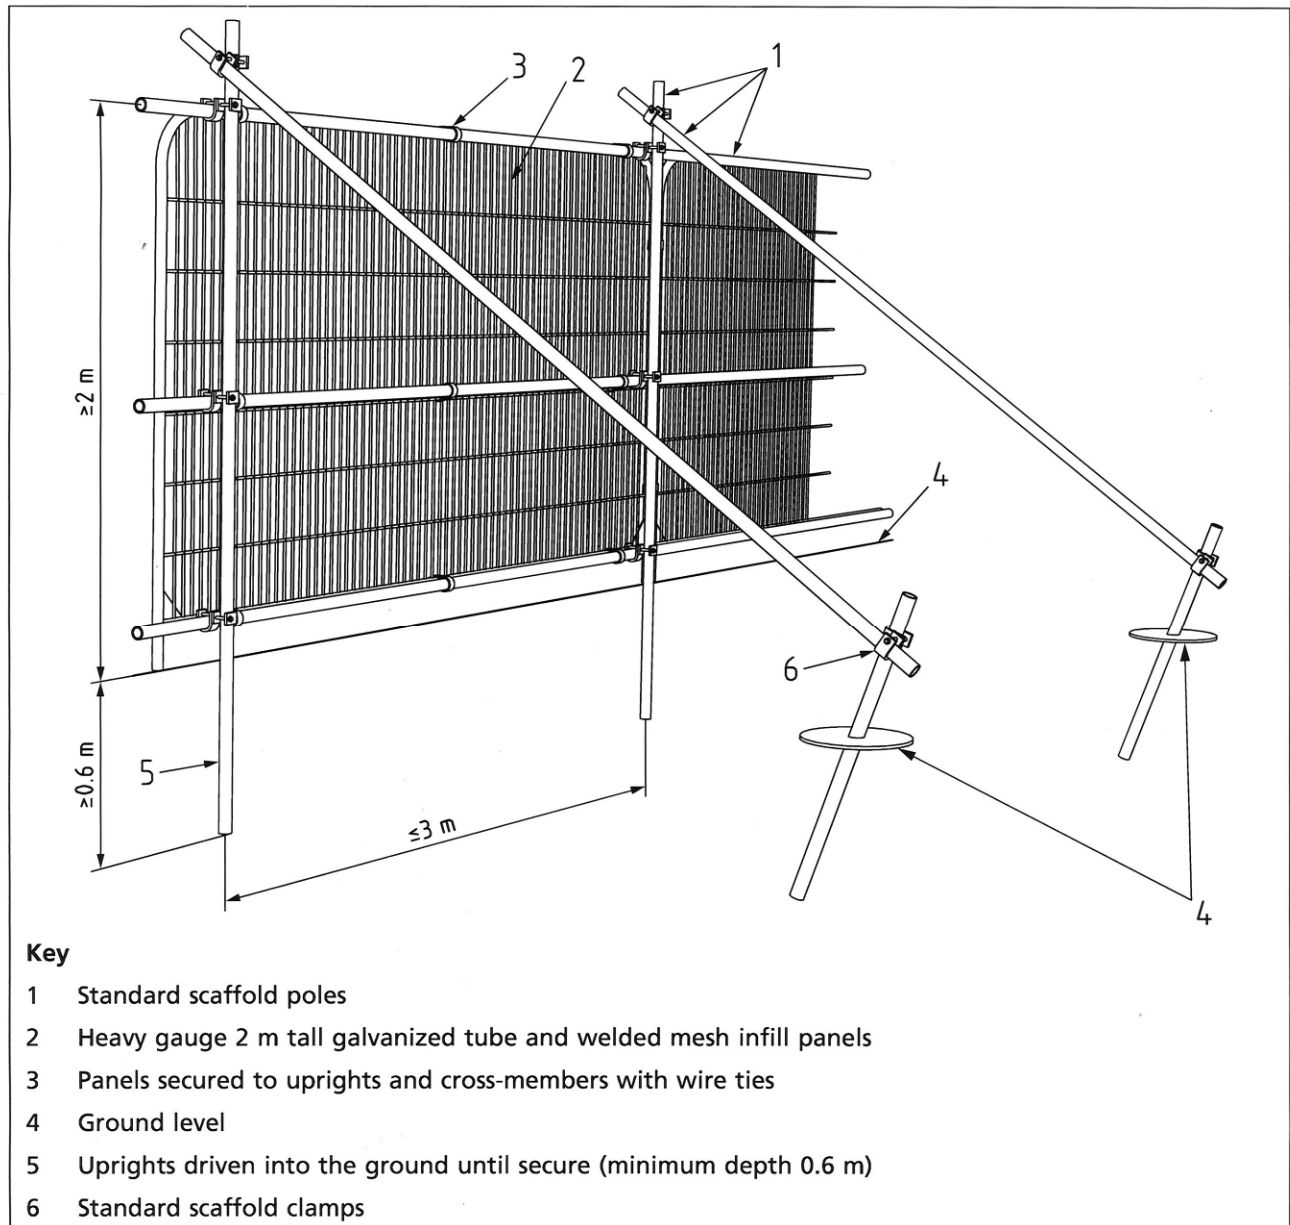
Protective Barrier to BS 5837: 2012.

A2.1 The protective barrier will be installed in accordance with BS5837: 2012. The default specification of BS 5837: 2012 (pictured below for reference) recommends a vertical and horizontal, scaffold framework, well braced to resist impacts, with vertical tubes at no more than 3m intervals. These should be driven into the ground. Weld mesh panels should be affixed to this framework with scaffold clamps.

- 3.1.3 The protective fencing will be installed in accordance with BS 5837: 2012 and will comprise of a vertical and horizontal scaffold framework, well braced to resist impacts. The vertical tubes should be spaced at a maximum interval of 3m and driven securely into the ground, taking care to avoid underground services and structural roots. Finally, weld mesh panels are to be securely fixed on the scaffold framework. Please refer to **Appendix 2** for protective fencing details.

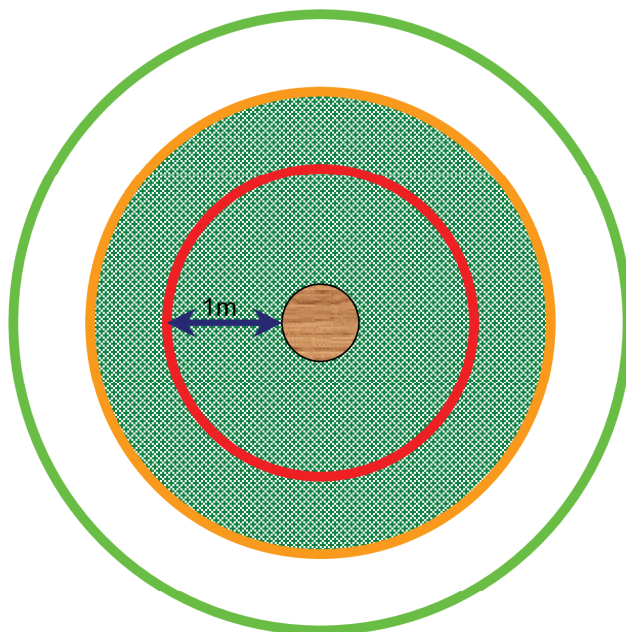
NJUG Guidelines for the Planning, Installation and Maintenance of Utility Apparatus in Proximity to Trees – Issue 2

TREE PROTECTION ZONE

**PROHIBITED ZONE – 1m from trunk.** Excavations of any kind must not be undertaken within this zone unless full consultation with Local Authority Tree Officer is undertaken. Materials, plant and spoil must not be stored within this zone.

**PRECAUTIONARY ZONE – 4 x tree circumference.** Where excavations must be undertaken within this zone the use of mechanical excavation plant should be prohibited. Precautions should be undertaken to protect any exposed roots. Materials, plant and spoil should not be stored within this zone. Consult with Local Authority Tree Officer if in any doubt.

**PERMITTED ZONE – outside of precautionary zone.** Excavation works may be undertaken within this zone however caution must be applied and the use of mechanical plant limited. Any exposed roots should be protected.

- A3.1 Over-ground services should be routed away from areas where they are likely to interfere with the crowns of trees. Similarly, any landscaping should take account of over-ground services and mature tree size.
- A3.2 Underground services must be routed outside the RPA of retained trees, unless otherwise specified within this report. NJUG Volume 4 Issue 2 (on the next page) is a set of accepted guidelines for installing services in the proximity of trees. Please note that this is not a substitute for site-specific advice by an arboriculturalist and consultation should be made wherever incursions of RPAs are envisaged. The contents of this report, specifically **Section 4.5**, supersede the set of guidelines on the next page, which are only included for reference.

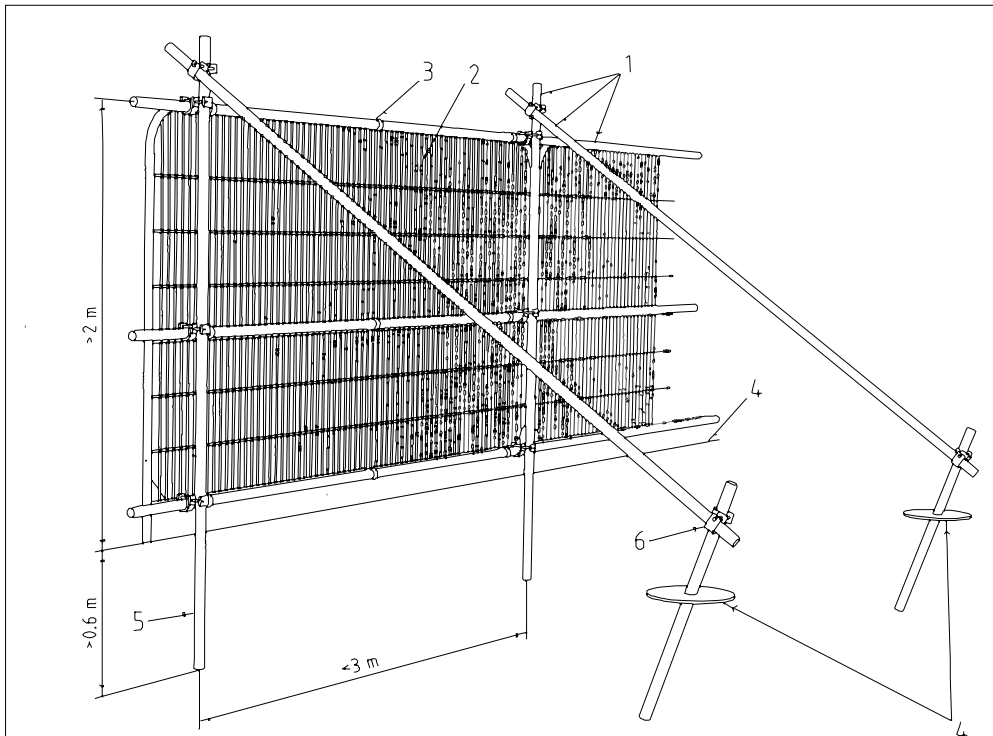
Default specification for a protective barrier

1. Standard scaffold poles
2. Heavy gauge 2m tall galvanized tube and welded mesh infill panels
3. Panels secured to uprights and cross-members with wire ties
4. Ground level
5. Uprights driven into the ground until secure (minimum depth 0.6m)
6. Standard scaffold clamps

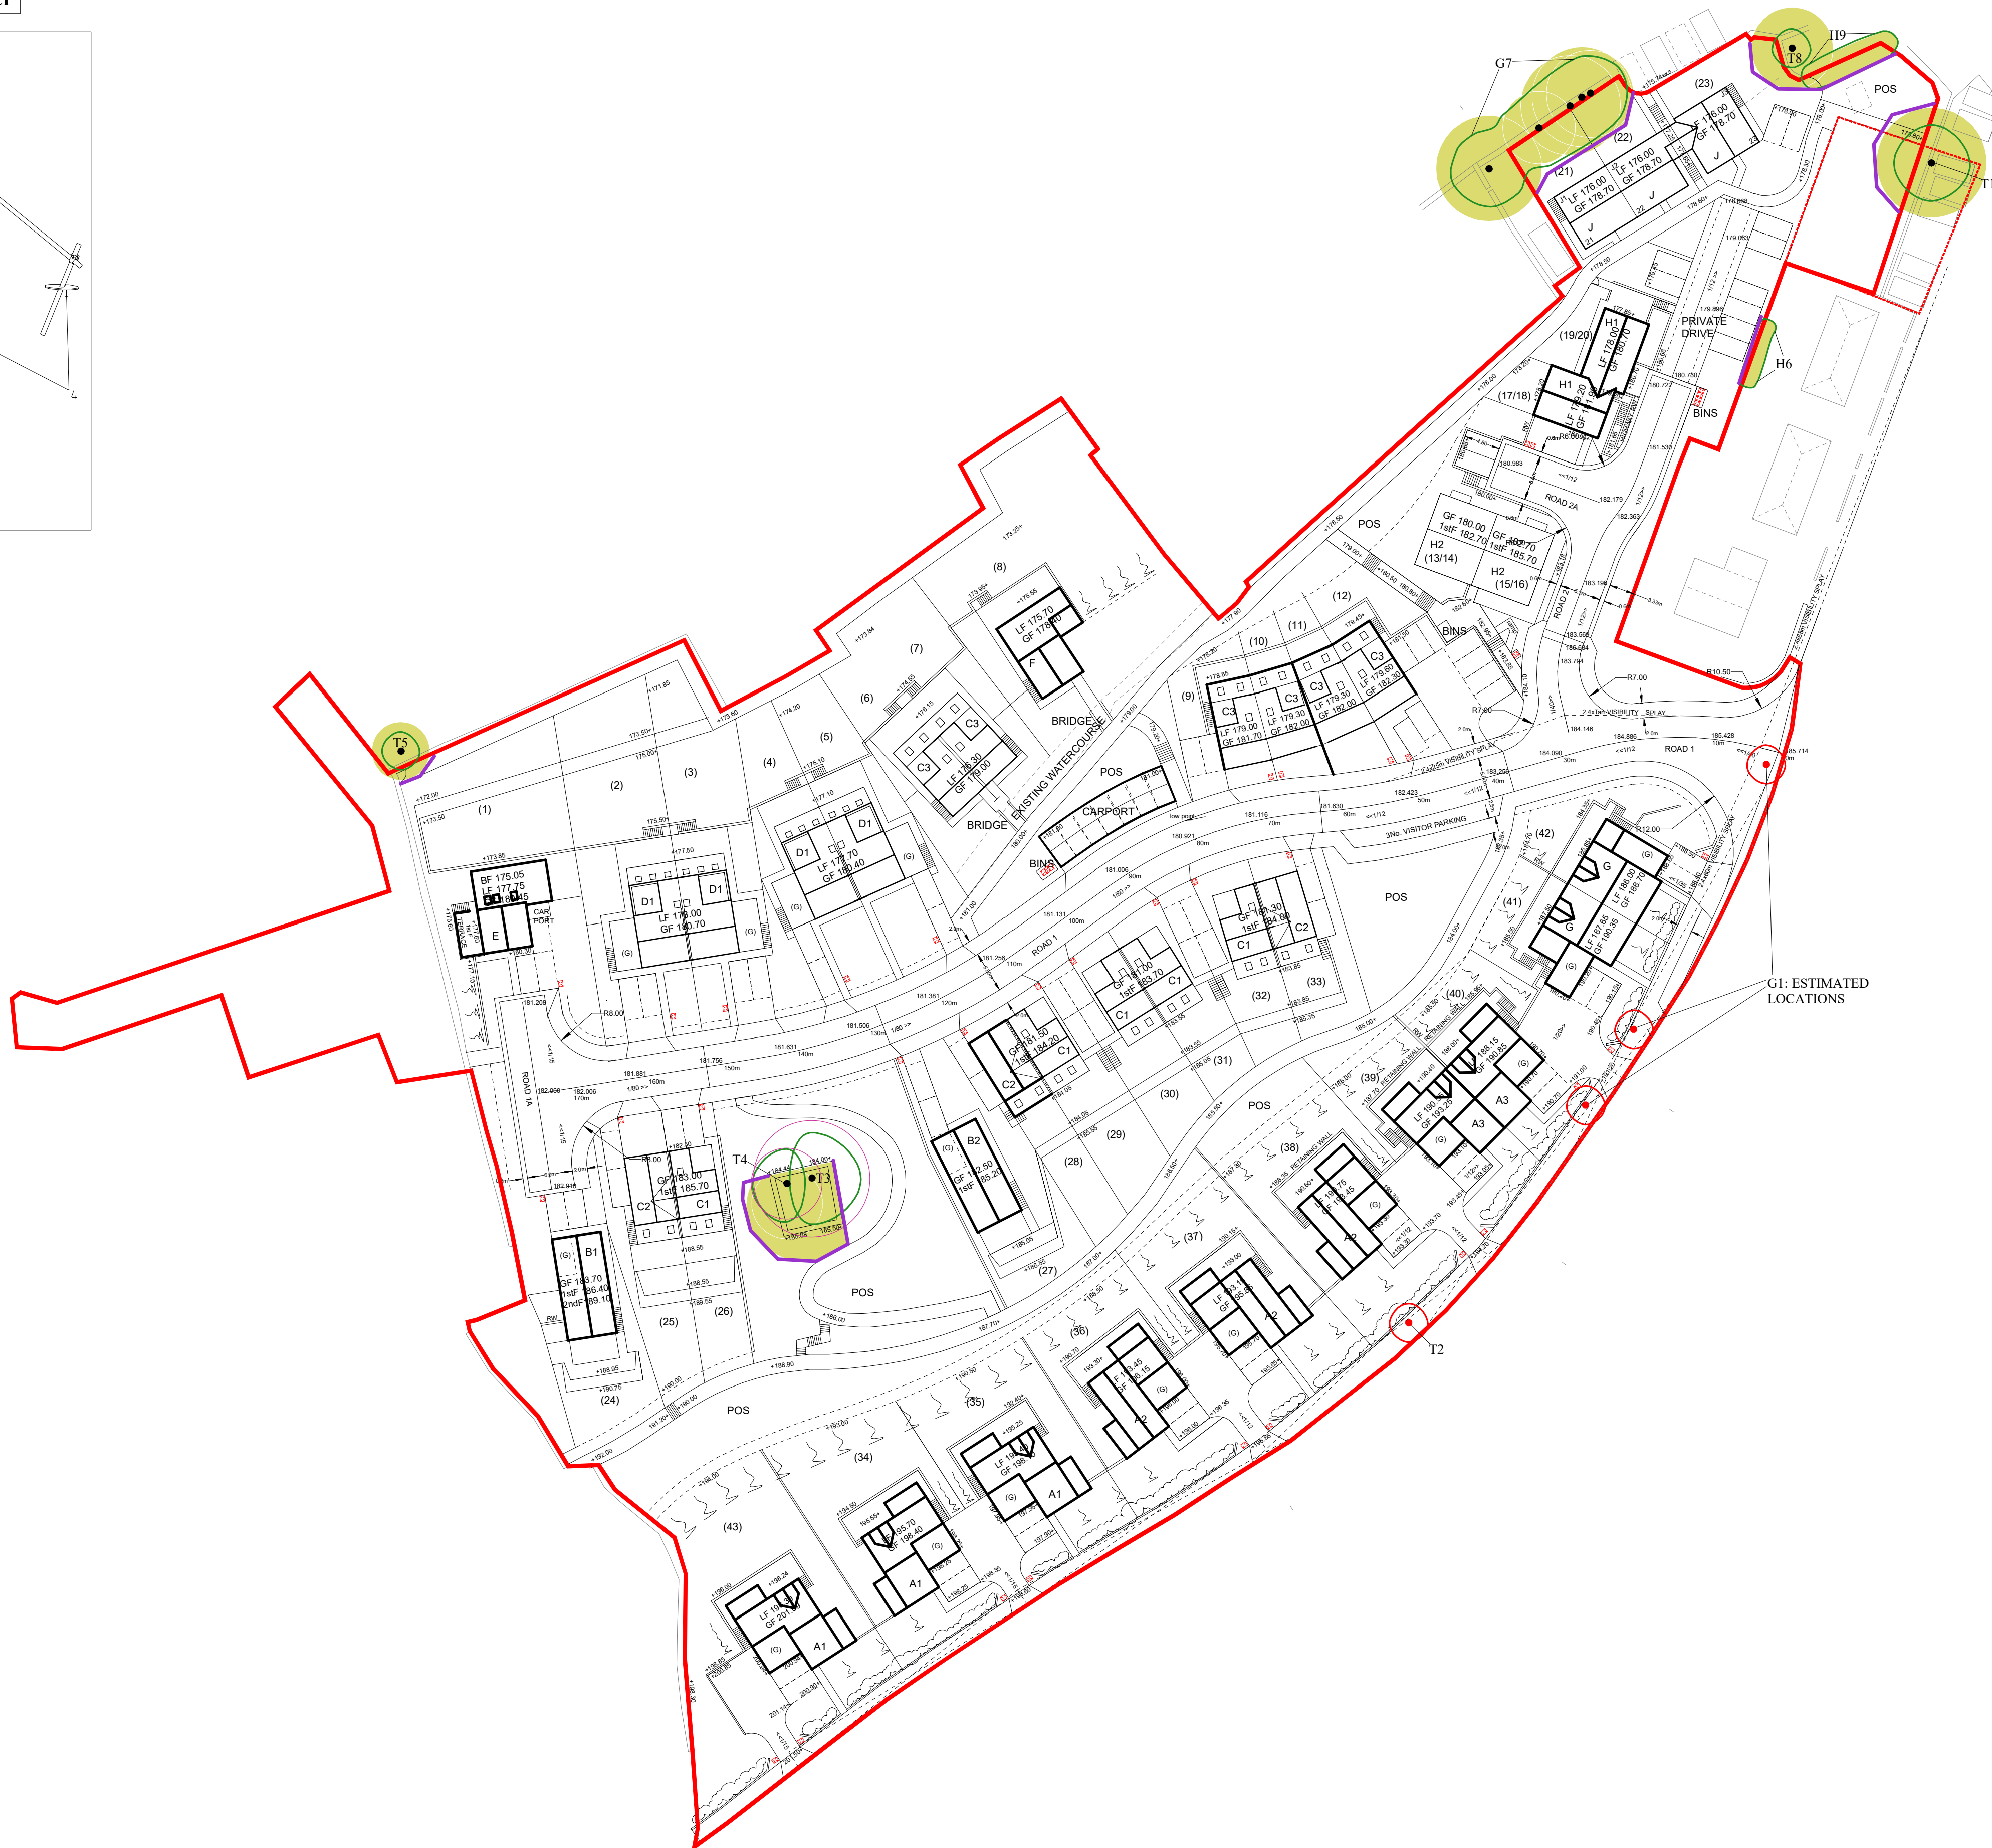
Appendix 4:  
Tree Protection Plan

TREE PROTECTION MEASURES

THE ROOT PROTECTION AREA (RPA) SHOULD IDEALLY REMAIN UNDISTURBED IF THE TREE IS TO BE RETAINED.

TO ACHIEVE THIS, PROTECTIVE FENCING WILL BE INSTALLED TO ENCLOSE THE RPA TO MAKE A CONSTRUCTION EXCLUSION ZONE (CEZ).

| | ROOT PROTECTION AREA (RPA) PRIOR TO OFF-SETTING TO ALLOW FOR THE ELEVATED LOCATION OF T3 AND T4 |
| | PROTECTIVE FENCE LINE (CEZ) |

- 3.1.2 The protective fencing must be constructed in accordance with BS 5837: 2012 *Trees in relation to design, demolition and construction - Recommendations* and will be located as shown on the Tree Protection Plan at **Appendix**. Where possible, the protective barrier will enclose the entire Root Protection Area (RPA) of the trees to make a Construction Exclusion Zone (CEZ); **this area is to be considered a restricted area; no pedestrians, vehicles, equipment or machinery are allowed within the CEZ and the storage of materials is not permitted, unless specified within this Method Statement.**

| Timescale | Action | ✓ | Initial |
|---|---|---|---|
| <b>Stage 3</b> | Install the temporary protective fencing around the trees (as detailed at <b>Appendix 2</b> and as shown on the Tree Protection Plan at <b>Appendix 4</b> ). | | |
