**ARBORICULTURAL METHOD STATEMENT  
to BS 5837:2012  
at  
Lingards Road  
Huddersfield  
Slaithwaite  
West Yorkshire  
HD7 5HY**

**JCA Ref:**  
20427/AJB

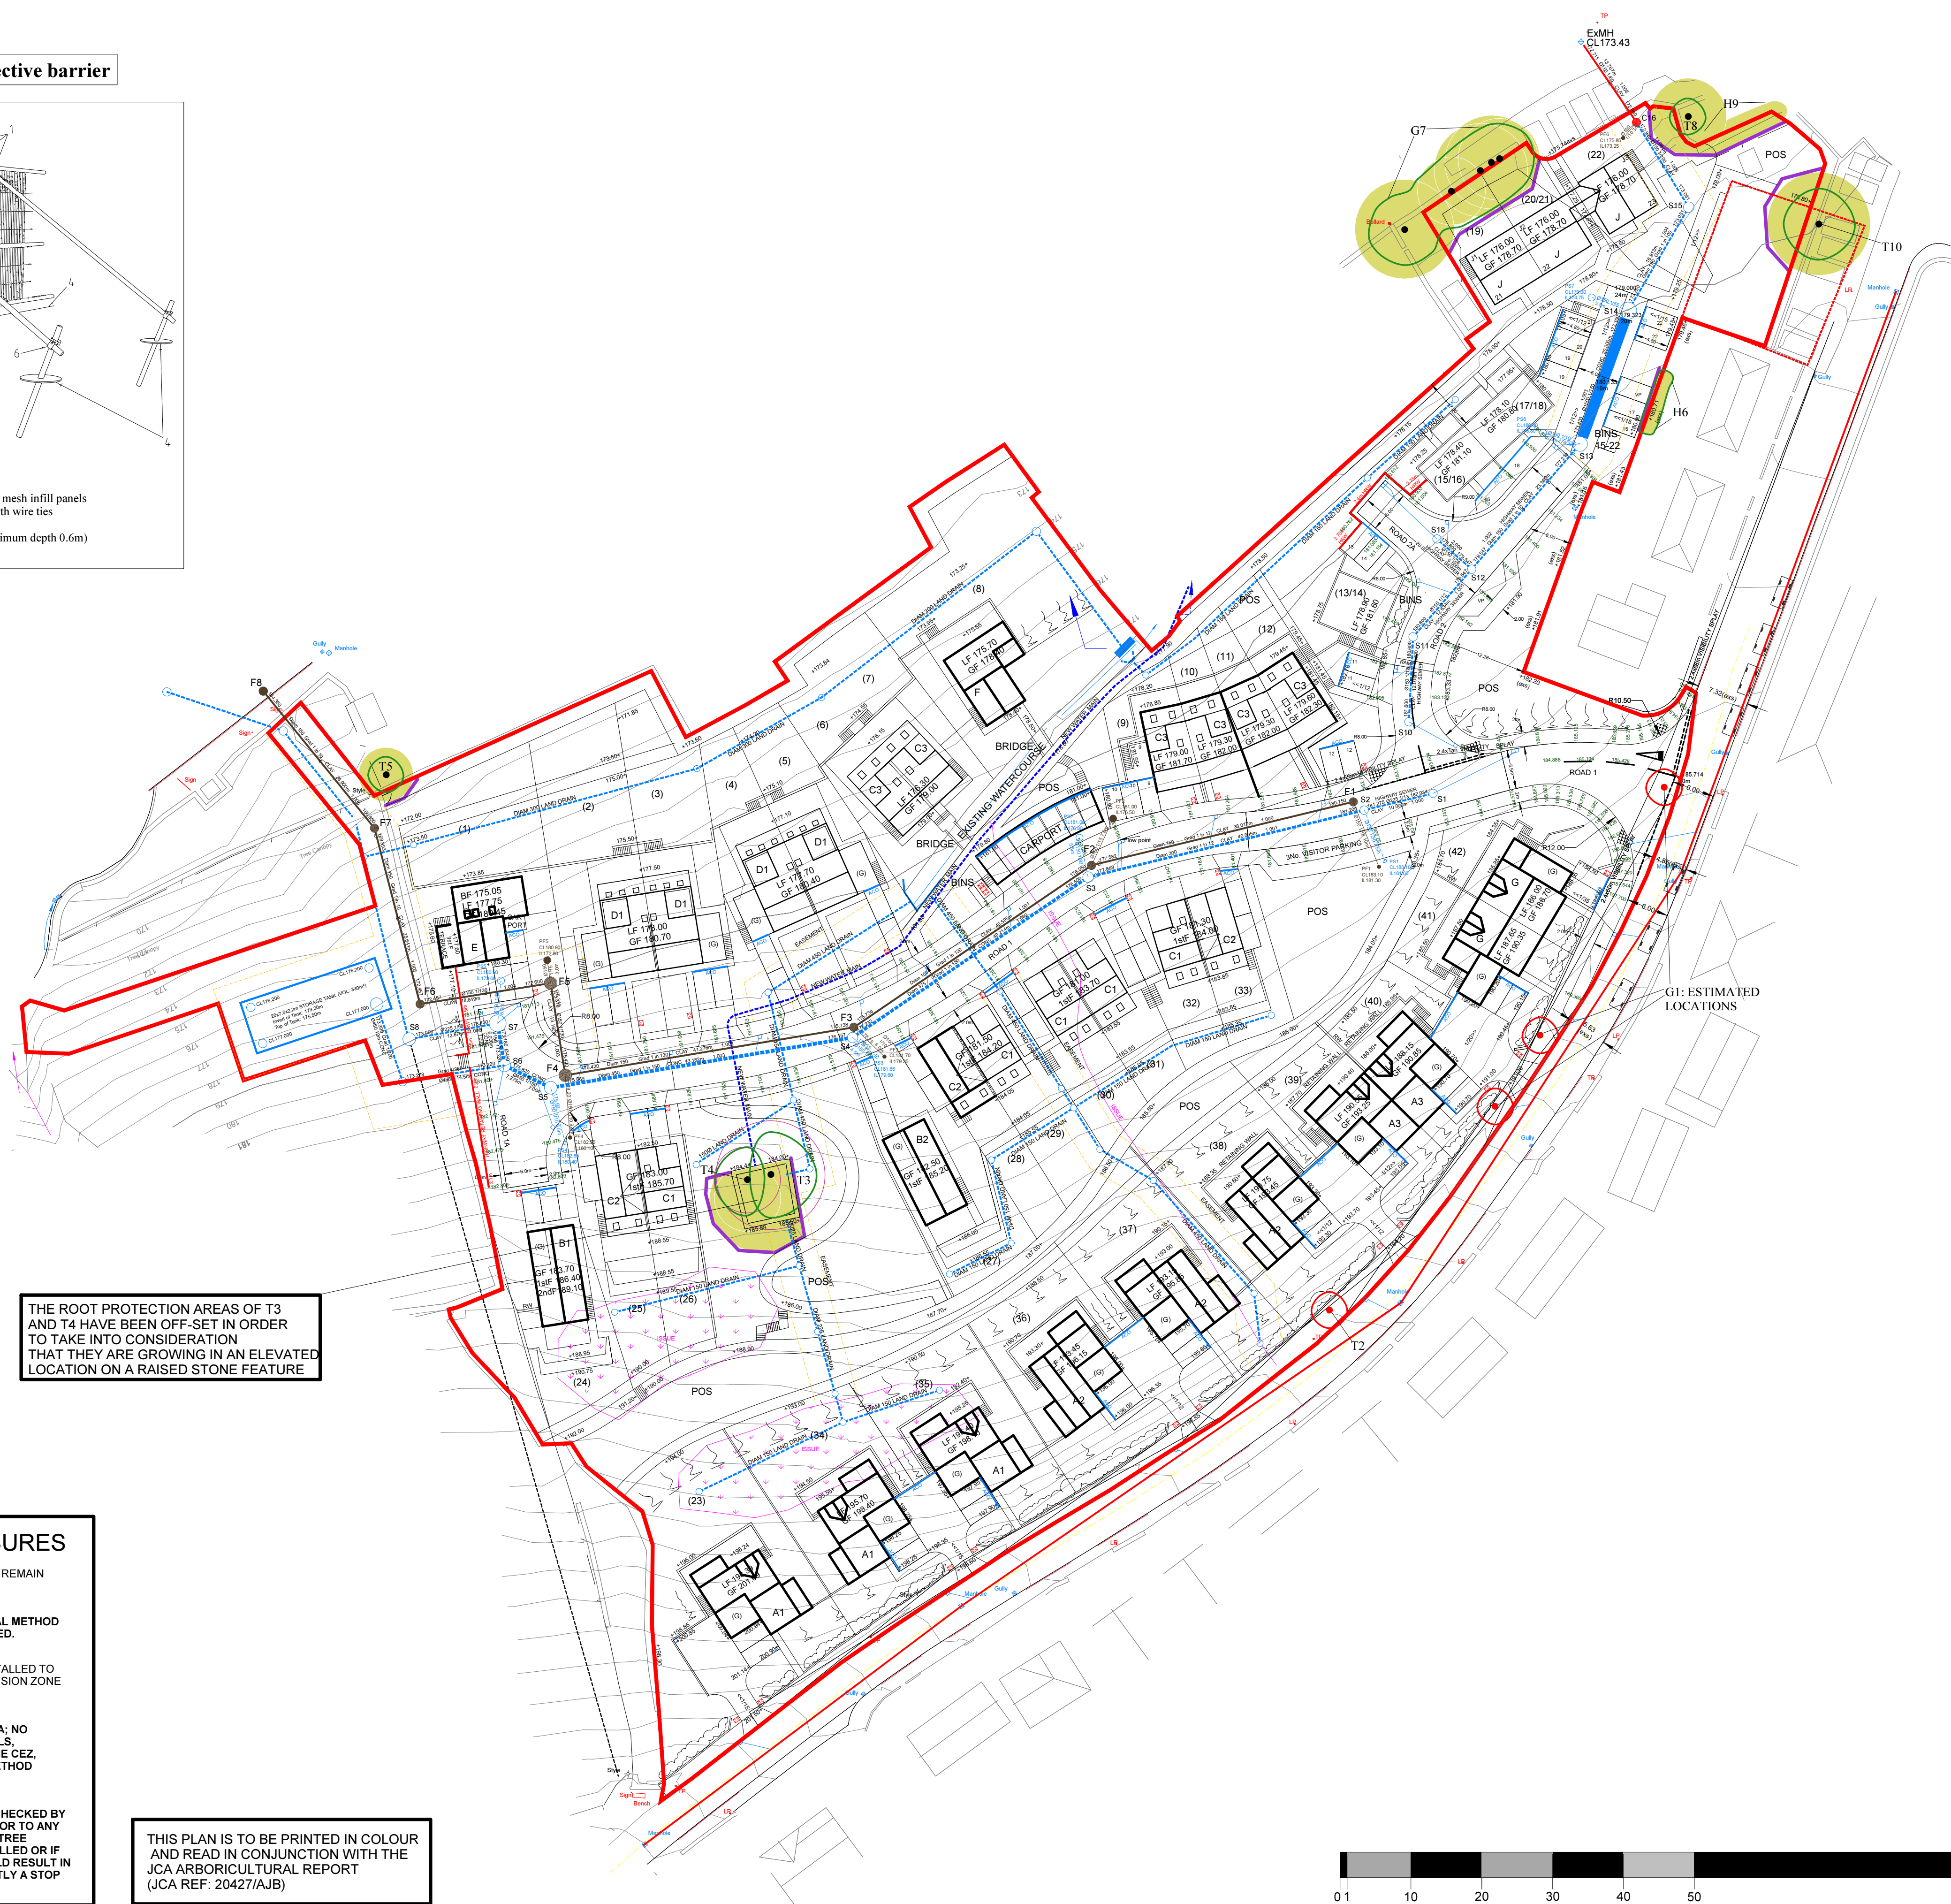
### Appendix 4: Tree Protection Plan

THE ROOT PROTECTION AREAS OF T3 AND T4 HAVE BEEN OFF-SET IN ORDER TO TAKE INTO CONSIDERATION THAT THEY ARE GROWING IN AN ELEVATED LOCATION ON A RAISED STONE FEATURE

TO ACHIEVE THIS, PROTECTIVE FENCING WILL BE INSTALLED TO ENCLOSE THE RPA TO MAKE A CONSTRUCTION EXCLUSION ZONE (CEZ);

| | ROOT PROTECTION AREA (RPA) PRIOR TO OFF-SETTING TO ALLOW FOR THE ELEVATED LOCATION OF T3 AND T4 |

- 3.1.2 The protective fencing must be constructed in accordance with BS 5837: 2012 *Trees in relation to design, demolition and construction - Recommendations* and will be located as shown on the Tree Protection Plan at **Appendix**. Where possible, the protective barrier will enclose the entire Root Protection Area (RPA) of the trees to make a Construction Exclusion Zone (CEZ); **this area is to be considered a restricted area; no pedestrians, vehicles, equipment or machinery are allowed within the CEZ and the storage of materials is not permitted, unless specified within this Method Statement.**

4.5.1 Whilst the drainage strategy can be seen on the plan at **Appendix 4**, further details on other service routes are not available at this time. As such, no provision for the routing of utilities within the RPAs is made within the scope of this report.
