**ARBORICULTURAL METHOD STATEMENT  
to BS 5837:2012**

**Land East of Penistone Road  
Fenay Bridge  
Huddersfield  
West Yorkshire  
HD8 0JS**

21115-B/AJB

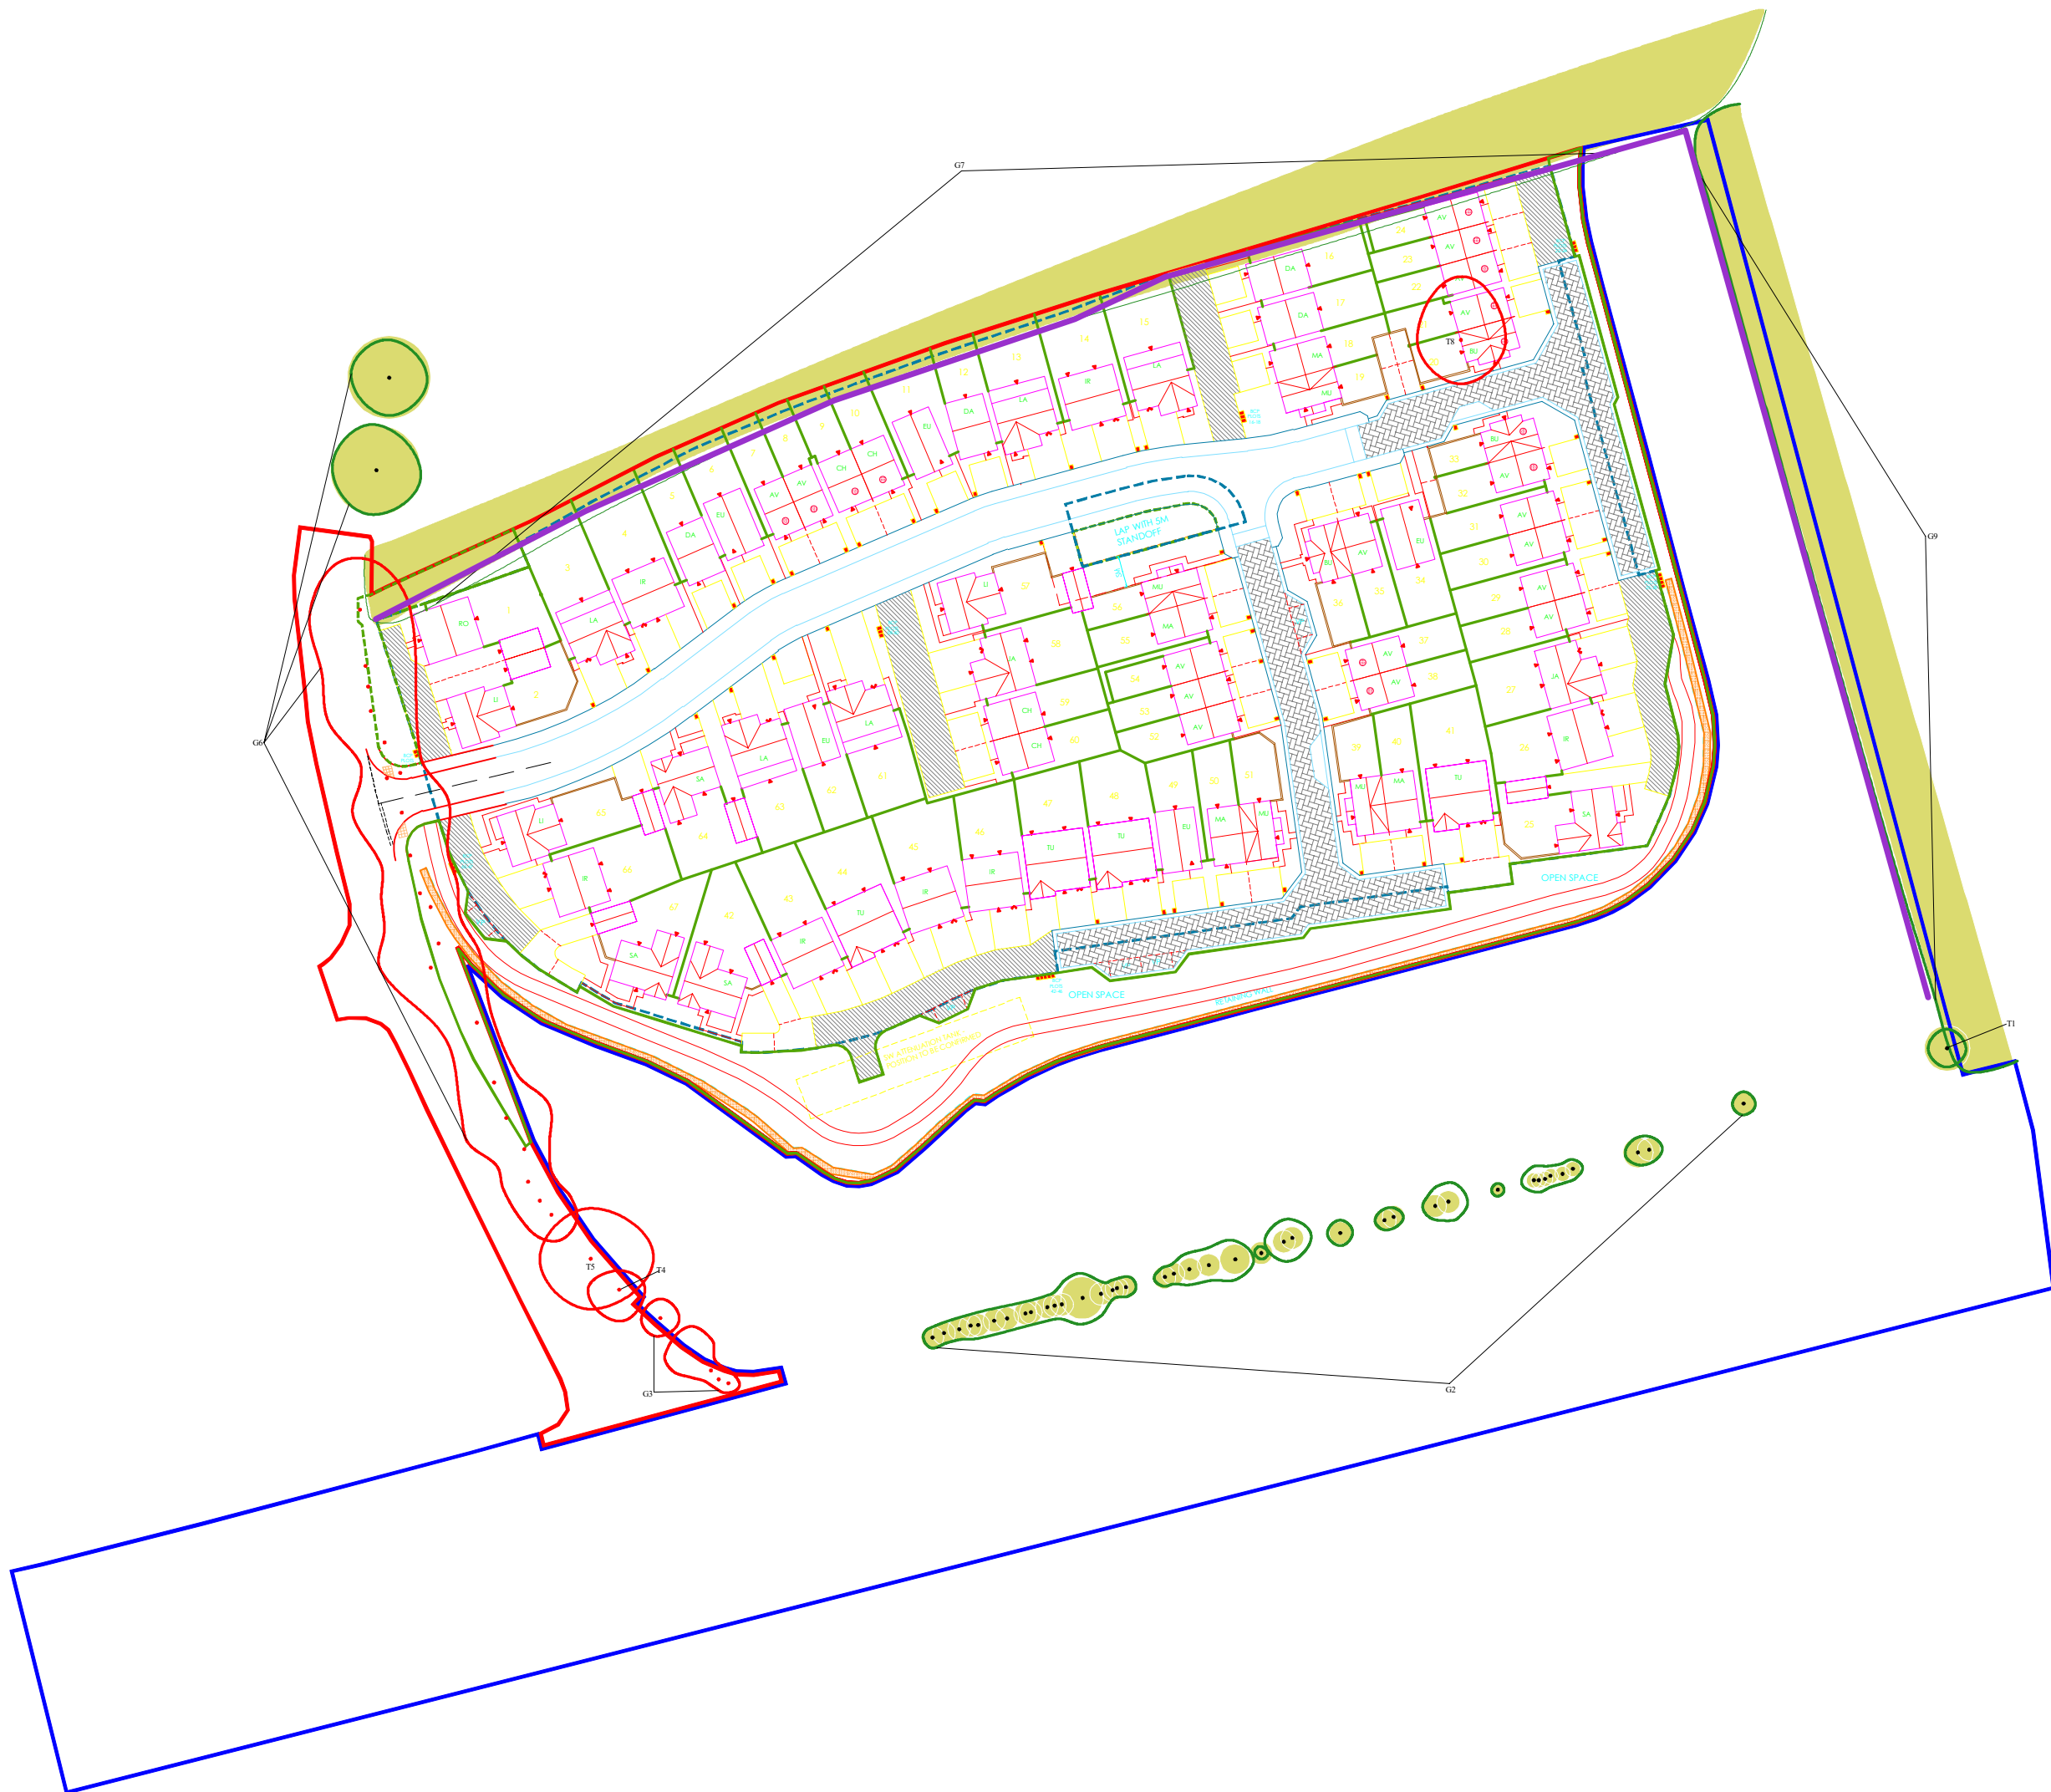
Appendix 4: Tree Protection Plan

THE ROOT PROTECTION AREA (RPA) SHOULD IDEALLY REMAIN UNDISTURBED IF THE TREE IS TO BE RETAINED.

TO ACHIEVE THIS, PROTECTIVE FENCING WILL BE INSTALLED TO ENCLOSE THE RPA TO MAKE A CONSTRUCTION EXCLUSION ZONE (CEZ).

THIS AREA IS TO BE CONSIDERED A RESTRICTED AREA; NO PEDESTRIANS, VEHICLES, THE STORAGE OF MATERIALS, EQUIPMENT OR MACHINERY ARE ALLOWED WITHIN THE CEZ, UNLESS SPECIFIED WITHIN THE ARBORICULTURAL METHOD STATEMENT.

- 2.1.1 Prior to any construction activity, the first operation on site will be the undertaking of the necessary arboricultural works, as described at **Appendix 1**.
- 2.1.2 The tree works include the removal of **G3, T4, T5**, circa nineteen trees within **G6** (as shown in red on the plan at **Appendix 4**) and **T8**, to facilitate the proposed development.

- 3.1.2 The protective fencing must be constructed in accordance with BS 5837: 2012 *Trees in relation to design, demolition and construction - Recommendations* and will be located as shown on the Tree Protection Plan at **Appendix 4**. Where possible, the protective barrier will enclose the entire Root Protection Area (RPA) of the trees to make a Construction Exclusion Zone (CEZ); **this area is to be considered a restricted area; no pedestrians, vehicles, equipment or machinery are allowed within the CEZ and the storage of materials is not permitted, unless specified within this Method Statement.**
