**ARBORICULTURAL METHOD STATEMENT  
to BS 5837:2012**

**Land East of Penistone Road  
Fenay Bridge  
Huddersfield  
West Yorkshire  
HD8 0JS**

21115-B/AJB

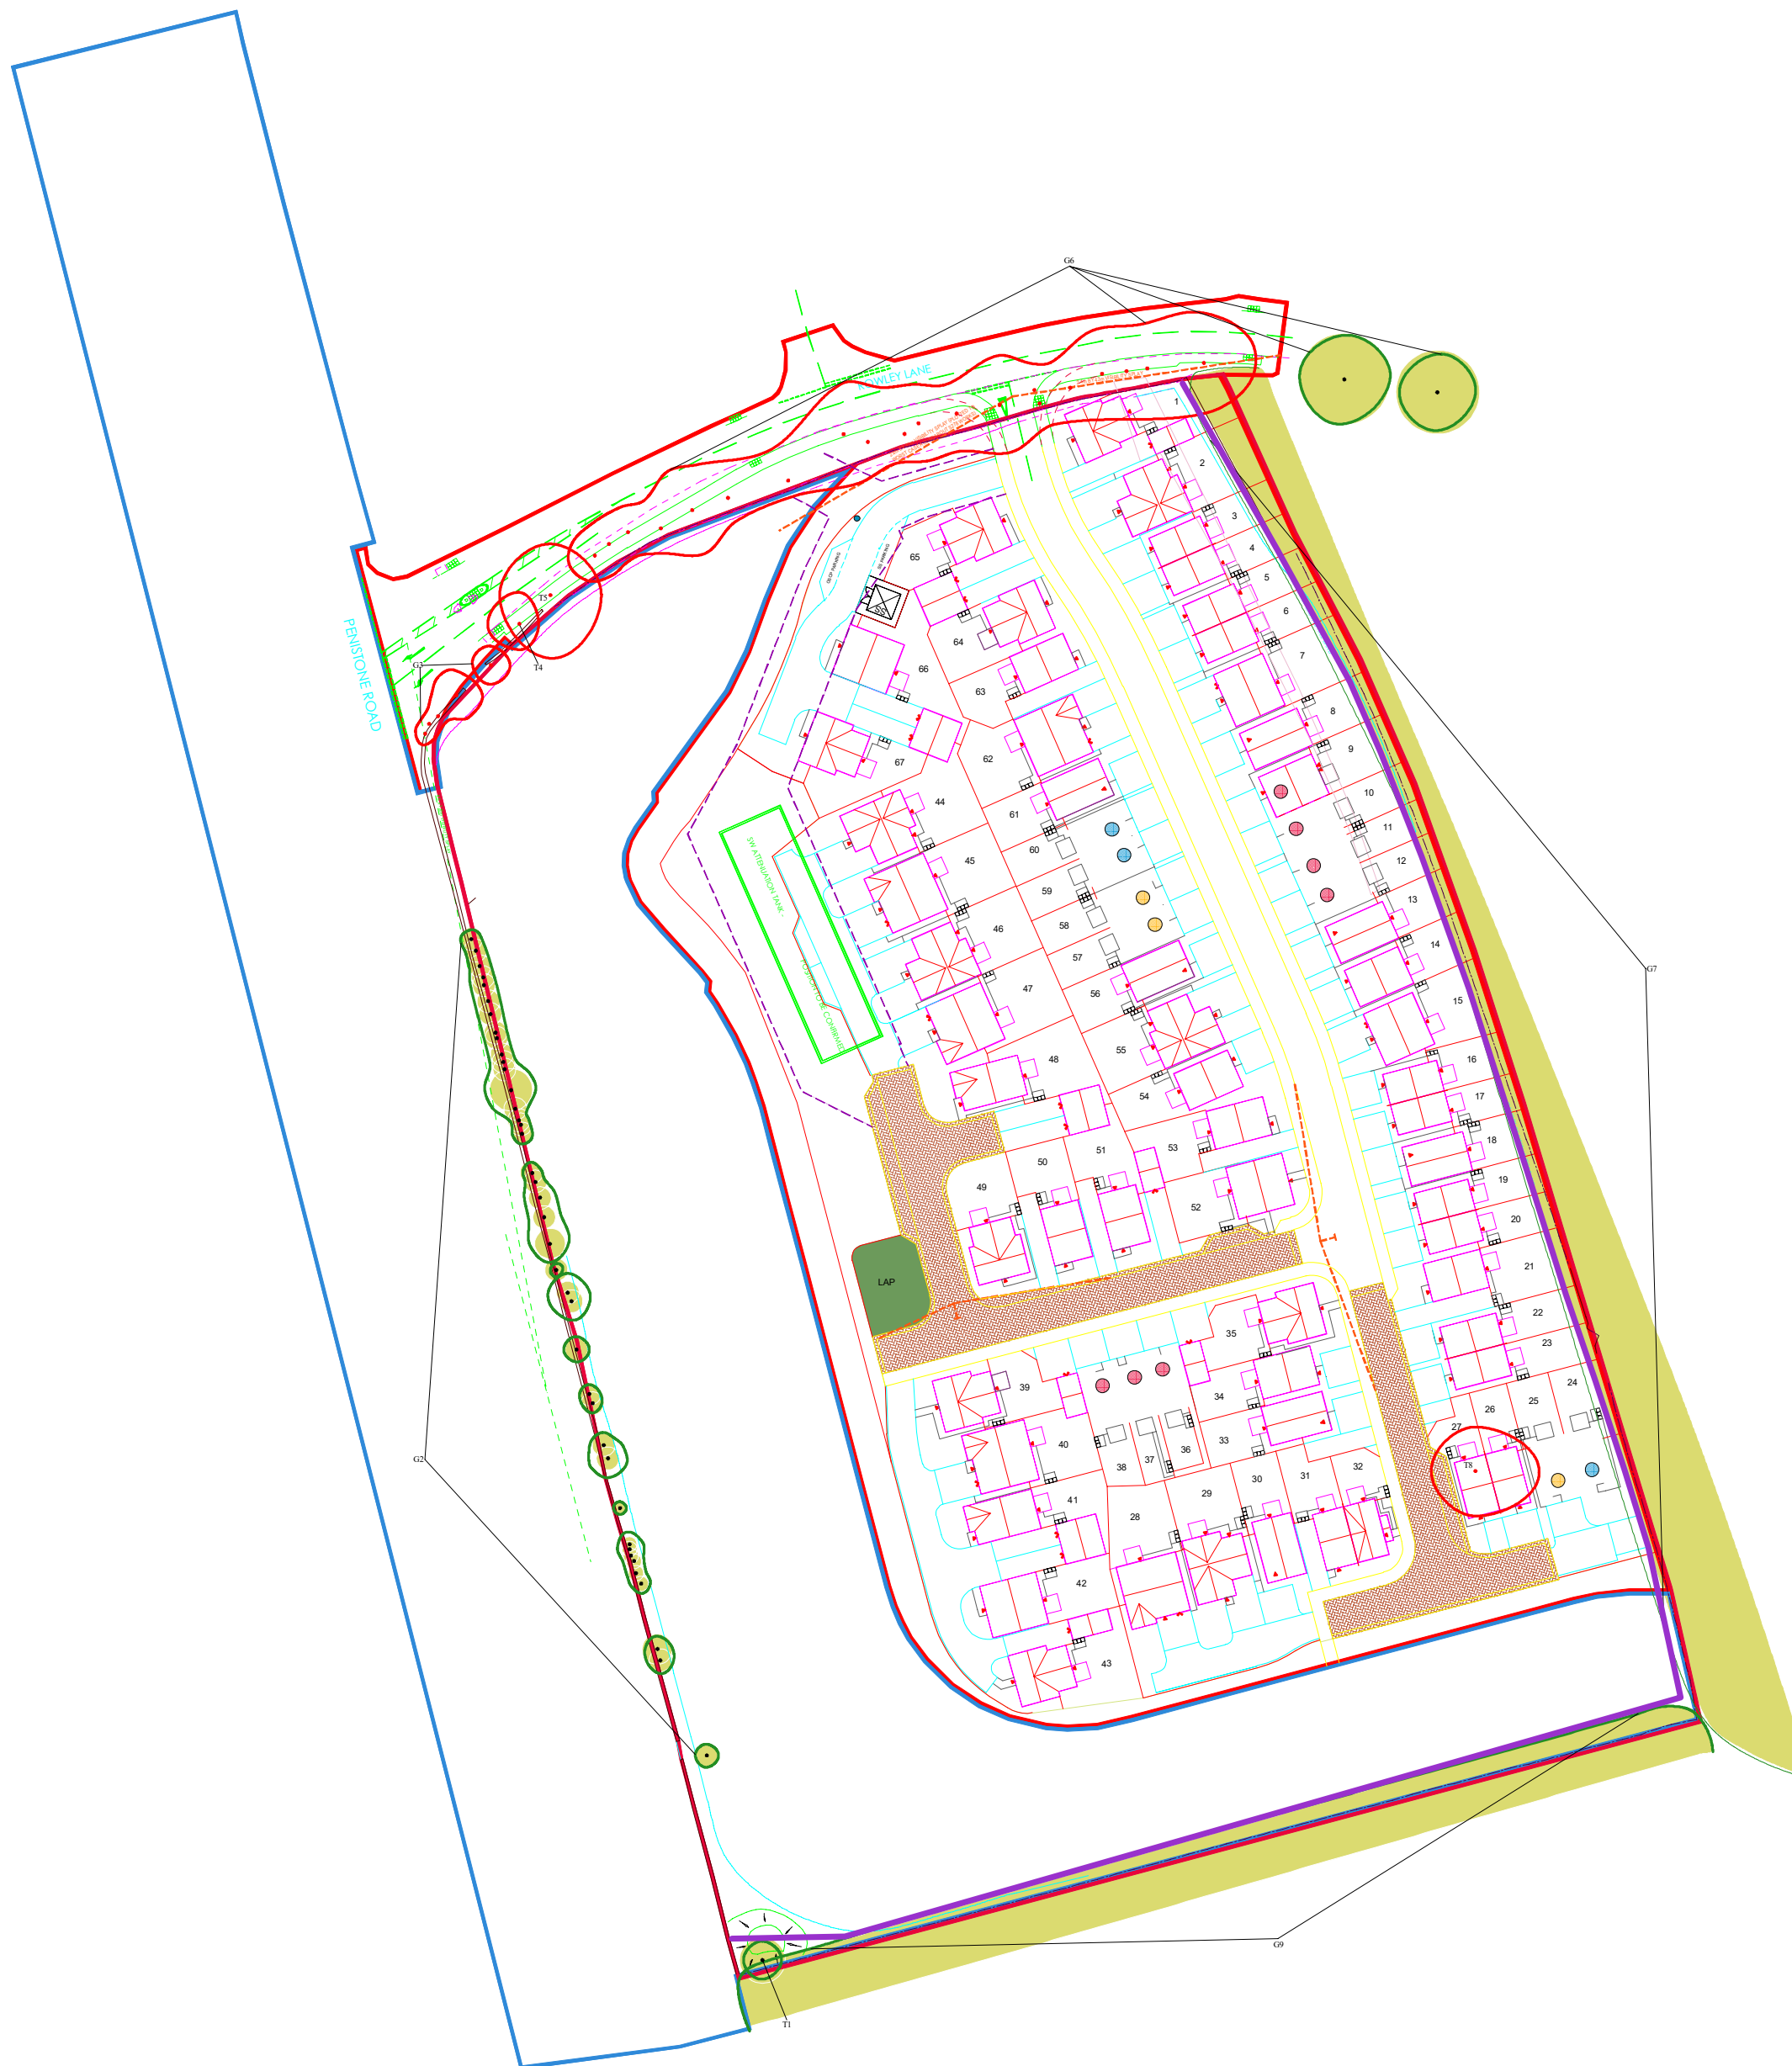
Appendix 4:  
Tree Protection Plan

TREE PROTECTION MEASURES

THE ROOT PROTECTION AREA (RPA) SHOULD IDEALLY REMAIN UNDISTURBED IF THE TREE IS TO BE RETAINED.

UNLESS OTHERWISE STATED IN THE ARBORICULTURAL METHOD STATEMENT, THE RPA NEEDS TO REMAIN UNDISTURBED.

TO ACHIEVE THIS, PROTECTIVE FENCING WILL BE INSTALLED TO ENCLOSE THE RPA TO MAKE A CONSTRUCTION EXCLUSION ZONE (CEZ).

THIS AREA IS TO BE CONSIDERED A RESTRICTED AREA; NO PEDESTRIANS, VEHICLES, THE STORAGE OF MATERIALS, EQUIPMENT OR MACHINERY ARE ALLOWED WITHIN THE CEZ, UNLESS SPECIFIED WITHIN THE ARBORICULTURAL METHOD STATEMENT.

IT IS IMPORTANT THAT THE PROTECTIVE FENCING IS CHECKED BY THE LPA OR THE ARBORICULTURAL CONSULTANT PRIOR TO ANY CONSTRUCTION WORKS BEING CARRIED OUT. IF THE TREE PROTECTION MEASURES ARE NOT CORRECTLY INSTALLED OR IF THEY DO NOT COMPLY WITH BS 5837: 2012, THIS COULD RESULT IN DAMAGE BEING CAUSED TO TREES AND CONSEQUENTLY A STOP NOTICE MAY BE SERVED BY THE LPA.

- 2.1.1 Prior to any construction activity, the first operation on site will be the undertaking of the necessary arboricultural works, as described at **Appendix 1**.
- 2.1.2 The tree works include the removal of **G3, T4, T5**, circa nineteen trees within **G6** (as shown in red on the plan at **Appendix 4**) and **T8**, to facilitate the proposed development.

- 3.1.2 The protective fencing must be constructed in accordance with BS 5837: 2012 *Trees in relation to design, demolition and construction - Recommendations* and will be located as shown on the Tree Protection Plan at **Appendix 4**. Where possible, the protective barrier will enclose the entire Root Protection Area (RPA) of the trees to make a Construction Exclusion Zone (CEZ); **this area is to be considered a restricted area; no pedestrians, vehicles, equipment or machinery are allowed within the CEZ and the storage of materials is not permitted, unless specified within this Method Statement.**
