S38 and S278 Works, Westgate, Cleckheaton

Stage 1 & 2 Road Safety Audit

COMBINED STAGE 1 & 2 ROAD SAFETY AUDIT

Ref: 23-285-001.01

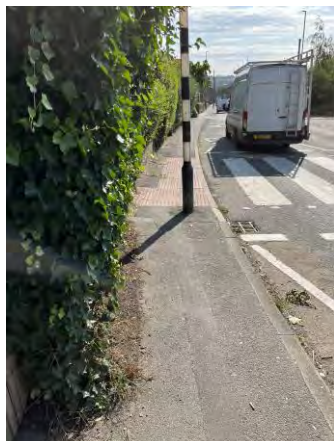
Location: Northern side of zebra crossing on A643 Westgate

Vegetation and obstructions in the footway to the north of the zebra crossing will increase the risk of pedestrians entering the carriageway into the path of oncoming vehicles resulting in collisions.

Vegetation along the back of footway to the north of A643 Westgate encroaches on the footway and reduces the available footway width. The reduced footway width will increase the risk of pedestrians entering the carriageway to pass pedestrians travelling in the opposite direction into the path of oncoming vehicles resulting in collisions.

The proposed location of the belisha beacon and lighting column at the back of footway will also reduce the footway width, creating a narrower footway across the northern side of the zebra crossing where people waiting to cross will further obstruct pedestrians travelling east/west on the footway. The obstructions created by the belisha beacon and lighting column combined with waiting pedestrians will also increase the risk of pedestrians entering the carriageway into the path of oncoming vehicles resulting in collisions.

It is recommended that overgrown vegetation along the back of footway is removed, and that the street furniture is relocated to reduce the impact of the obstruction they introduce.
