**ARBORICULTURAL IMPACT ASSESSMENT  
to BS 5837:2012  
at  
Swallow Lane (Phase 2)  
Golcar  
Huddersfield  
West Yorkshire  
HD7 4NB**

Jones Homes  
(Yorkshire) Limited

15543/AJB

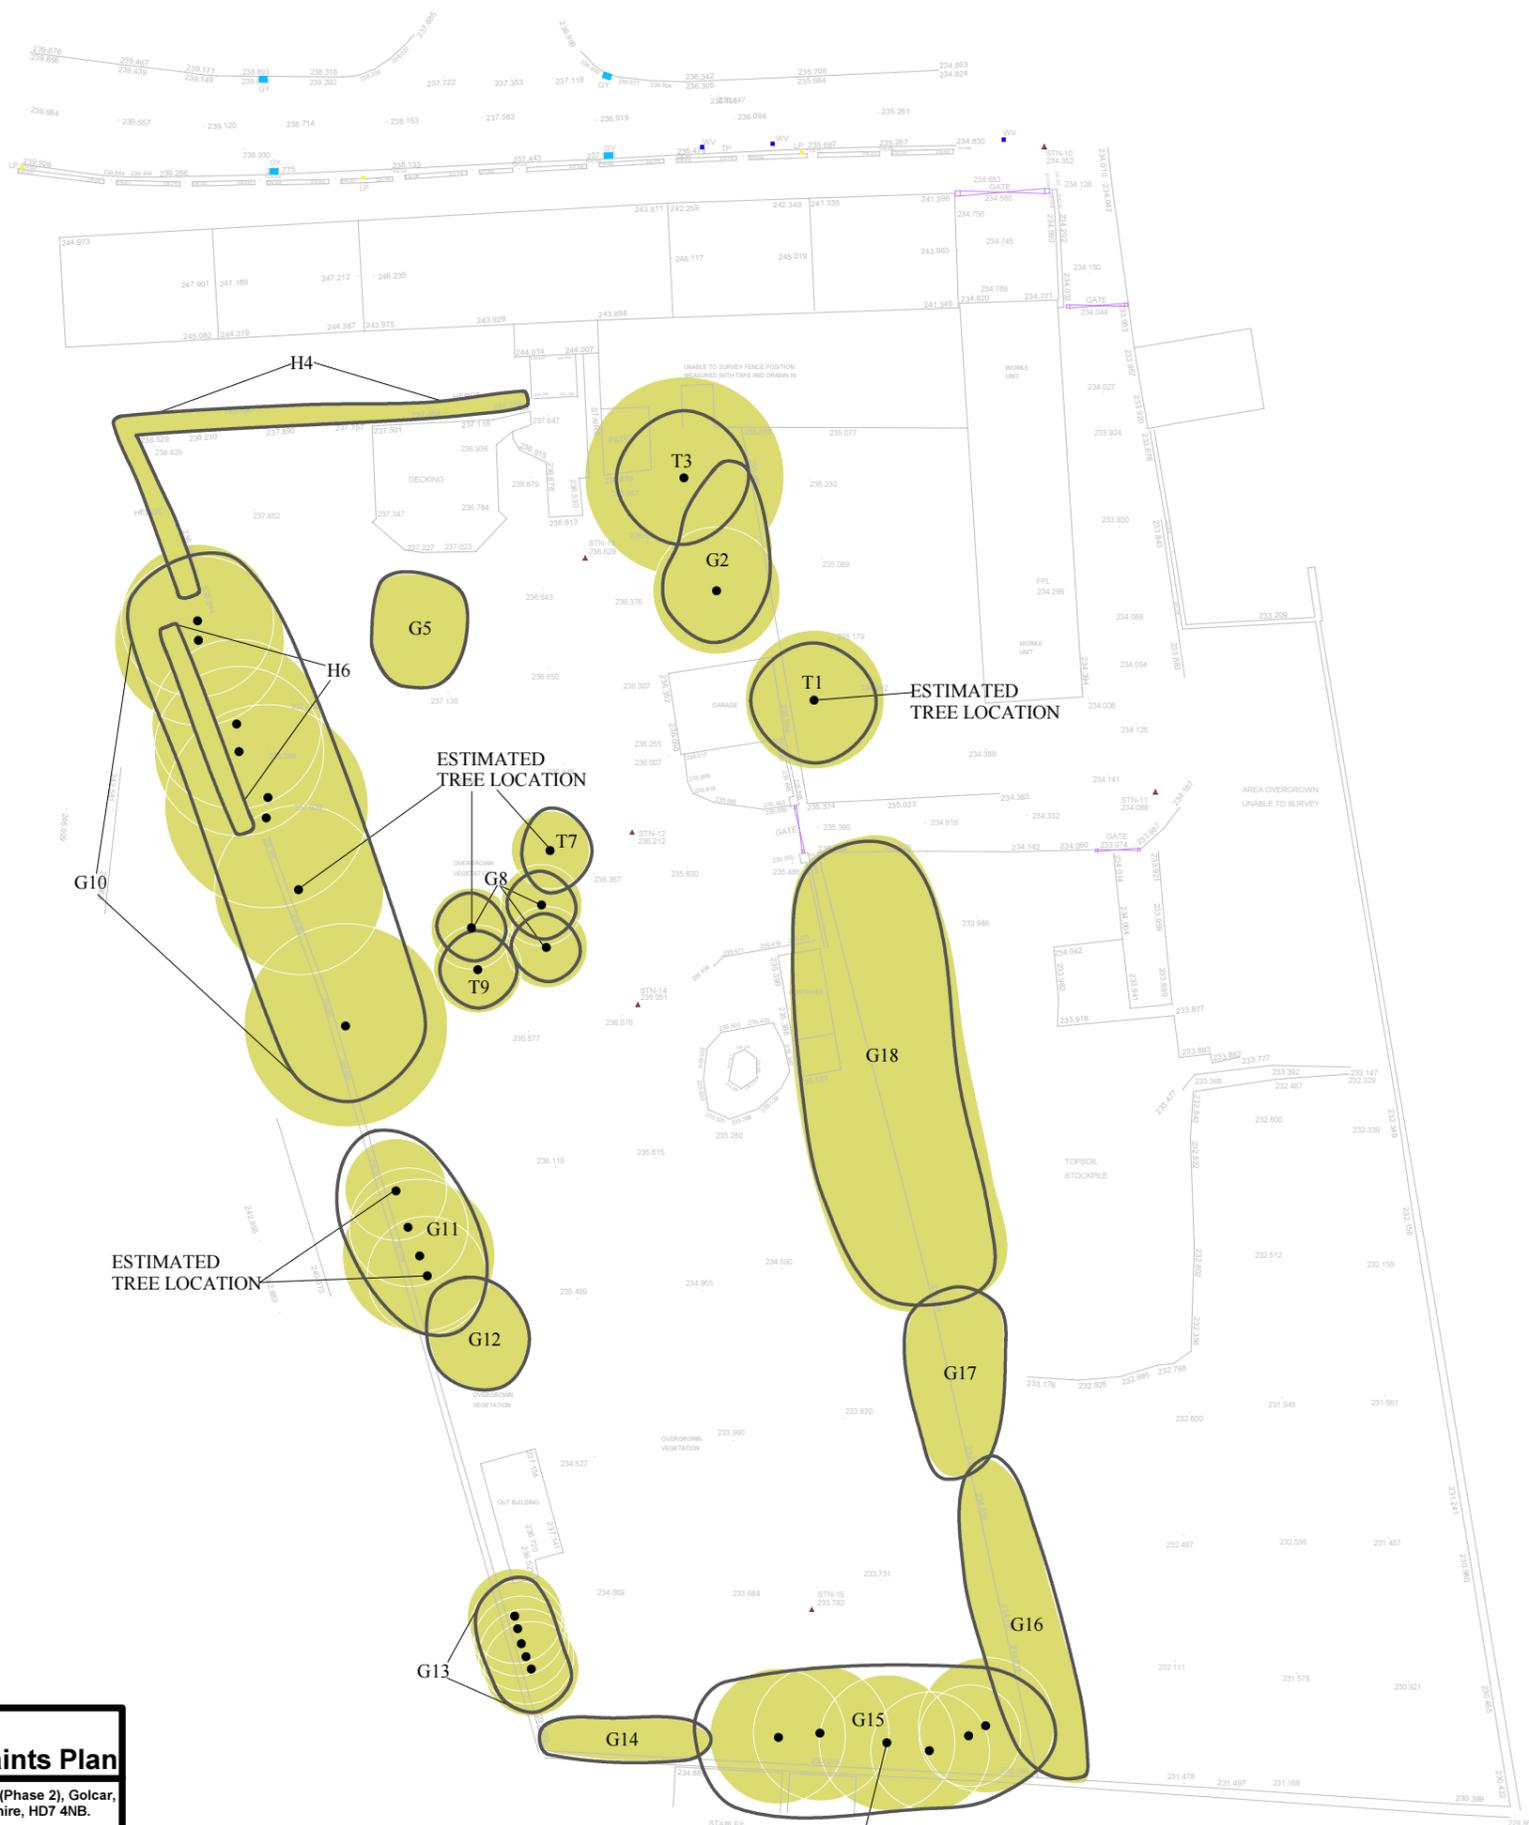
**Appendix 6:  
Tree Constraints Plan**

- 2.1 Full details of all individual trees surveyed are recorded in the tables at **Appendix 1**. A full explanation of the tables can be found at **Appendix 2**. Please refer also to the Tree Constraints Plan at **Appendix 6** for tree locations.

- 4.6 The protection of retained trees can be achieved by the creation of a Construction Exclusion Zone based on the Root Protection Area of a tree. The Root Protection Area of each tree or group is marked on the Tree Constraints Plan at **Appendix 6**.

**Root Protection Area: RPA**

THE ROOT PROTECTION AREA (RPA) INDICATES THE LIKELY ROOTING ZONE OF A TREE.

THIS AREA SHOULD IDEALLY REMAIN UNDISTURBED IF THE TREE IS TO BE RETAINED.

THE DEVELOPMENT PROPOSALS SHOULD THEREFORE BE DESIGNED TO AVOID THE RPA OF ANY TREE WHICH IS TO BE RETAINED.

IF IT IS NECESSARY FOR THE DEVELOPMENT TO ENCROACH INTO THE RPA OF A TREE WHICH IS TO BE RETAINED THEN SPECIALIST CONSTRUCTION TECHNIQUES AND MATERIALS MUST BE CONSIDERED.

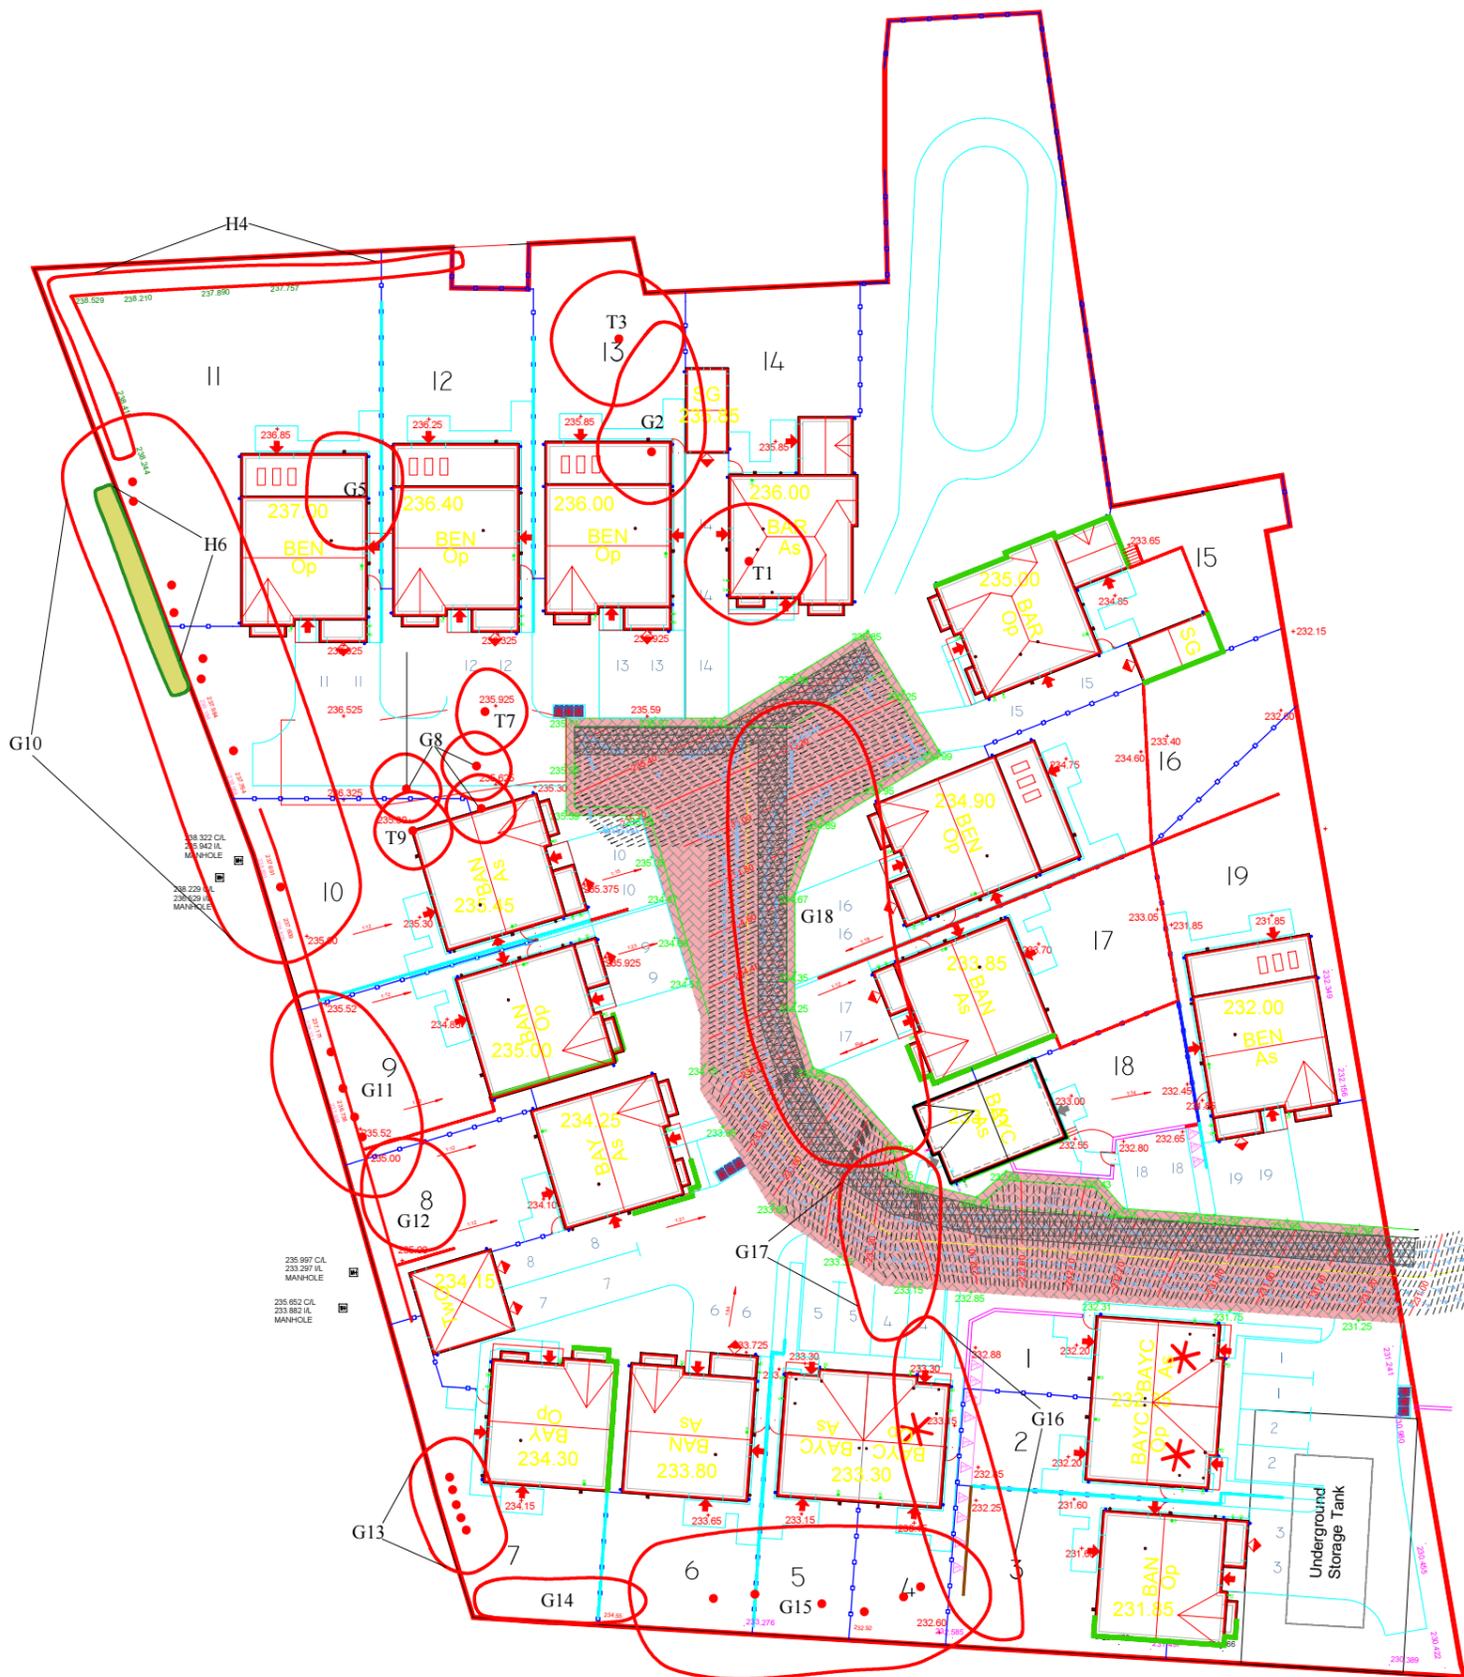
**Appendix 7: Arboricultural Implications Plan**

- 1.3.1 This report is compiled in accordance with *BS 5837:2012 'Trees in relation to design, demolition and construction – Recommendations'* and is based on an objective assessment of the existing vegetation.
- 1.3.2 The specific design of the proposed development has been considered within the Arboricultural Implication Assessment in **Section 3** and is detailed on the Arboricultural Implications Plan at **Appendix 7**.

- 3.4.1.1 **H6**, an off-site garden boundary hedge, is located beyond an existing boundary wall which will provide adequate protection to this hedge during the construction phase.

- 4.3 All trees within the site boundary are to be removed in order to facilitate the development. These are discussed in **Section 3.2** and their locations are shown on the Arboricultural Implications Plan at **Appendix 7**.

- 3.2.1 In order to facilitate the proposed development, it will be necessary to remove **T1, G2, T3, H4, G5, T7, G8, T9, G10, G11, G12, G13, G14, G15, G16, G17** and **G18**, each of which are considered to be of a low value, provide little to the local amenity and as such, fall into retention category 'C'.
