Moss Edge Farm, Hollin Brigg, Holmbridge, HD9 2SD

Foul Drainage Assessment

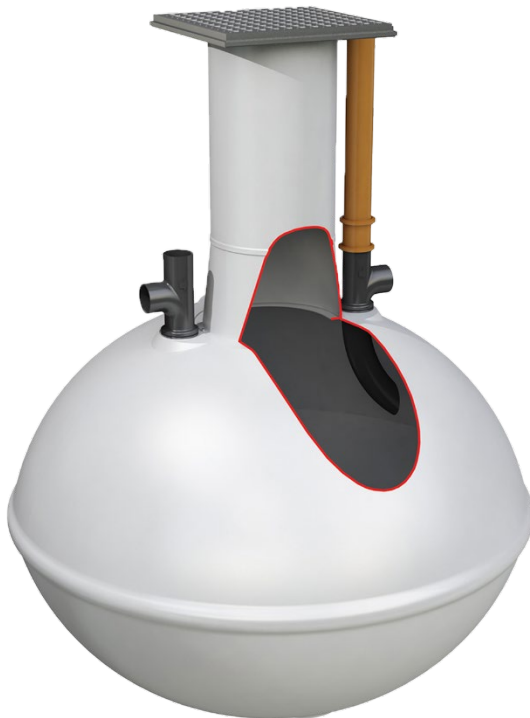
Klargester Alpha Septic Tank – Ref STS04610

Proposed Septic Tank

The existing farm is surrounded by fields owned by the applicant, where the existing farmhouse is perched on the hill of Moss Edge at the top of Holmbridge. Percolation tests have not been conducted, as the farm currently has a septic tank and drainage field. The existing tank is to be replaced and re-positioned away from the proposed dwelling although the current drainage field will be re-used.
