**ARBORICULTURAL REPORT  
to BS 5837:2012  
at  
Former Kirklees College  
New North Road  
Huddersfield  
West Yorkshire  
HD1 5NN**

**JCA Ref:**  
22125/AJB

## Appendix 5: Tree Constraints Plan

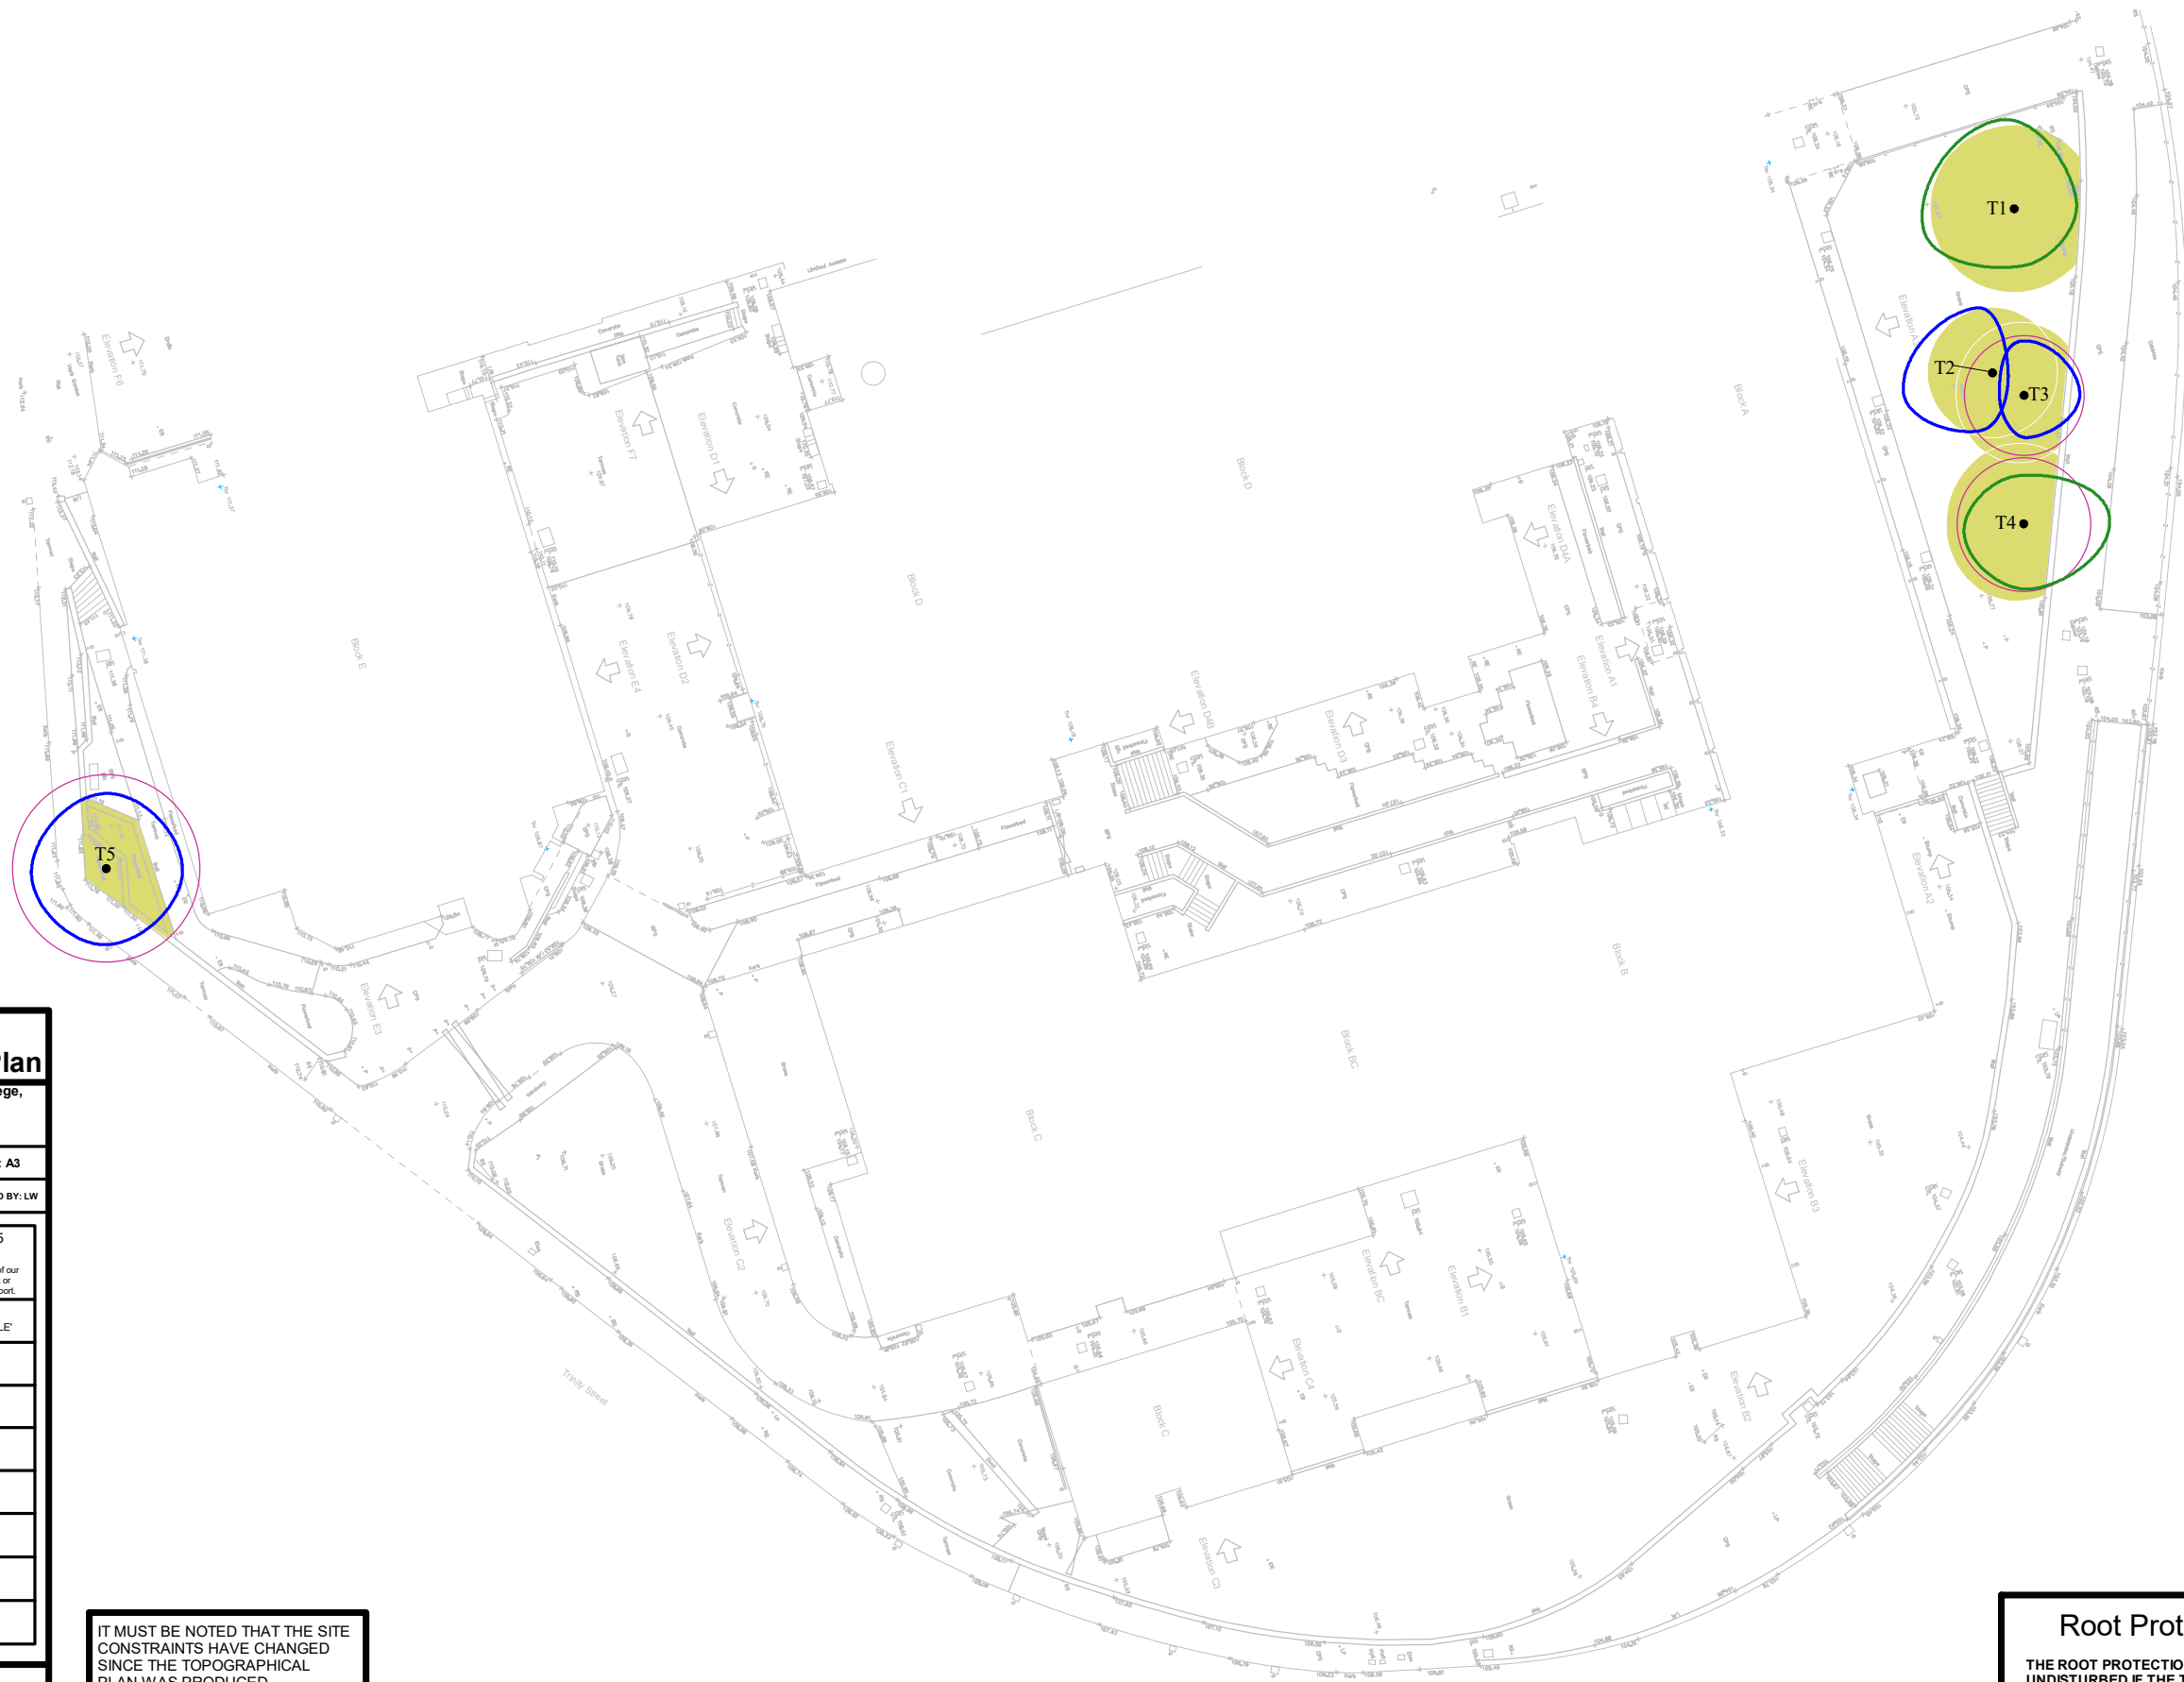
- 4.1 The location of each tree is plotted on the Tree Constraints Plan at **Appendix 5**. The canopy spread of each surveyed item is colour coded as follows; Retention Category A: **Green**, Retention Category B: **Blue**, Retention Category C: **Grey**, Retention Category U: **Red**. The associated Root Protection Area (RPA) is also shown in **Gold**.

IT MUST BE NOTED THAT THE SITE  
CONSTRAINTS HAVE CHANGED  
SINCE THE TOPOGRAPHICAL  
PLAN WAS PRODUCED

THE ROOT PROTECTION AREA SHOULD IDEALLY REMAIN  
UNDISTURBED IF THE TREE IS TO BE RETAINED.

THE DEVELOPMENT PROPOSALS SHOULD THEREFORE BE  
DESIGNED TO AVOID THE RPA OF ANY TREE WHICH IS TO  
BE RETAINED.

IF IT IS NECESSARY FOR THE DEVELOPMENT TO ENCROACH  
INTO THE RPA OF A TREE WHICH IS TO BE RETAINED THEN  
SPECIALIST CONSTRUCTION TECHNIQUES AND MATERIALS  
MUST BE CONSIDERED.

- 4.2 In order to enable the survival of trees shown to be retained within any proposals, encroachment into the canopy of the tree and/or its RPA should be avoided wherever possible. This relates to not just the location of new buildings, but also to the location of new areas of hard standing, proposed utility routes and any ground level changes (both excavations and soil piling). Where this is not possible, specialist construction methods and materials will need to be used.

- 4.4 Retained trees will require adequate protective measures during development. Such measures typically entail temporary protective fencing, installed to the full extent of the RPA. Where this is not entirely possible, ground protection may also comprise part of the protective measures. This includes a compaction reducing construction detail which enables a degree of construction traffic over/within the RPA.
