# HERITAGE IMPACT ASSESSMENT

# APPENDIX 3.1 – Built Heritage Impact Assessment and Setting Assessment

## Phase 2 – Kirklees Cultural Heart – Combined Museum & Art Gallery

On behalf of Kirklees Council

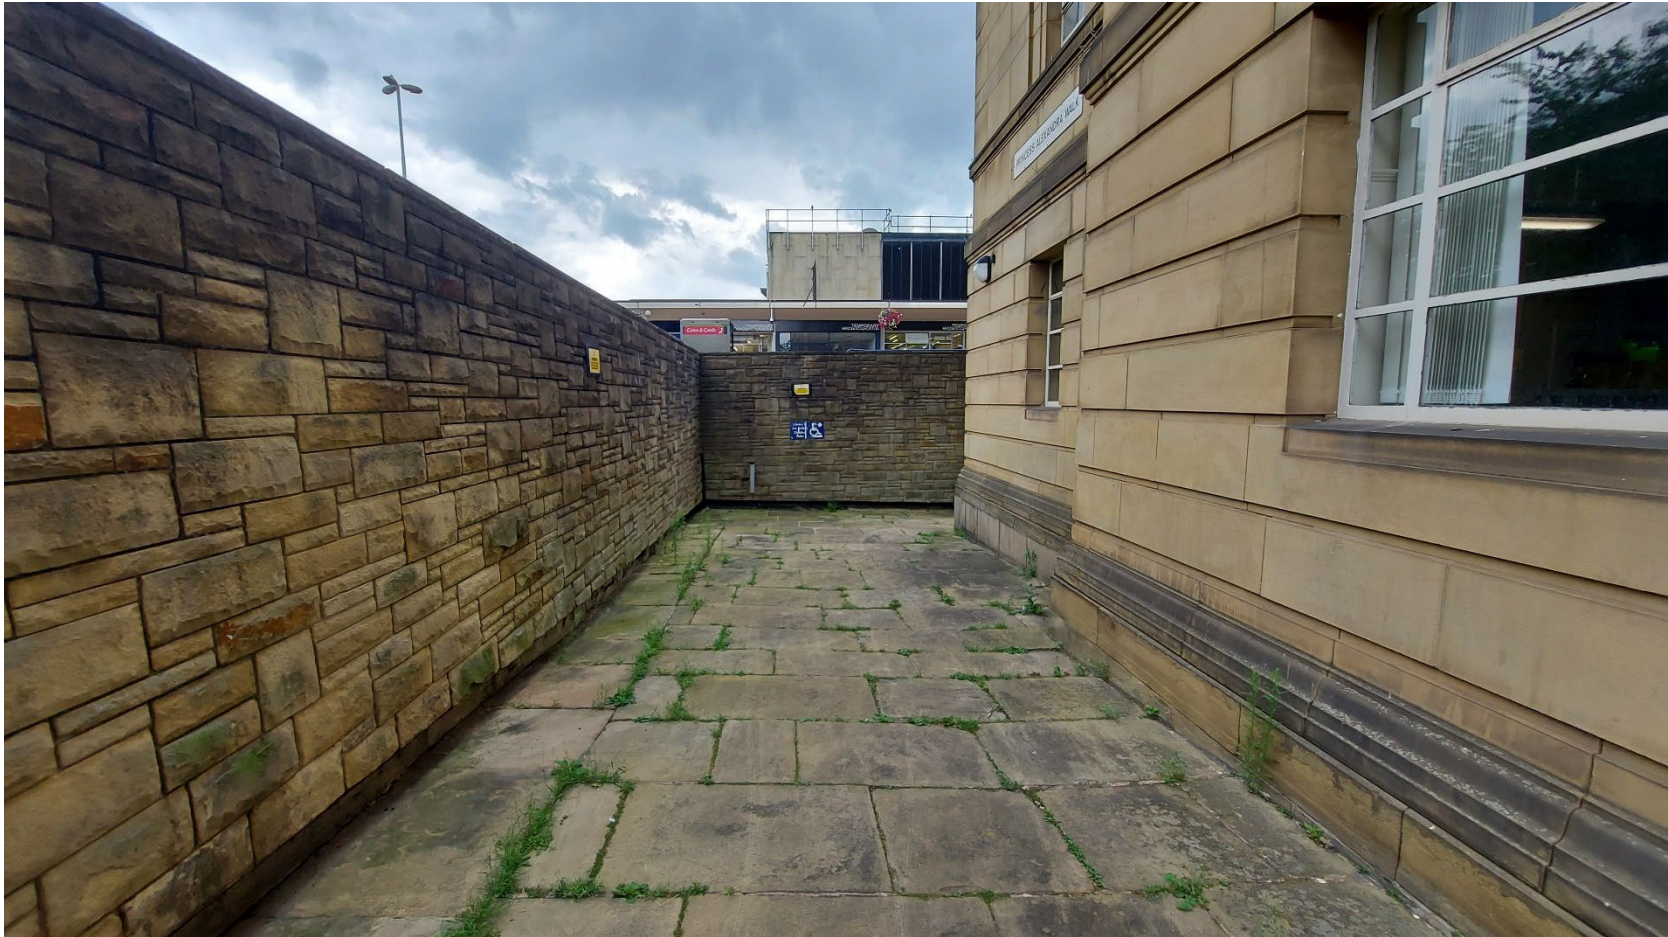
*Plate 5: The area of the proposed outdoor classroom and modern retaining wall as existing.*

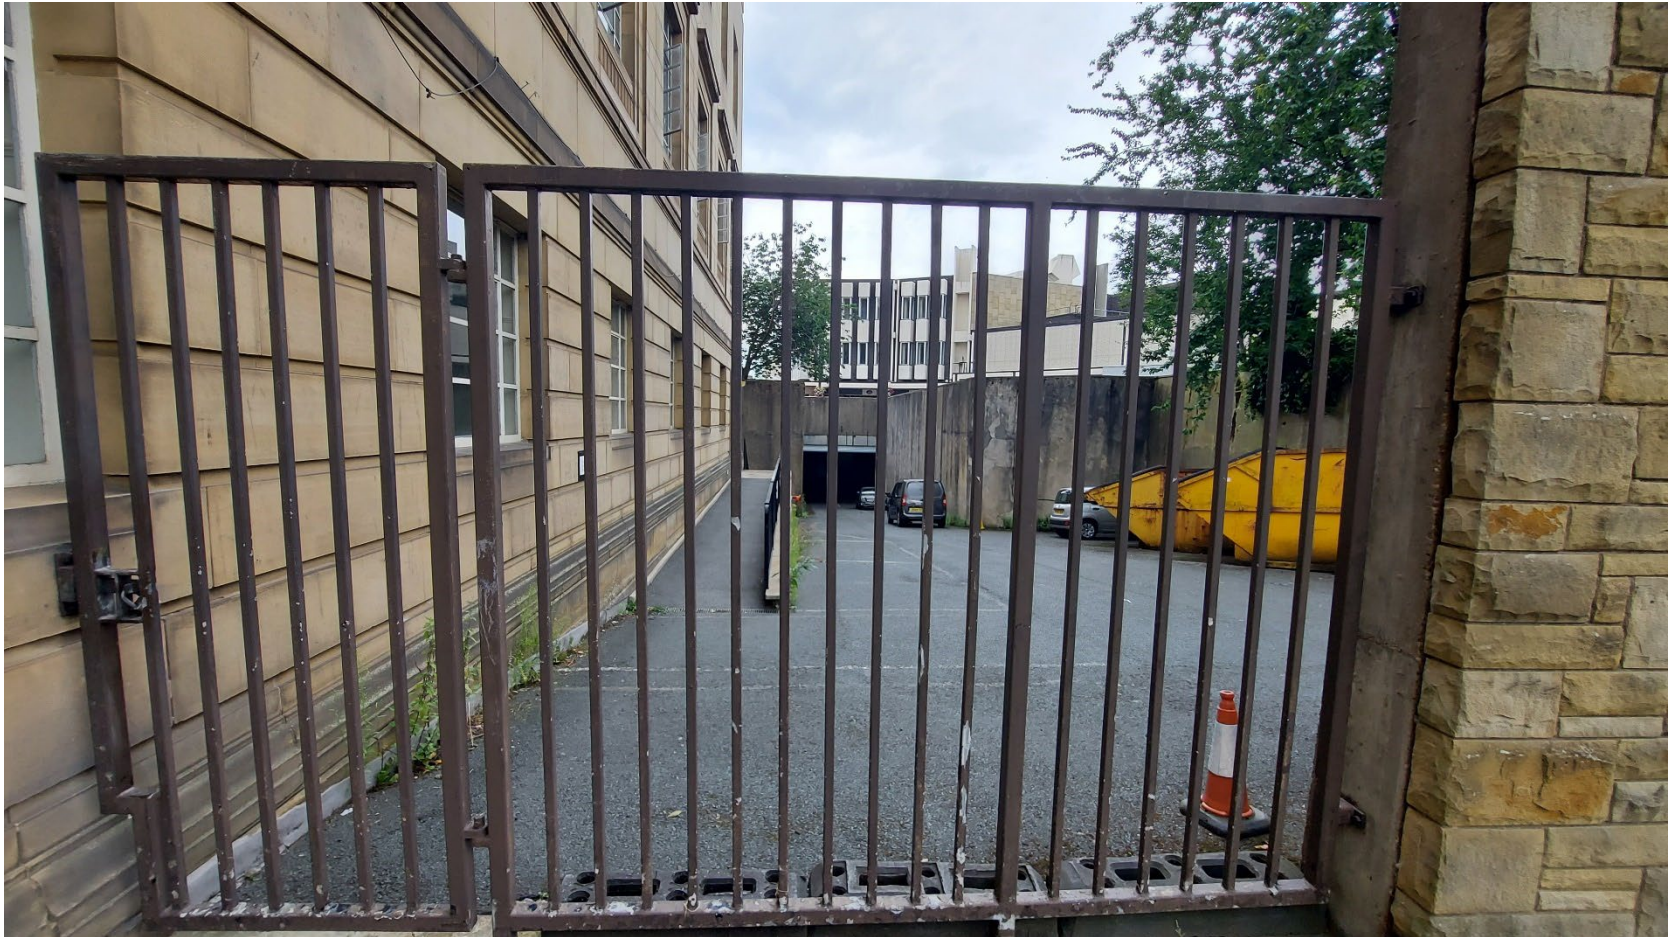
*Plate 6: The area of the proposed outdoor classroom and modern retaining wall as existing.*

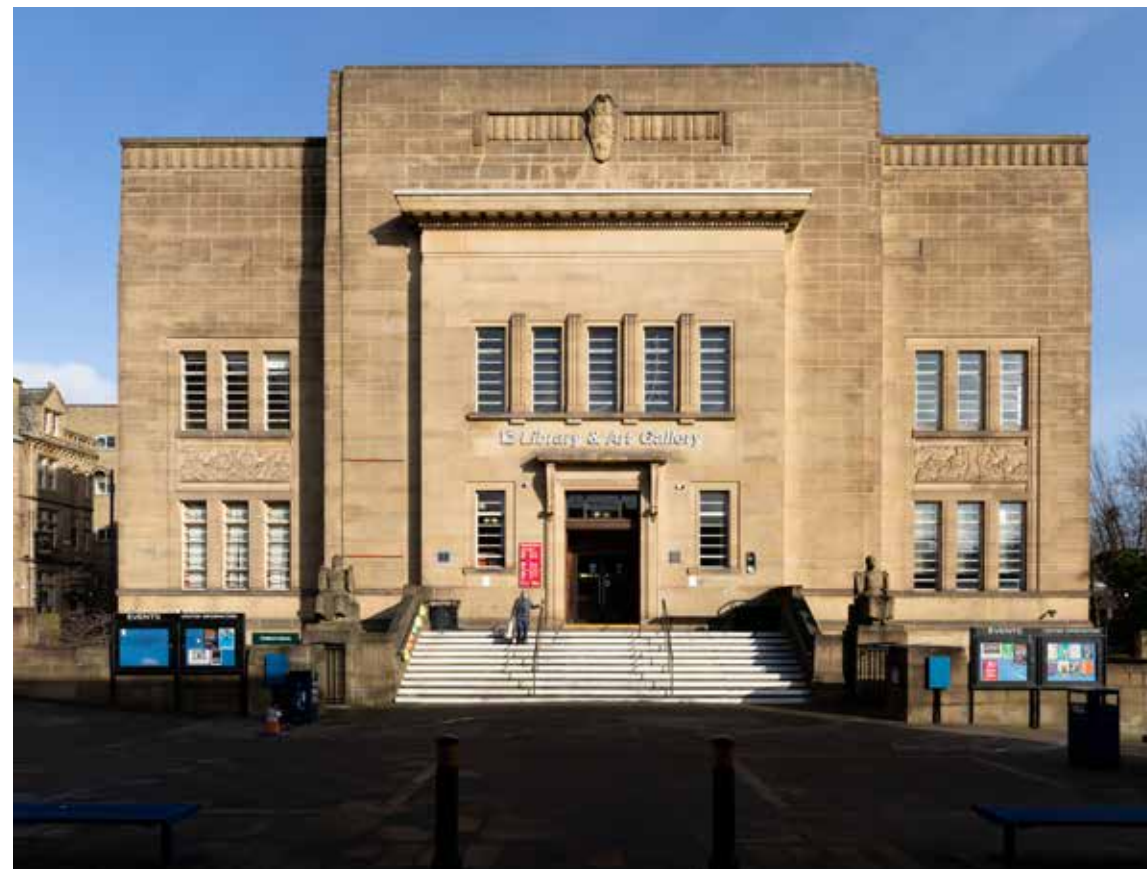
4.4.1 - South elevation onto Princess Alexandra Walk

This south-facing elevation is in a reductive Art Deco style with clear Egyptian and Greek stylistic influences. The entrance is somewhat pinched, set at the centre of the elevation below a series of five tall windows that describe the first-floor landing above the entrance hall. The public entrance seems too understated a gesture for the boldness of the elevation but is likely the consequence of achieving a practical threshold between inside and out. The two enthroned sculptured of 'Spirit of Literature' and 'Spirit of Art', by James Woodford RA and situated to the west and east of the entrance respectively, are of very high aesthetic and artistic value. These are carved from local stone and are highly significant assets in their own right, but also as components in the composition and stylistic execution of the primary elevation. Their inclusion emphasises the main entrance approach. Woodford also created the decoratively carved relief panels set in the spandrel between the ground and first floor windows, which comprise grouped figures symbolising arts and cultural activities. Bronze grilles that originally marked the entrance door head and windows flanking the entrance have since been lost. The central handrails on the approach stair are later 1980s additions.

As an aesthetic and architectural composition, the south elevation is carefully controlled and has an austere elegance. The detailing shows a strong transition between the Art Deco influences of the 1930s and the Modern Movement that was set to dominate.

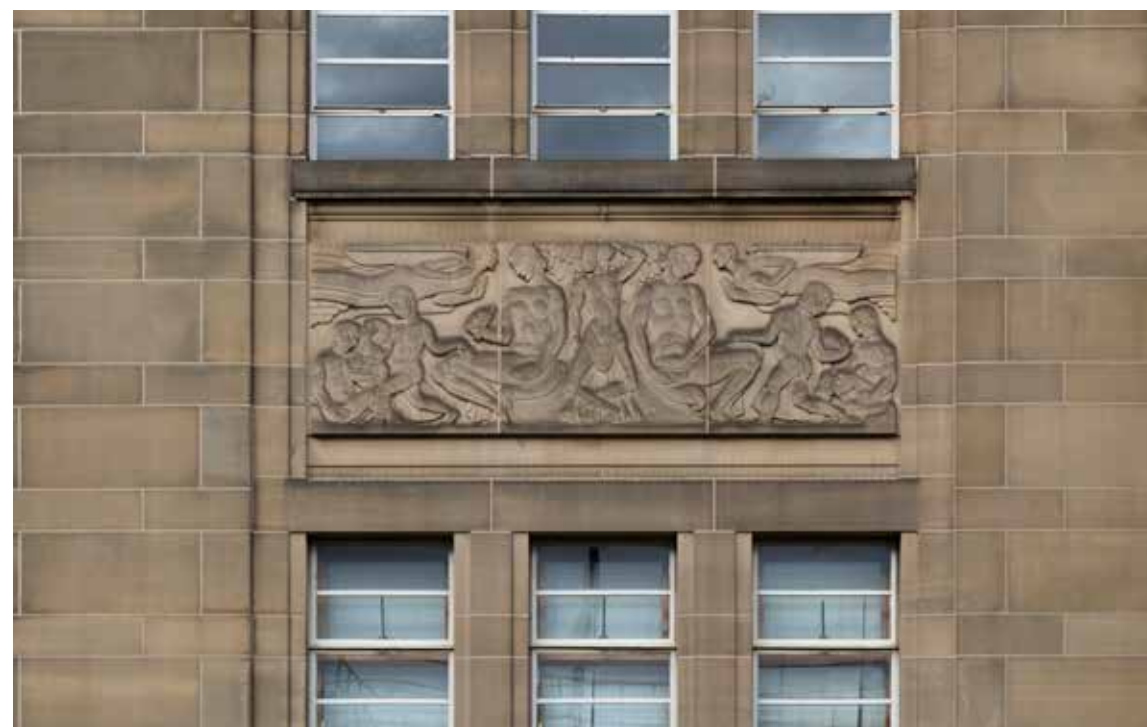
4.4.3 - Decorative panel on south elevation, James Woodford, 1939

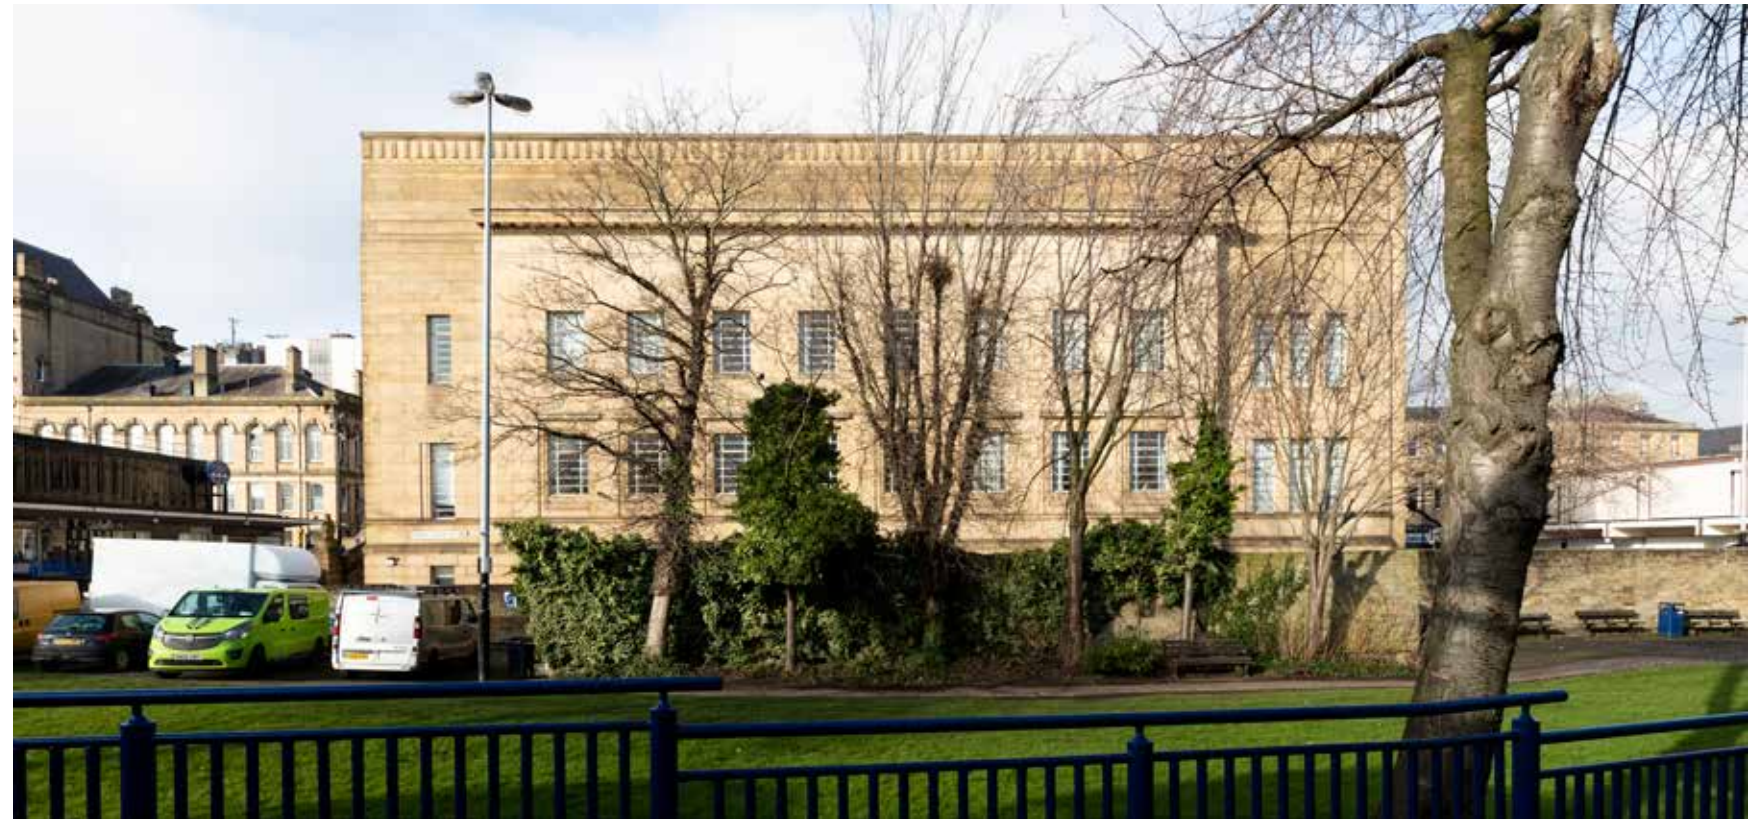
4.4.5 - East elevation facing the Piazza Shopping Centre

The façade of the Library was to be seen in the context of the primary elevation and as a continuation is of the same architectural aesthetic, but on a simplified canvas with reduced artistic adornment. The changes made to the surrounding townscape as a result of the 1969-1974 Murrayfield development left this elevation far more visible than Ashburner would have envisaged. Furthermore, the removal of Bull and Mouth Street and the subsequent formation of a steeply sloping route into subterranean tunnels has served to isolate this elevation from the public realm. This space was initially excavated to form a car park and adjacent delivery zone. The continuation of this as an access route from the tunnels to the upper street level was made some time after 1990.

The east elevation holds value for its architectural detailing, however the erosion of it imposes a negative impact on this aspect of the building.

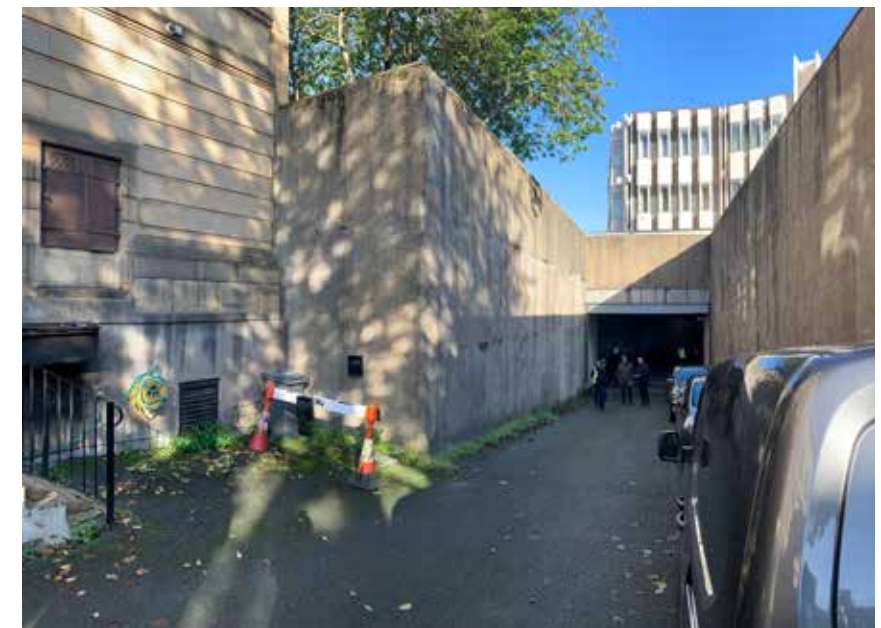
4.4.7 - Tunnel access below east elevation

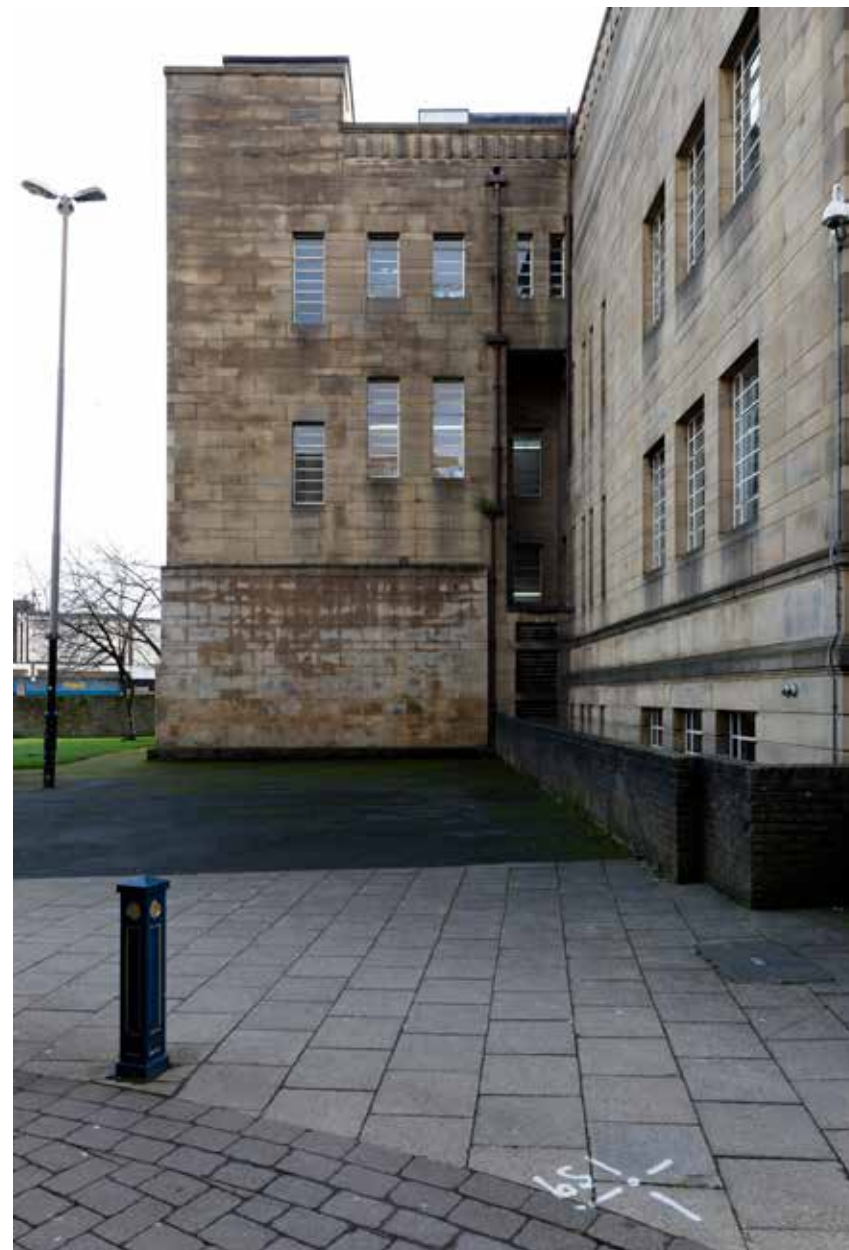
4.4.11 - North elevation

The north elevation was not designed to be of aesthetic significance, with architectural detailing only retained at the wall head which, from a distance, would have been visible above the roofs of the adjoining properties. The current setting is the result of the Murrayfield redevelopment, which resulted in the extensive excavation of this area to a substantial depth so that access tunnels could be formed. This has effectively removed much of the archaeological potential. To maintain the service route to the rear of the service block, a small retaining wall was formed in the same brickwork as found in the wider Murrayfield development and in the Market Hall. Although the ground level was reinstated, the land which was subsequently given over to a combination of soft and hard landscaping offers almost no positive relationship to the adjoining spaces or buildings. The open aspect of this area was left in this manner to enable future development at the northern end of the building. Furthermore, it is noted that a strategy for northward expansion formed part of Ashburner's original design intent, which may explain the blank nature of this elevation.

In summary, the north elevation in isolation comprises little in the way of aesthetic value and is of low significance when compared to the building's other elevations. Furthermore, it could be argued to embody negative significance when weighed in the round with its immediate setting, which is considered to impart a negative impact on the building as a whole and its wider context.

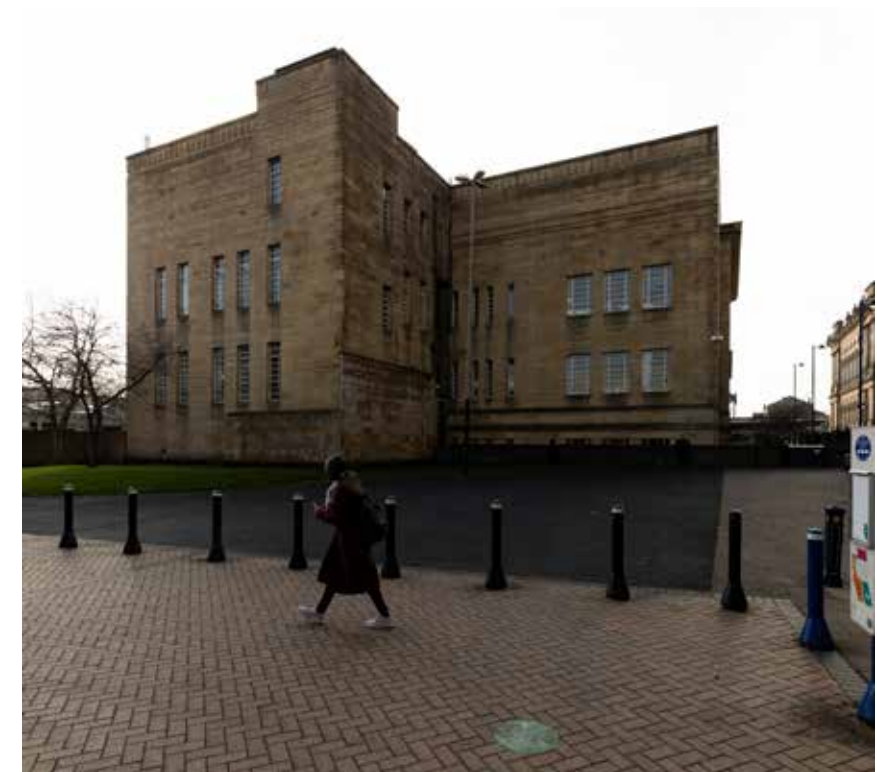
4.4.12 - North elevation from Victoria Lane

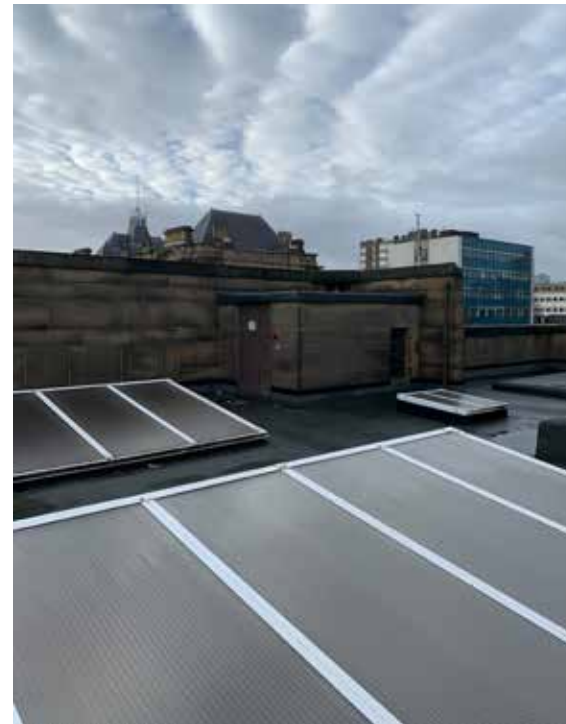
4.4.13 - Modern lanterns to roof

The presence of roof lanterns illuminating the gallery holds some significance tied to the functional operation of these spaces, however the absence of original material and the architectural form of the lanterns themselves offer little historic value.

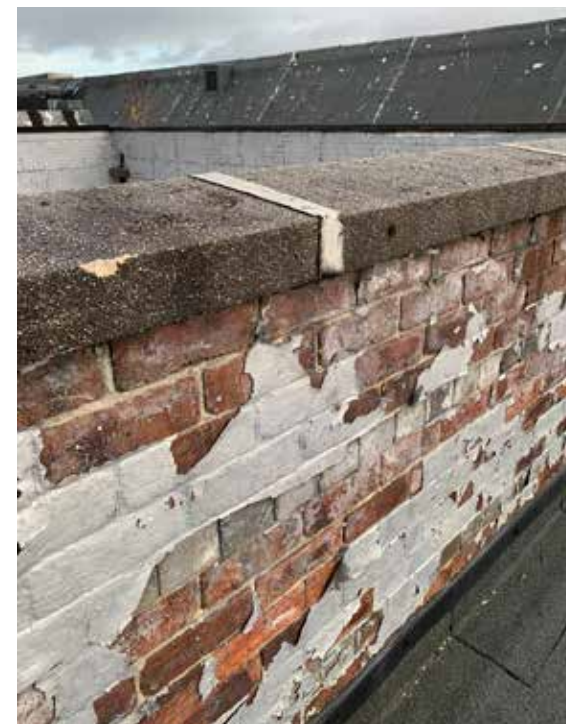
4.4.17 - Deteriorating roof parapet

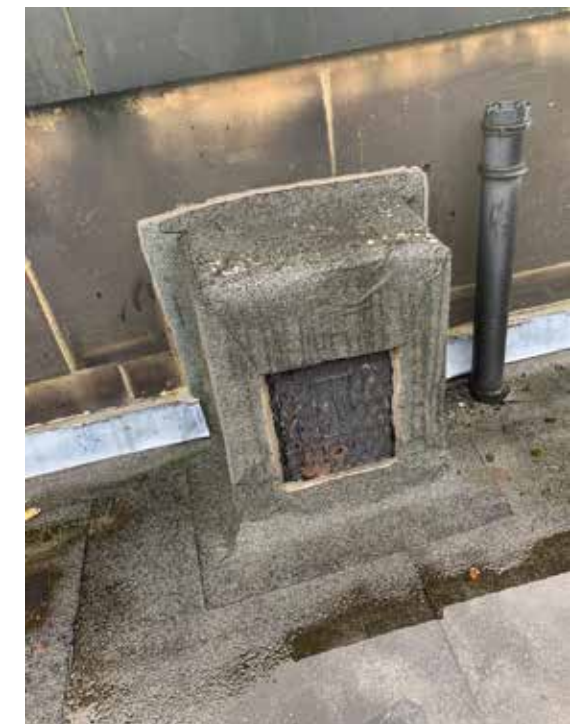
4.4.18 - Service access at roof

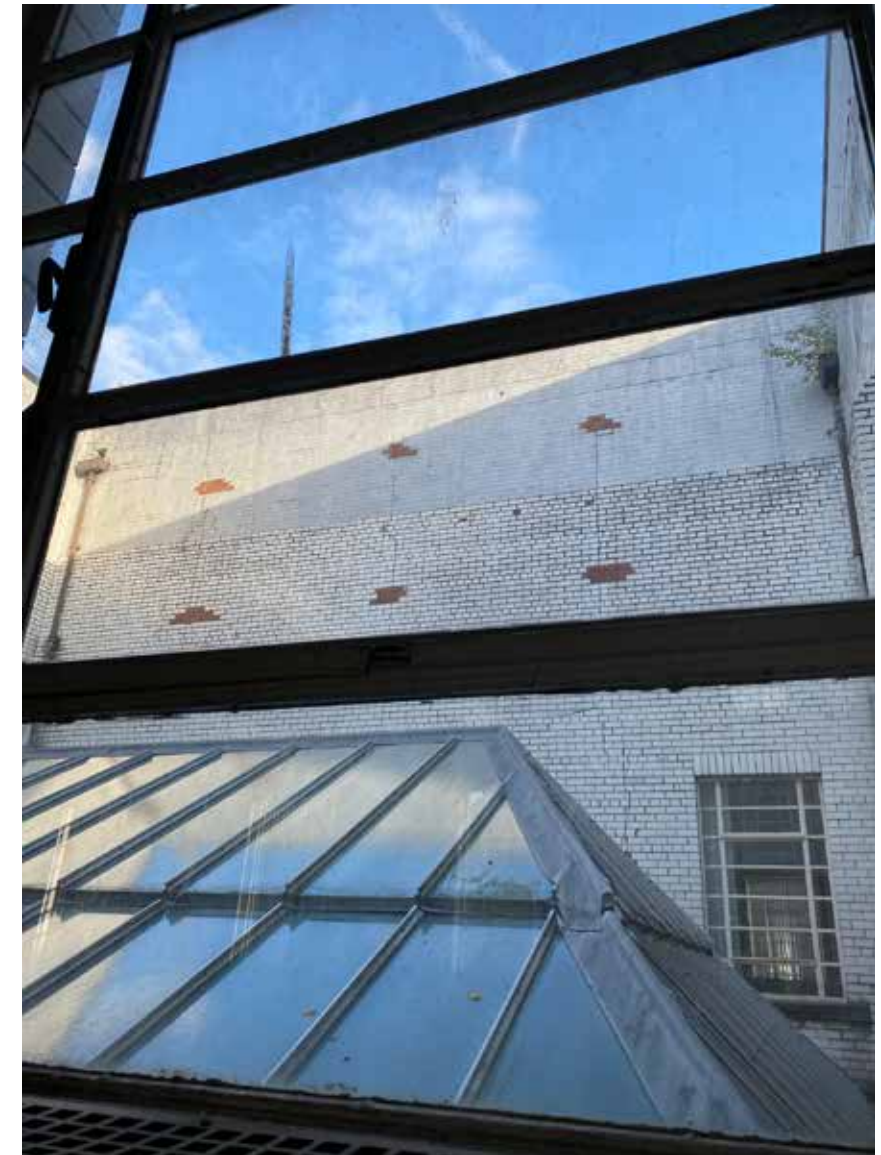
4.4.19 - Lightwell above atrium

4.4.20 - Lightwell above atrium

The lightwell's form and application of materials are not unique or remarkable features, however its inclusion is a key articulating device that drives the building's typology and floor plan arrangement. The importance of natural light penetrating deep into the building characterises these spaces afforded by the lightwell serves to heighten the building's role as a hub for civic and cultural life. As such, the lightwell has historic value for its form and purpose within the wider arrangement of spaces but is low in aesthetic value in relation to its design and use of materials.

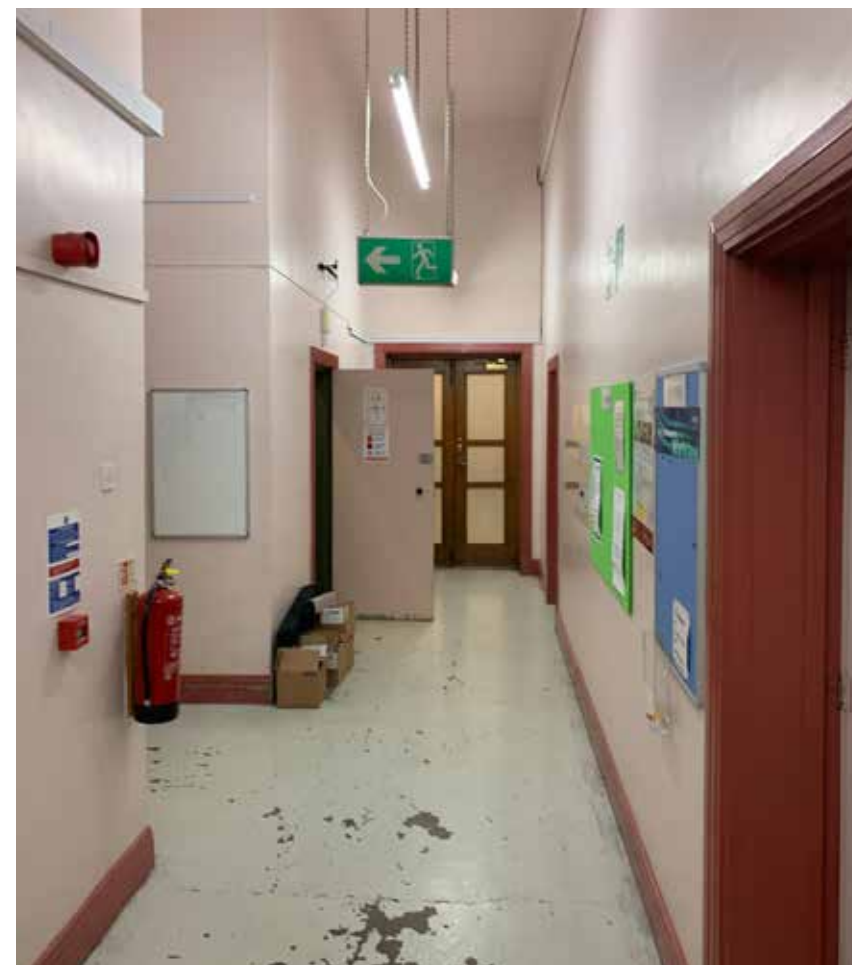
4.5.31 - Corridor (Rm.43)

The service corridor is plain, with the walls and ceiling plastered but without decorative features. The floor appears to be painted concrete. Doors opening into the corridor are typically flush, with those opening into formal library spaces constructed in oak and usually glazed. Skirtings and door architraves are in a stepped profile and painted. Generally, the building's circulation spaces hold no aesthetic value, and only very limited historic value for their part in the overall layout of the library floor plan where their original form remains unchanged.

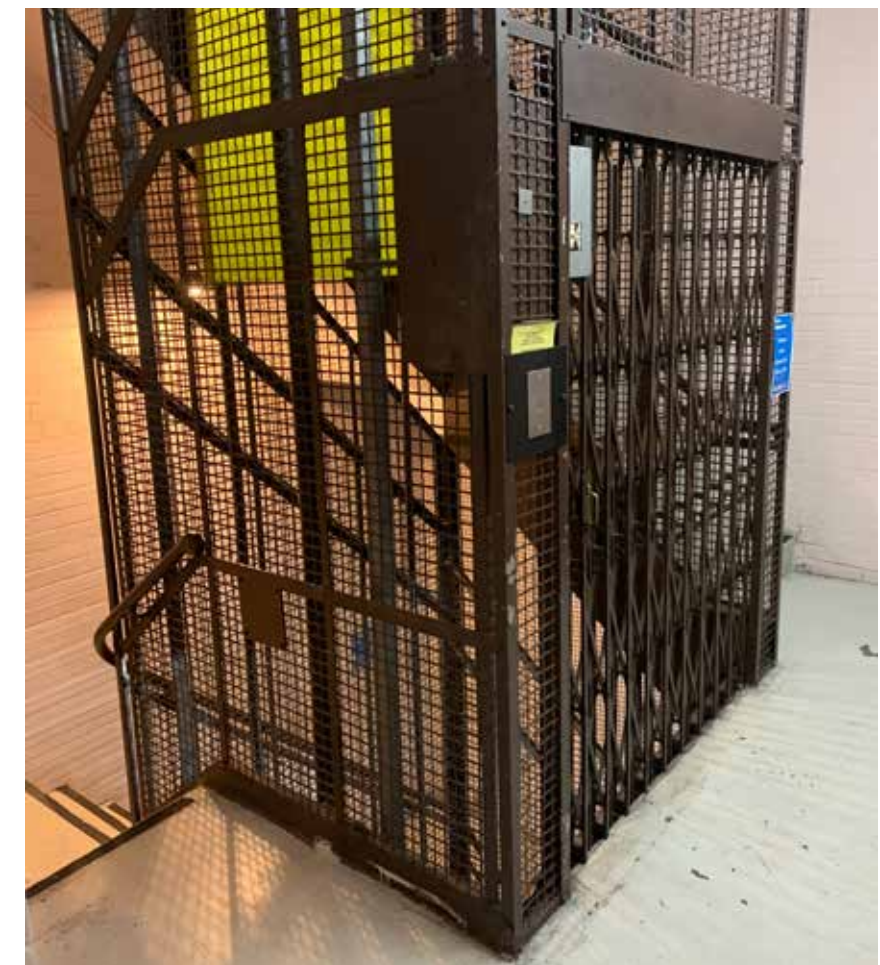
4.5.32 - Stair and Lift (Rm.40 & 41)

The service stair, landing and lift core are common between the floors. The walls of the stair are painted common brickwork in Flemish bond and the stair and floor are painted concrete. Tall Crittall windows occur at each level, with the lower panes in obscure cast glass. The service lift is original, comprising a caged car set within a steel mesh shaft with manual-folding guarding at each entry point. The space is appropriately utilitarian in nature. The lift has historic value as a component of the original design but has no broader significance.

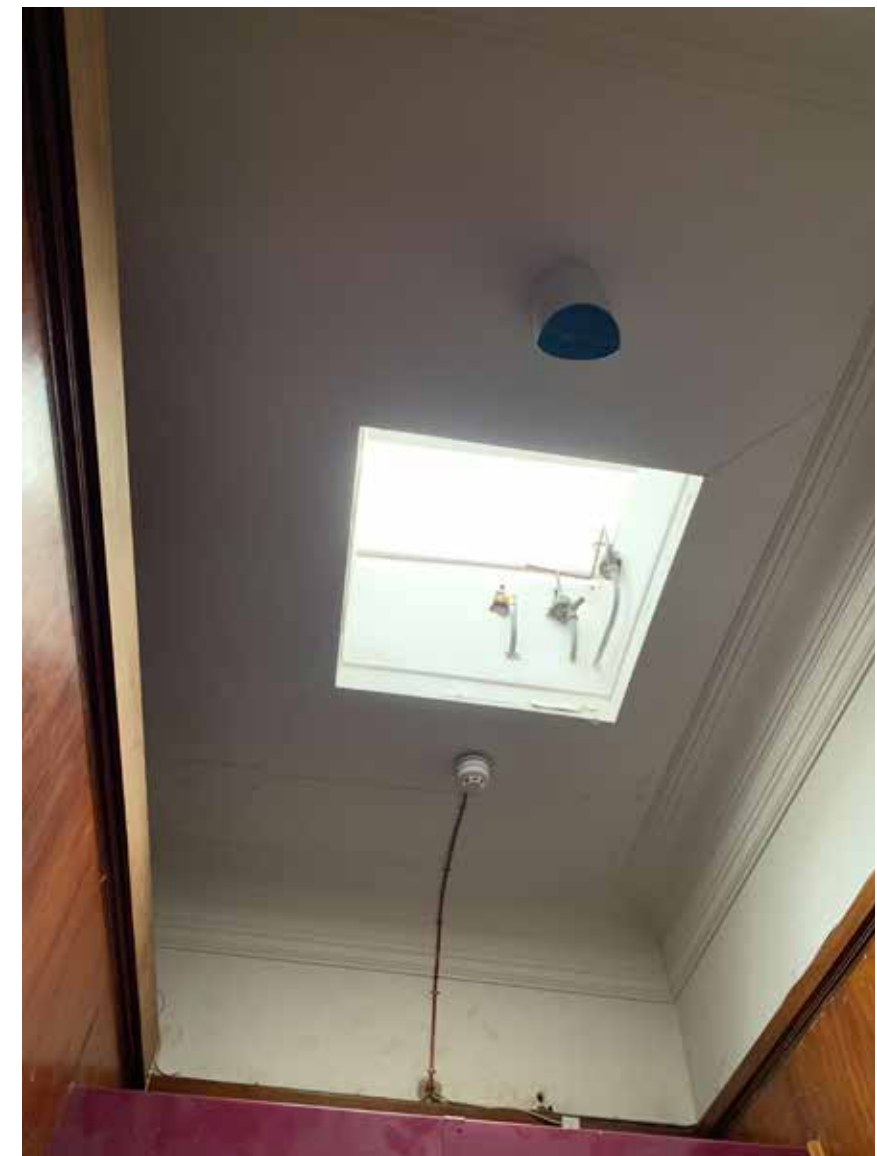
4.7.4 - Rooflight to Gallery Exit Lobby (Extension of Rm.91)

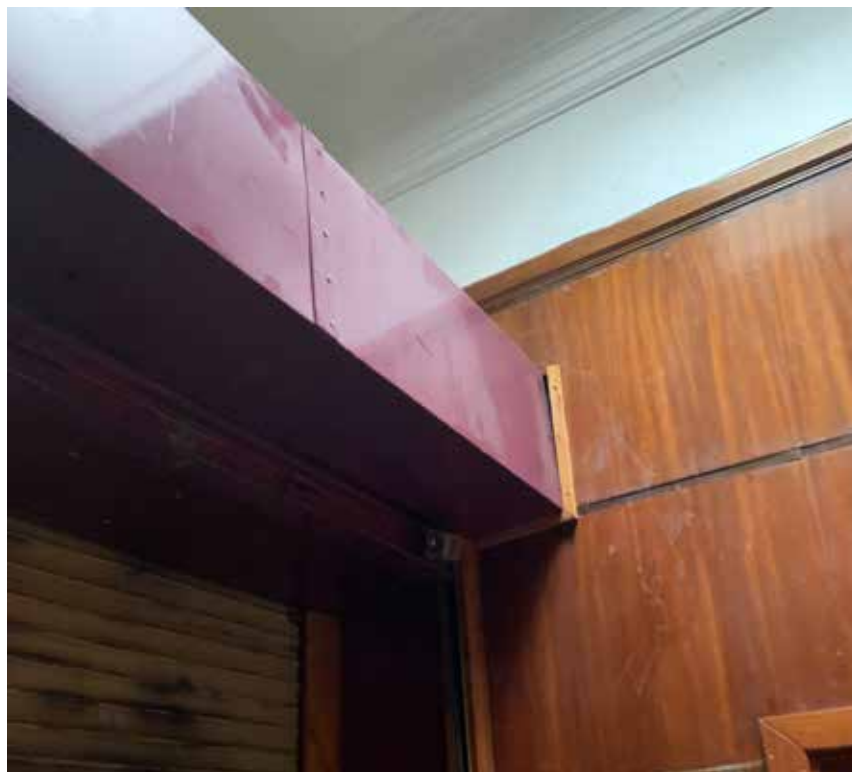
4.7.5 - Roller shutter to Gallery Exit Lobby (Extension of Rm.91)

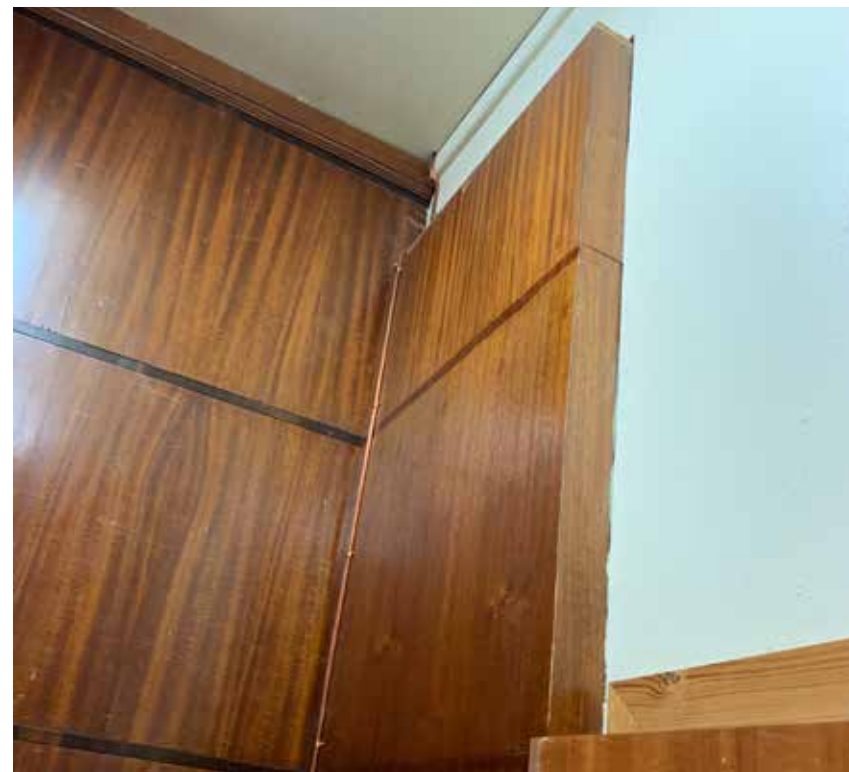
4.7.6 - Timber panelling to Gallery Exit Lobby (Extension of Rm.91)

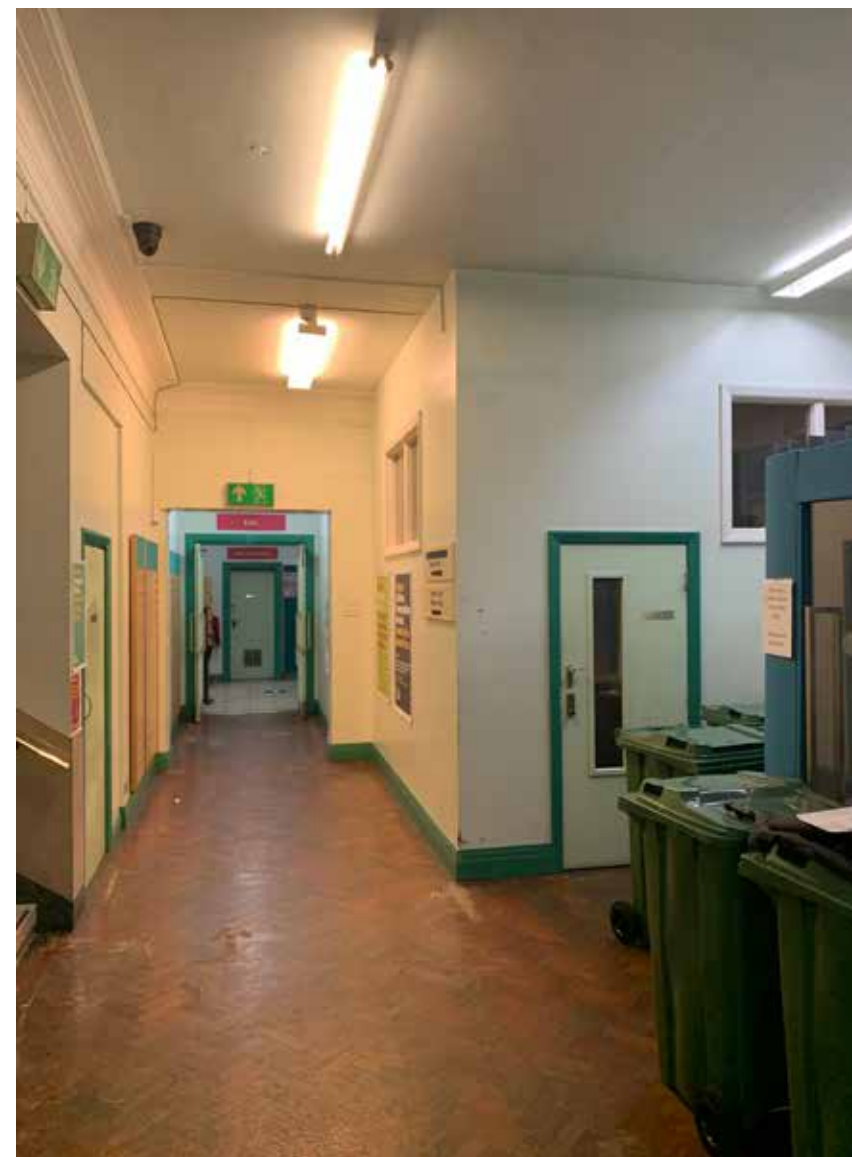
4.8.1 - Lower Ground Stair Lobby (Rm.24) with new room on right (Rm.26)

There have been a number of changes since the building was constructed, all of which appear to date from the 1960s or 70s. Double doors have been added across the top of the lower flight of stairs that separate the Lower Ground Stair Lobby from the main Entrance Lobby above. In addition, doors have been inserted through the return walls on each side of the stair to create small storage cupboards using space

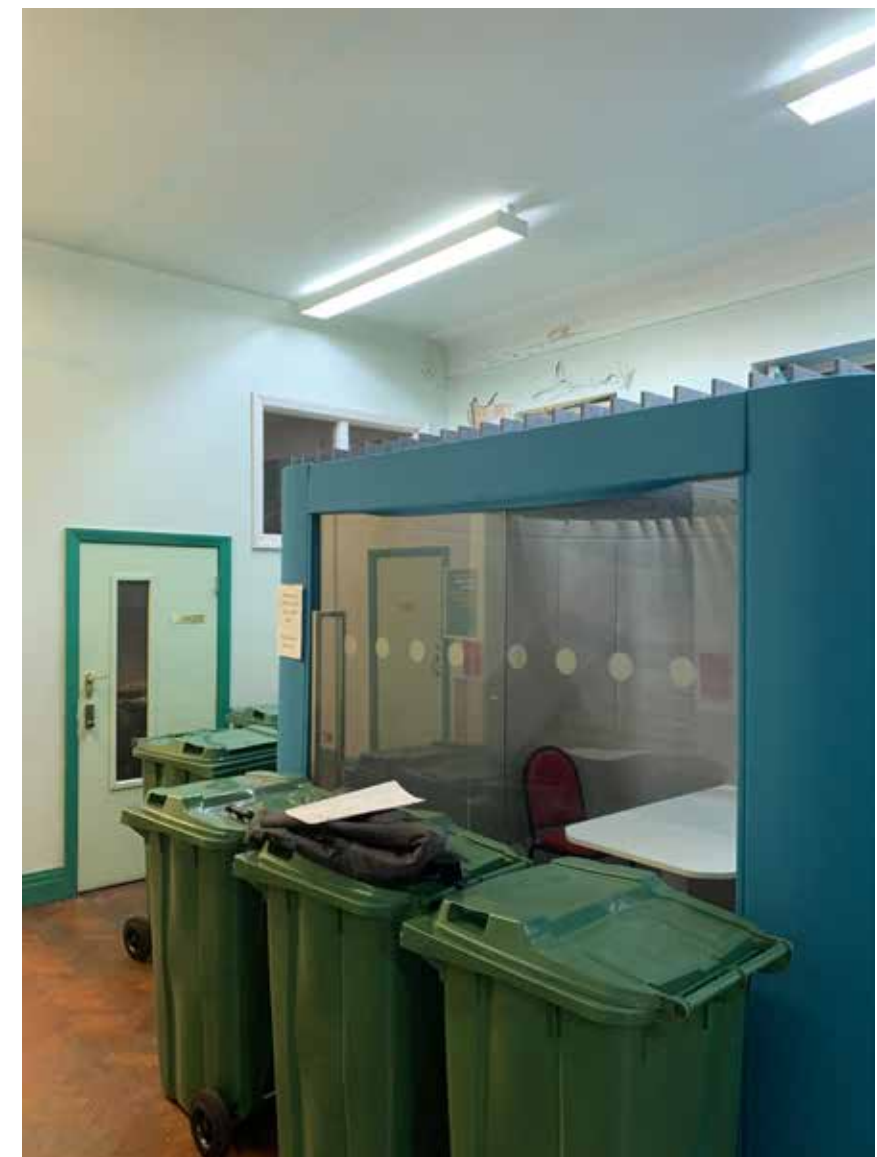
4.8.2 - Lower Ground Stair Lobby (Rm.24) with new room on left (Rm.26) and new enclosure

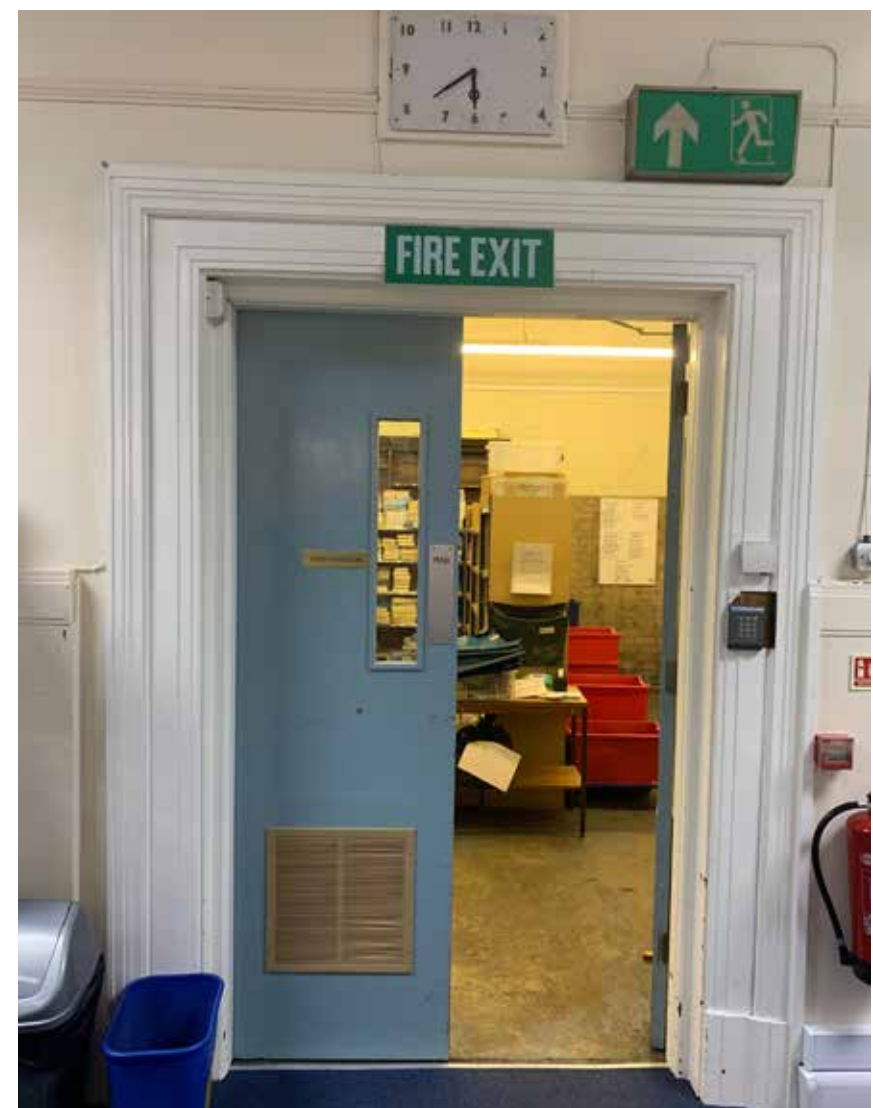
4.8.11 - Original clock and early fire signage in Interlibrary Loans (Rm.31)
