ARBORICULTURAL METHOD STATEMENT
to BS 5837:2012
at
Wappy Spring Inn
Lindley Moor Road
Huddersfield
West Yorkshire
HD3 3TD

Frank Marshall Estates

22184-A/AJB

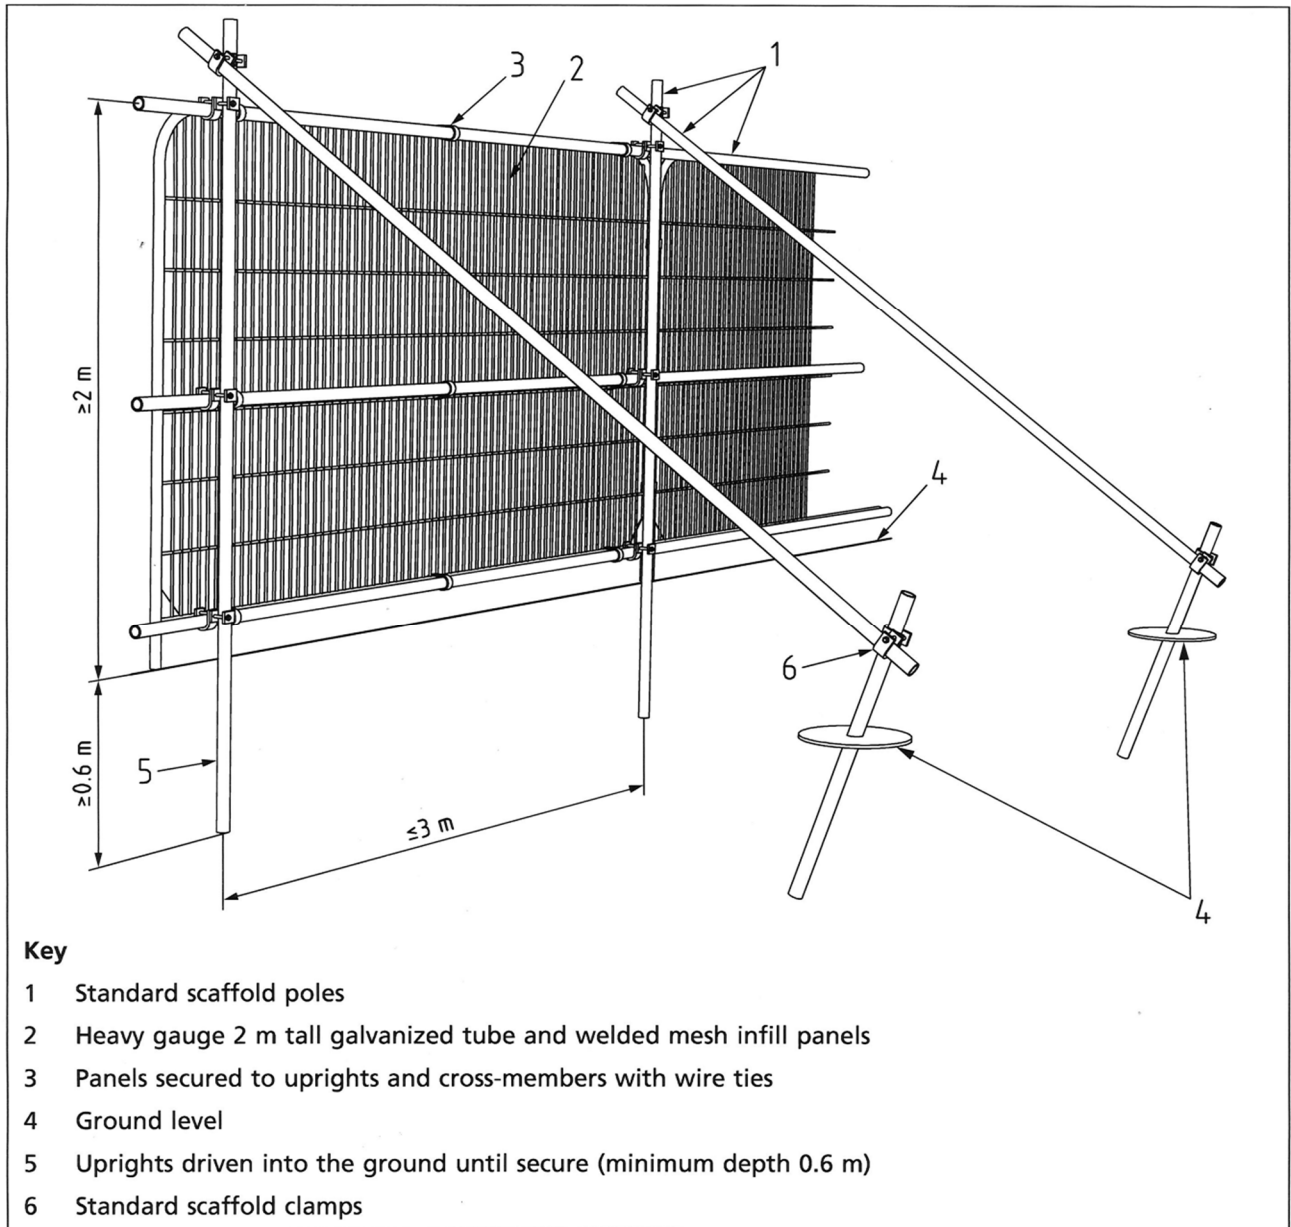
Protective Barrier to BS 5837: 2012.

A2.1 The protective barrier will be installed in accordance with BS5837: 2012. The default specification of BS 5837: 2012 (pictured below for reference) recommends a vertical and horizontal, scaffold framework, well braced to resist impacts, with vertical tubes at no more than 3m intervals. These should be driven into the ground. Weld mesh panels should be affixed to this framework with scaffold clamps.

- 3.1.3 The protective fencing will be installed in accordance with BS 5837: 2012 and will comprise of a vertical and horizontal scaffold framework, well braced to resist impacts. The vertical tubes should be spaced at a maximum interval of 3m and driven securely into the ground, taking care to avoid underground services and structural roots. Finally, weld mesh panels are to be securely fixed on the scaffold framework. Please refer to **Appendix 2** for protective fencing details.

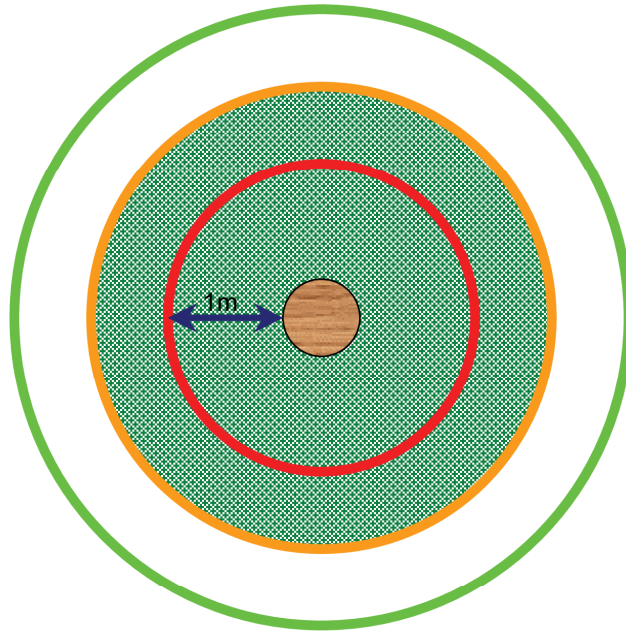
NJUG Guidelines for the Planning, Installation and Maintenance of Utility Apparatus in Proximity to Trees – Issue 2

PROHIBITED ZONE – 1m from trunk. Excavations of any kind must not be undertaken within this zone unless full consultation with Local Authority Tree Officer is undertaken. Materials, plant and spoil must not be stored within this zone.

PRECAUTIONARY ZONE – 4 x tree circumference. Where excavations must be undertaken within this zone the use of mechanical excavation plant should be prohibited. Precautions should be undertaken to protect any exposed roots. Materials, plant and spoil should not be stored within this zone. Consult with Local Authority Tree Officer if in any doubt.

PERMITTED ZONE – outside of precautionary zone. Excavation works may be undertaken within this zone however caution must be applied and the use of mechanical plant limited. Any exposed roots should be protected.

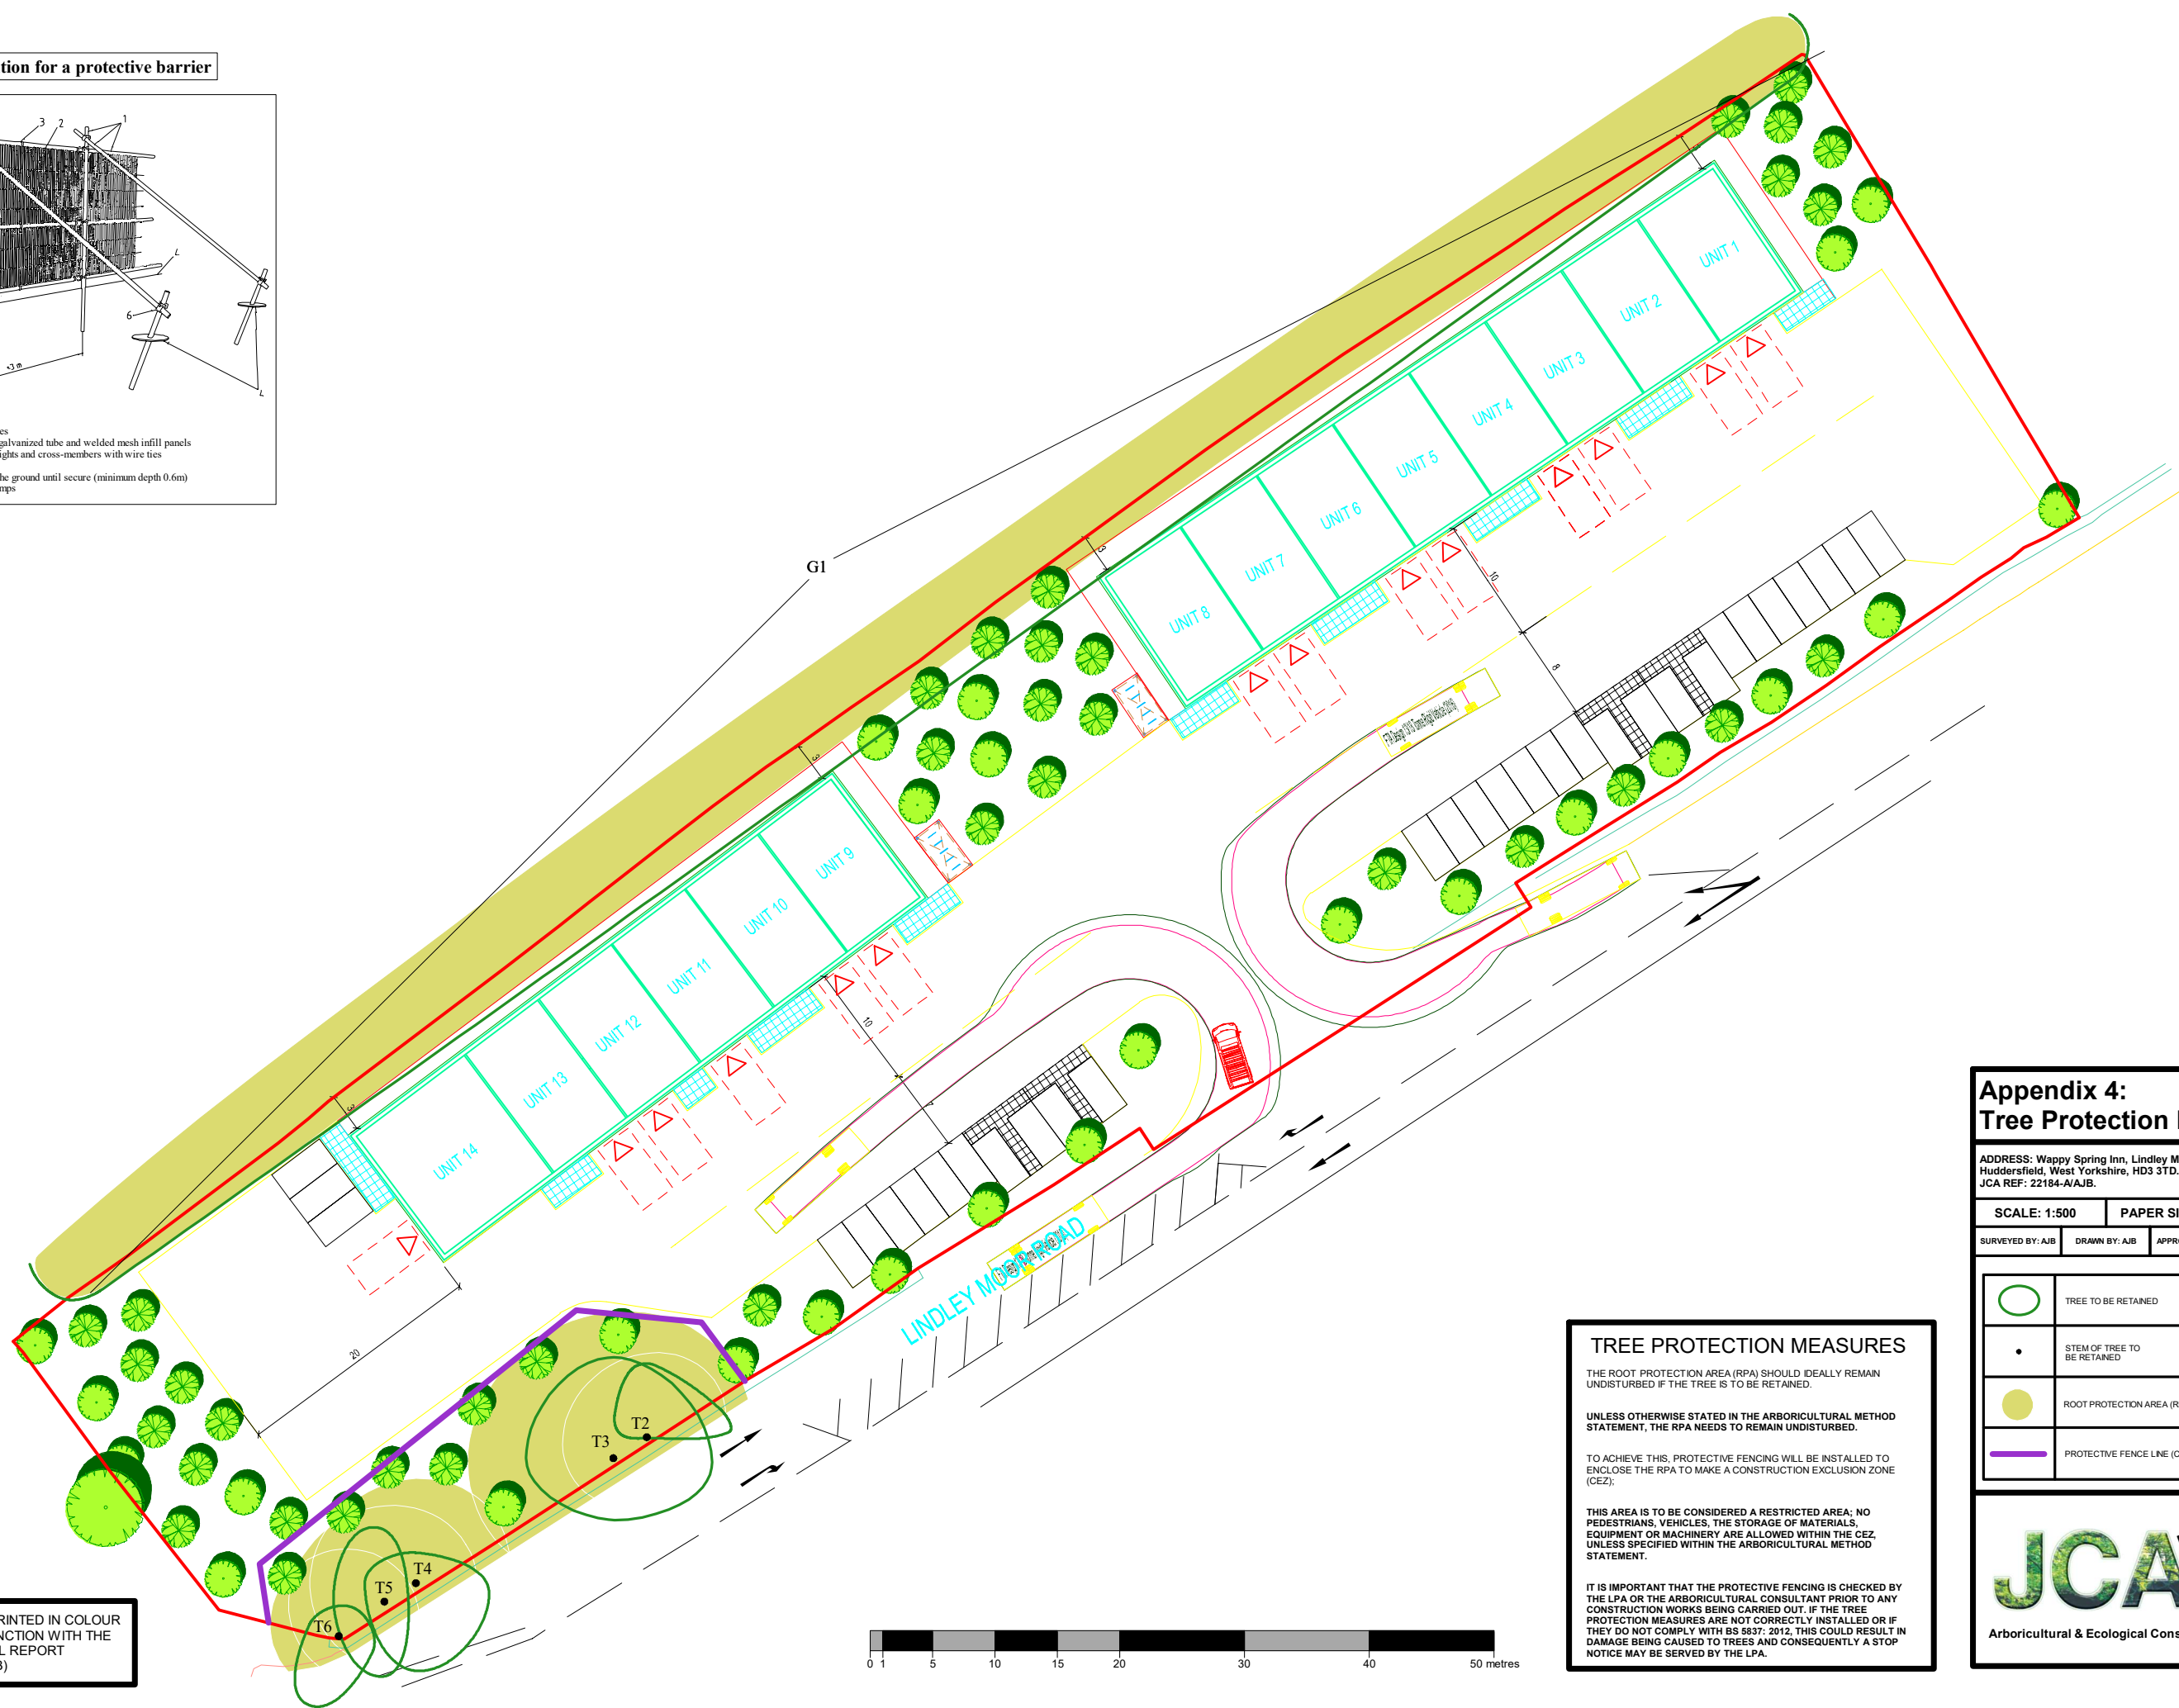
Appendix 4: Tree Protection Plan

TREE PROTECTION MEASURES

THE ROOT PROTECTION AREA (RPA) SHOULD IDEALLY REMAIN UNDISTURBED IF THE TREE IS TO BE RETAINED.

UNLESS OTHERWISE STATED IN THE ARBORICULTURAL METHOD STATEMENT, THE RPA NEEDS TO REMAIN UNDISTURBED.

TO ACHIEVE THIS, PROTECTIVE FENCING WILL BE INSTALLED TO ENCLOSE THE RPA TO MAKE A CONSTRUCTION EXCLUSION ZONE (CEZ).

THIS AREA IS TO BE CONSIDERED A RESTRICTED AREA: NO PEDESTRIANS, VEHICLES, THE STORAGE OF MATERIALS, EQUIPMENT OR MACHINERY ARE ALLOWED WITHIN THE CEZ UNLESS SPECIFIED WITHIN THE ARBORICULTURAL METHOD STATEMENT.

TREE TO BE RETAINED
	STEM OF TREE TO BE RETAINED
	ROOT PROTECTION AREA (RPA)
	PROTECTIVE FENCE LINE (CEZ)

- 3.1.2 The protective fencing must be constructed in accordance with BS 5837: 2012 *Trees in relation to design, demolition and construction - Recommendations* and will be located as shown on the Tree Protection Plan at **Appendix 4**. The protective barrier will enclose the entire Root Protection Area (RPA) retained trees to create a Construction Exclusion Zone (CEZ); **this area is to be considered a restricted area; no pedestrians, vehicles, equipment or machinery are allowed within the CEZ and the storage of materials is not permitted, unless specified within this Method Statement.**
