Miller Homes & Vistry Group
Blackmoorfoot Road
Huddersfield

Arboricultural Impact Assessment

February 2025

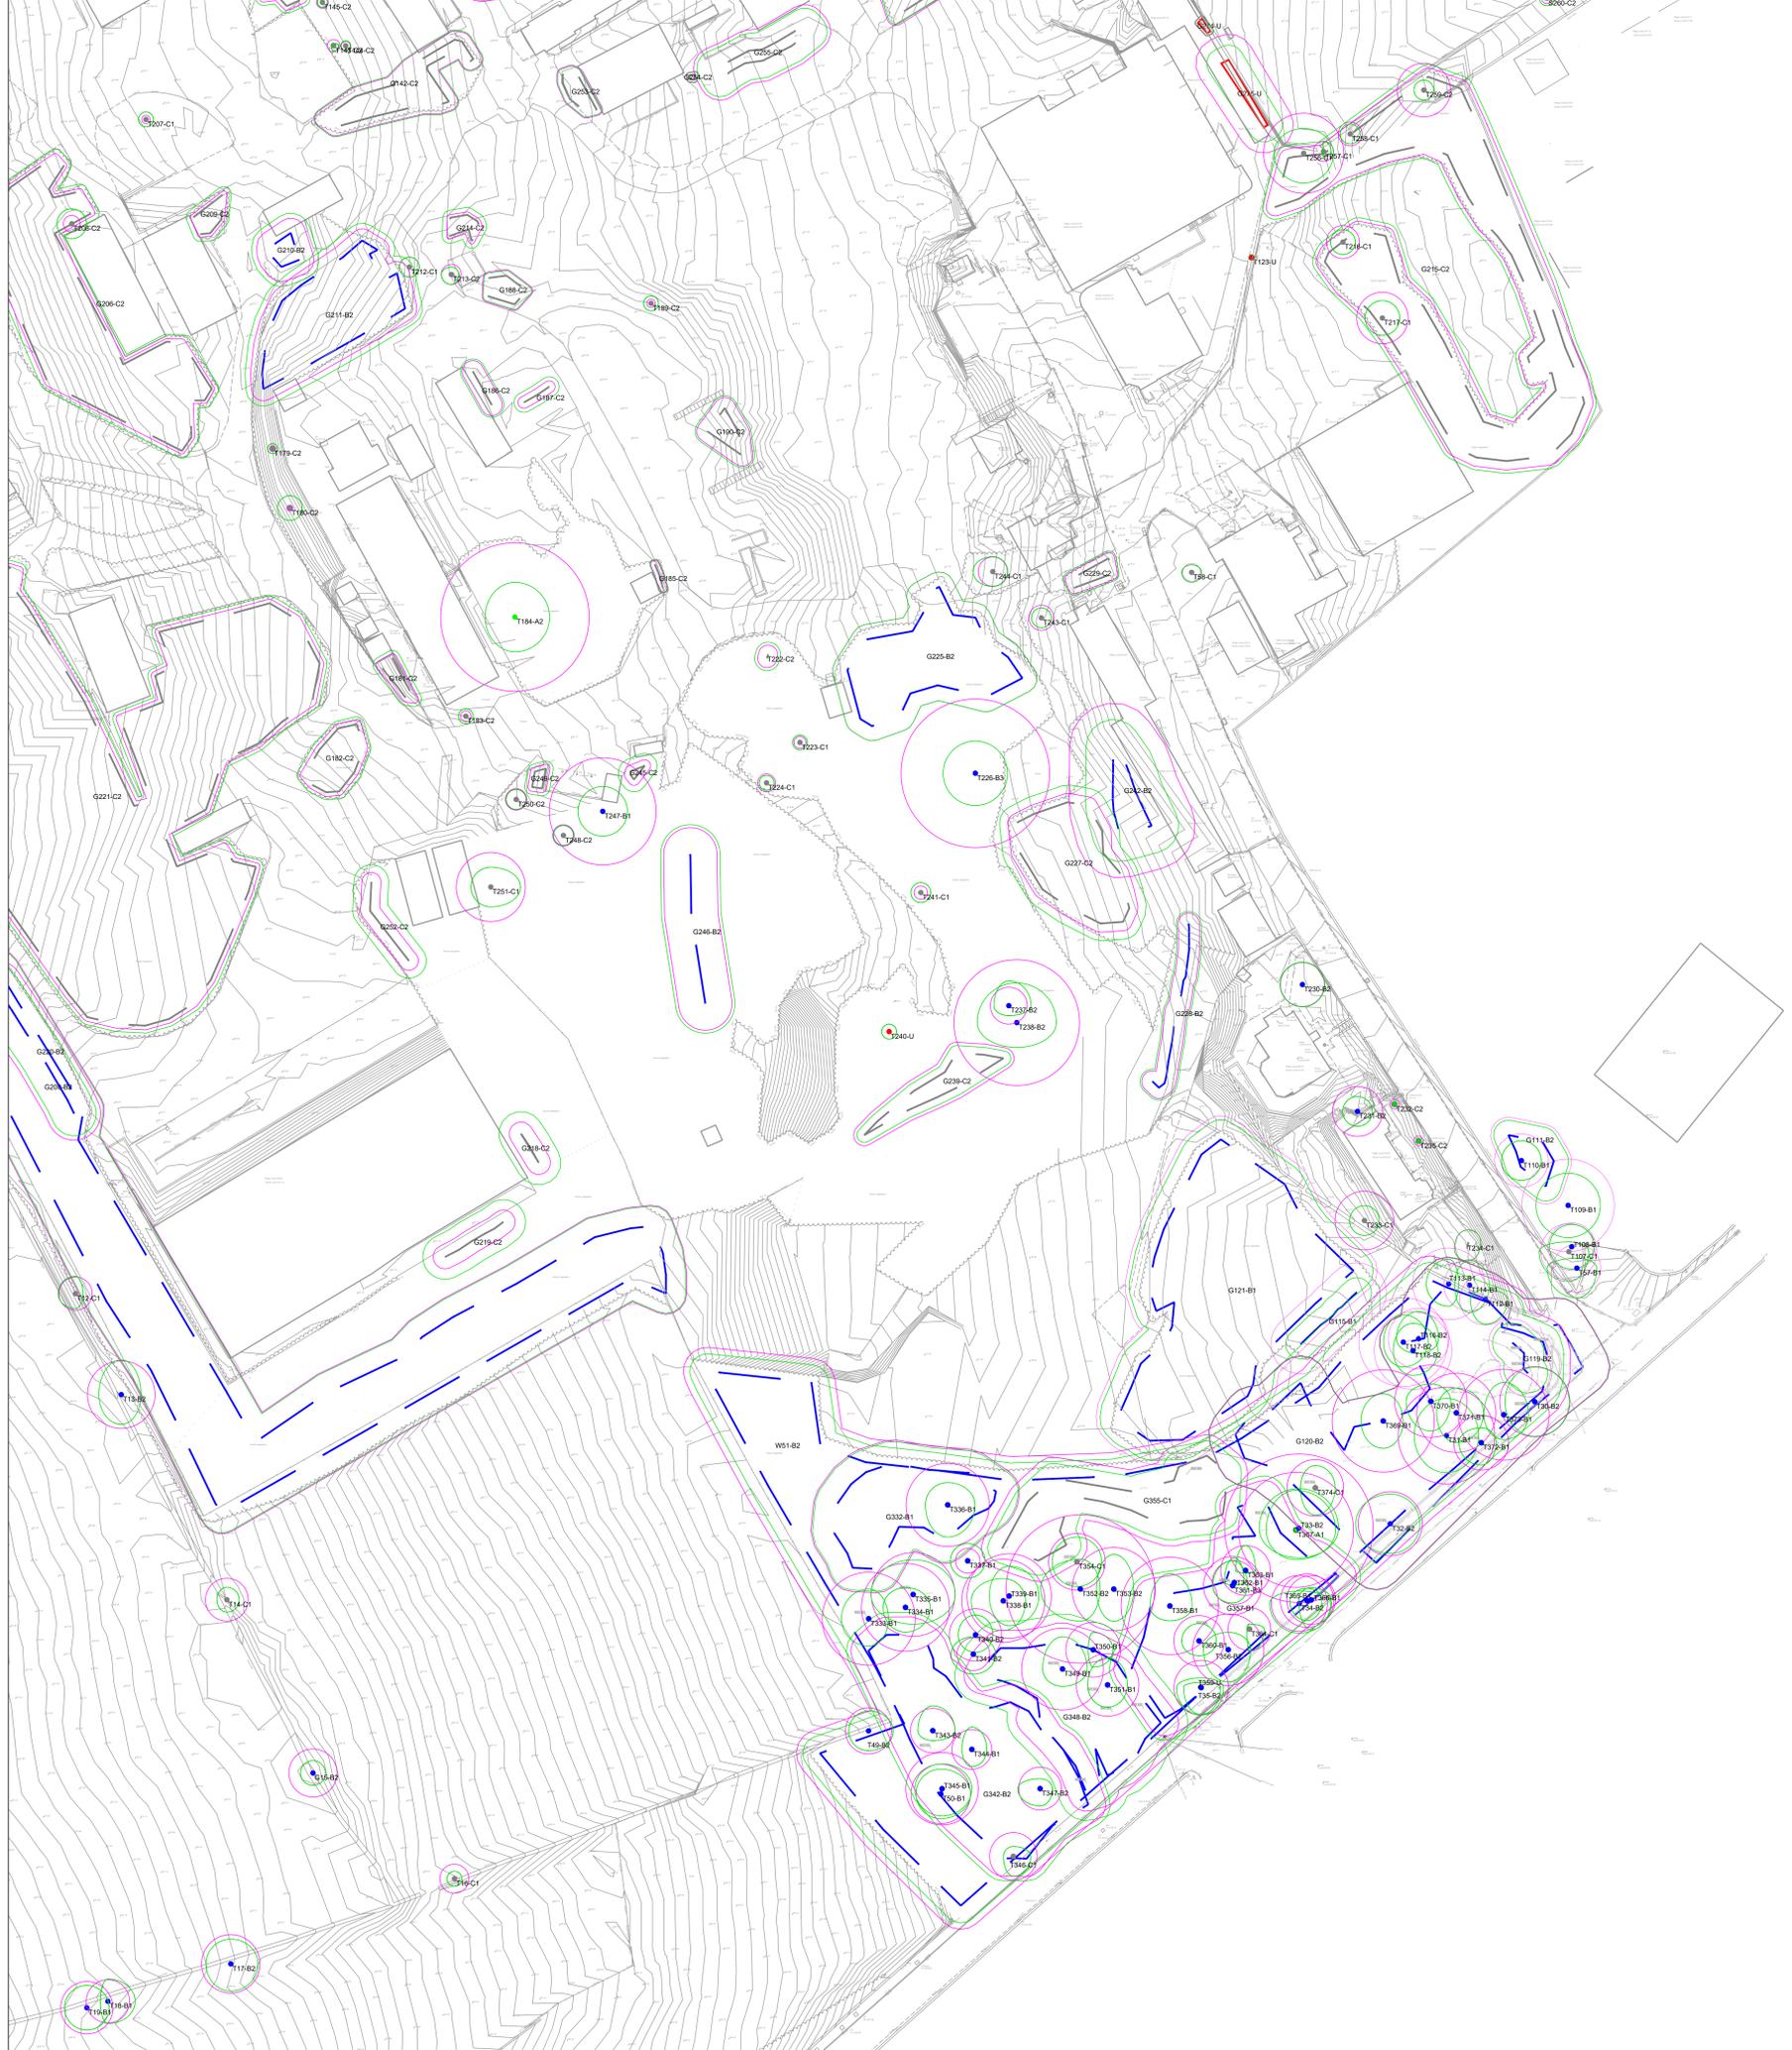
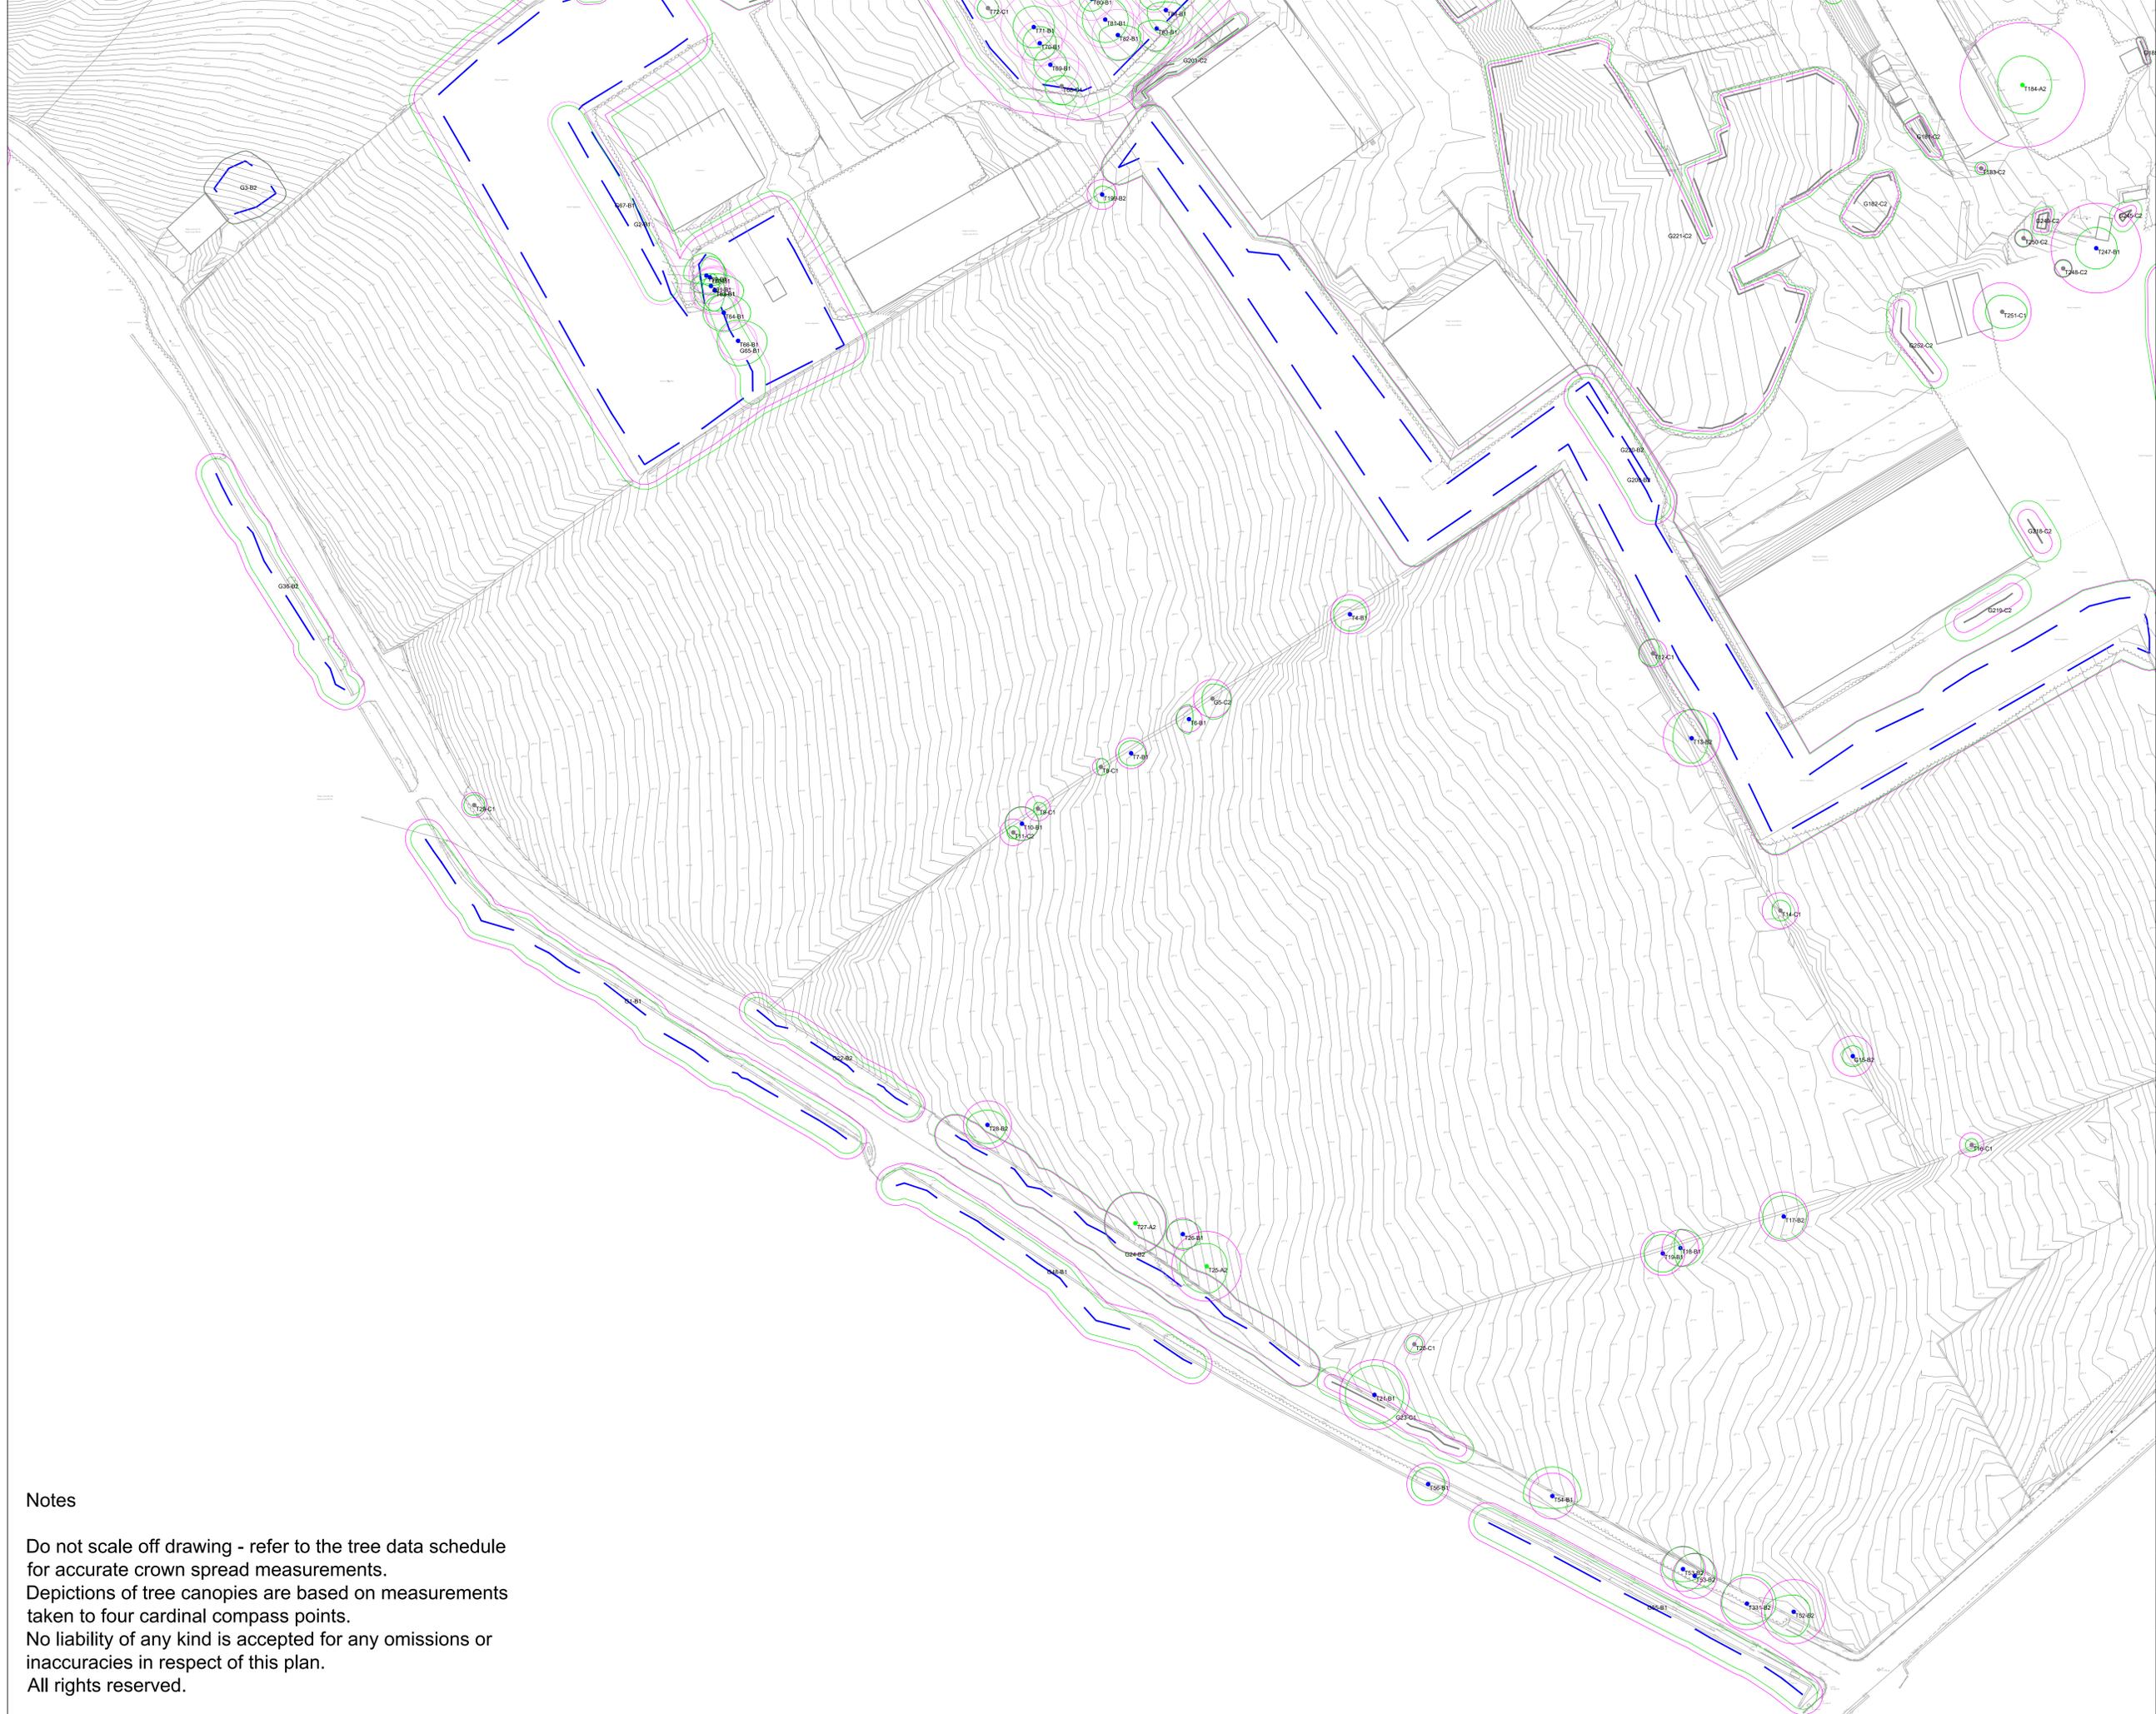
APPENDIX 1: Tree Constraints Plan

- Trees Showing Canopy extents, category colour and tag number (with category).
 - Category A: Trees of high quality with an estimated remaining life expectancy of at least 40 years. (Green circle)
 - Category B: Trees of moderate quality with an estimated remaining life expectancy of at least 20 years. (Blue circle)
 - Category C: Trees of low quality with an estimated remaining life expectancy of at least 10 years, or young trees with a stem diameter below 150 mm. (Black circle)
 - Category U: Trees in such a condition that they can not realistically be retained as living trees in the context of the current land use for longer than 10 years. (Red circle)
- Tree Groups: Shown as dashed centre/boundary line. Colour represents category (see above). (Dashed line)
- BS 5837:2012 Root Protection Area: (Pink dashed line)

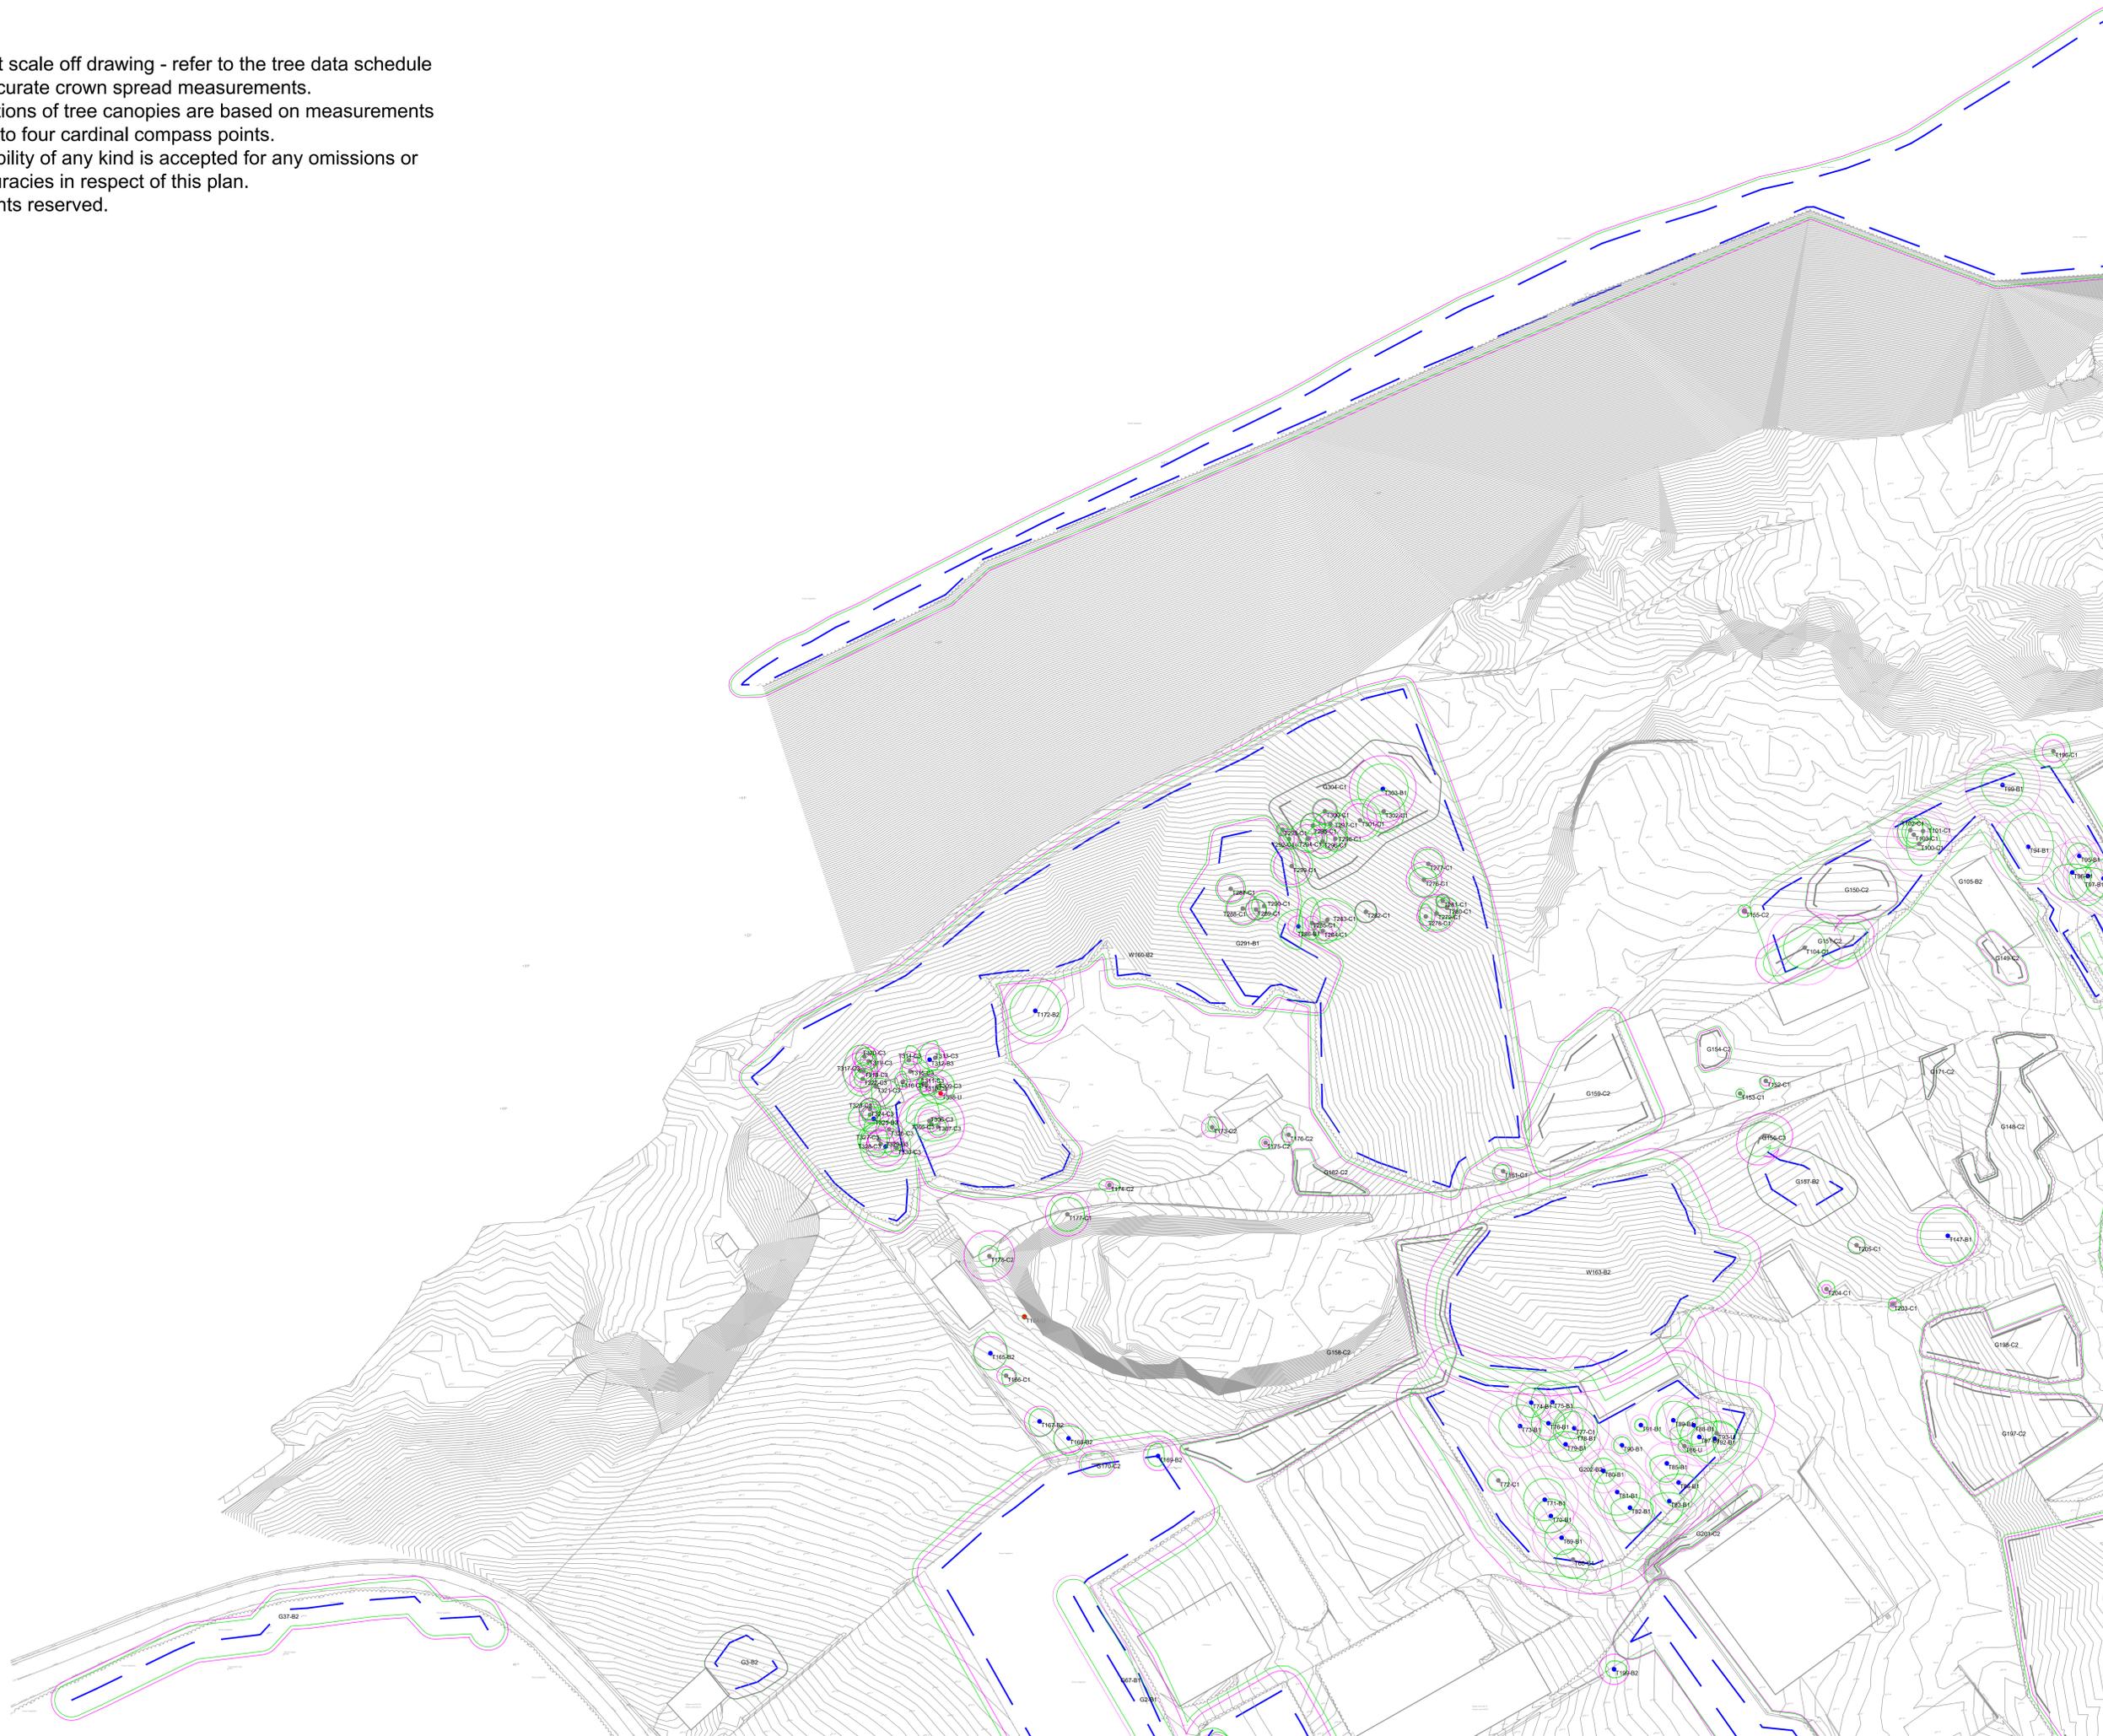
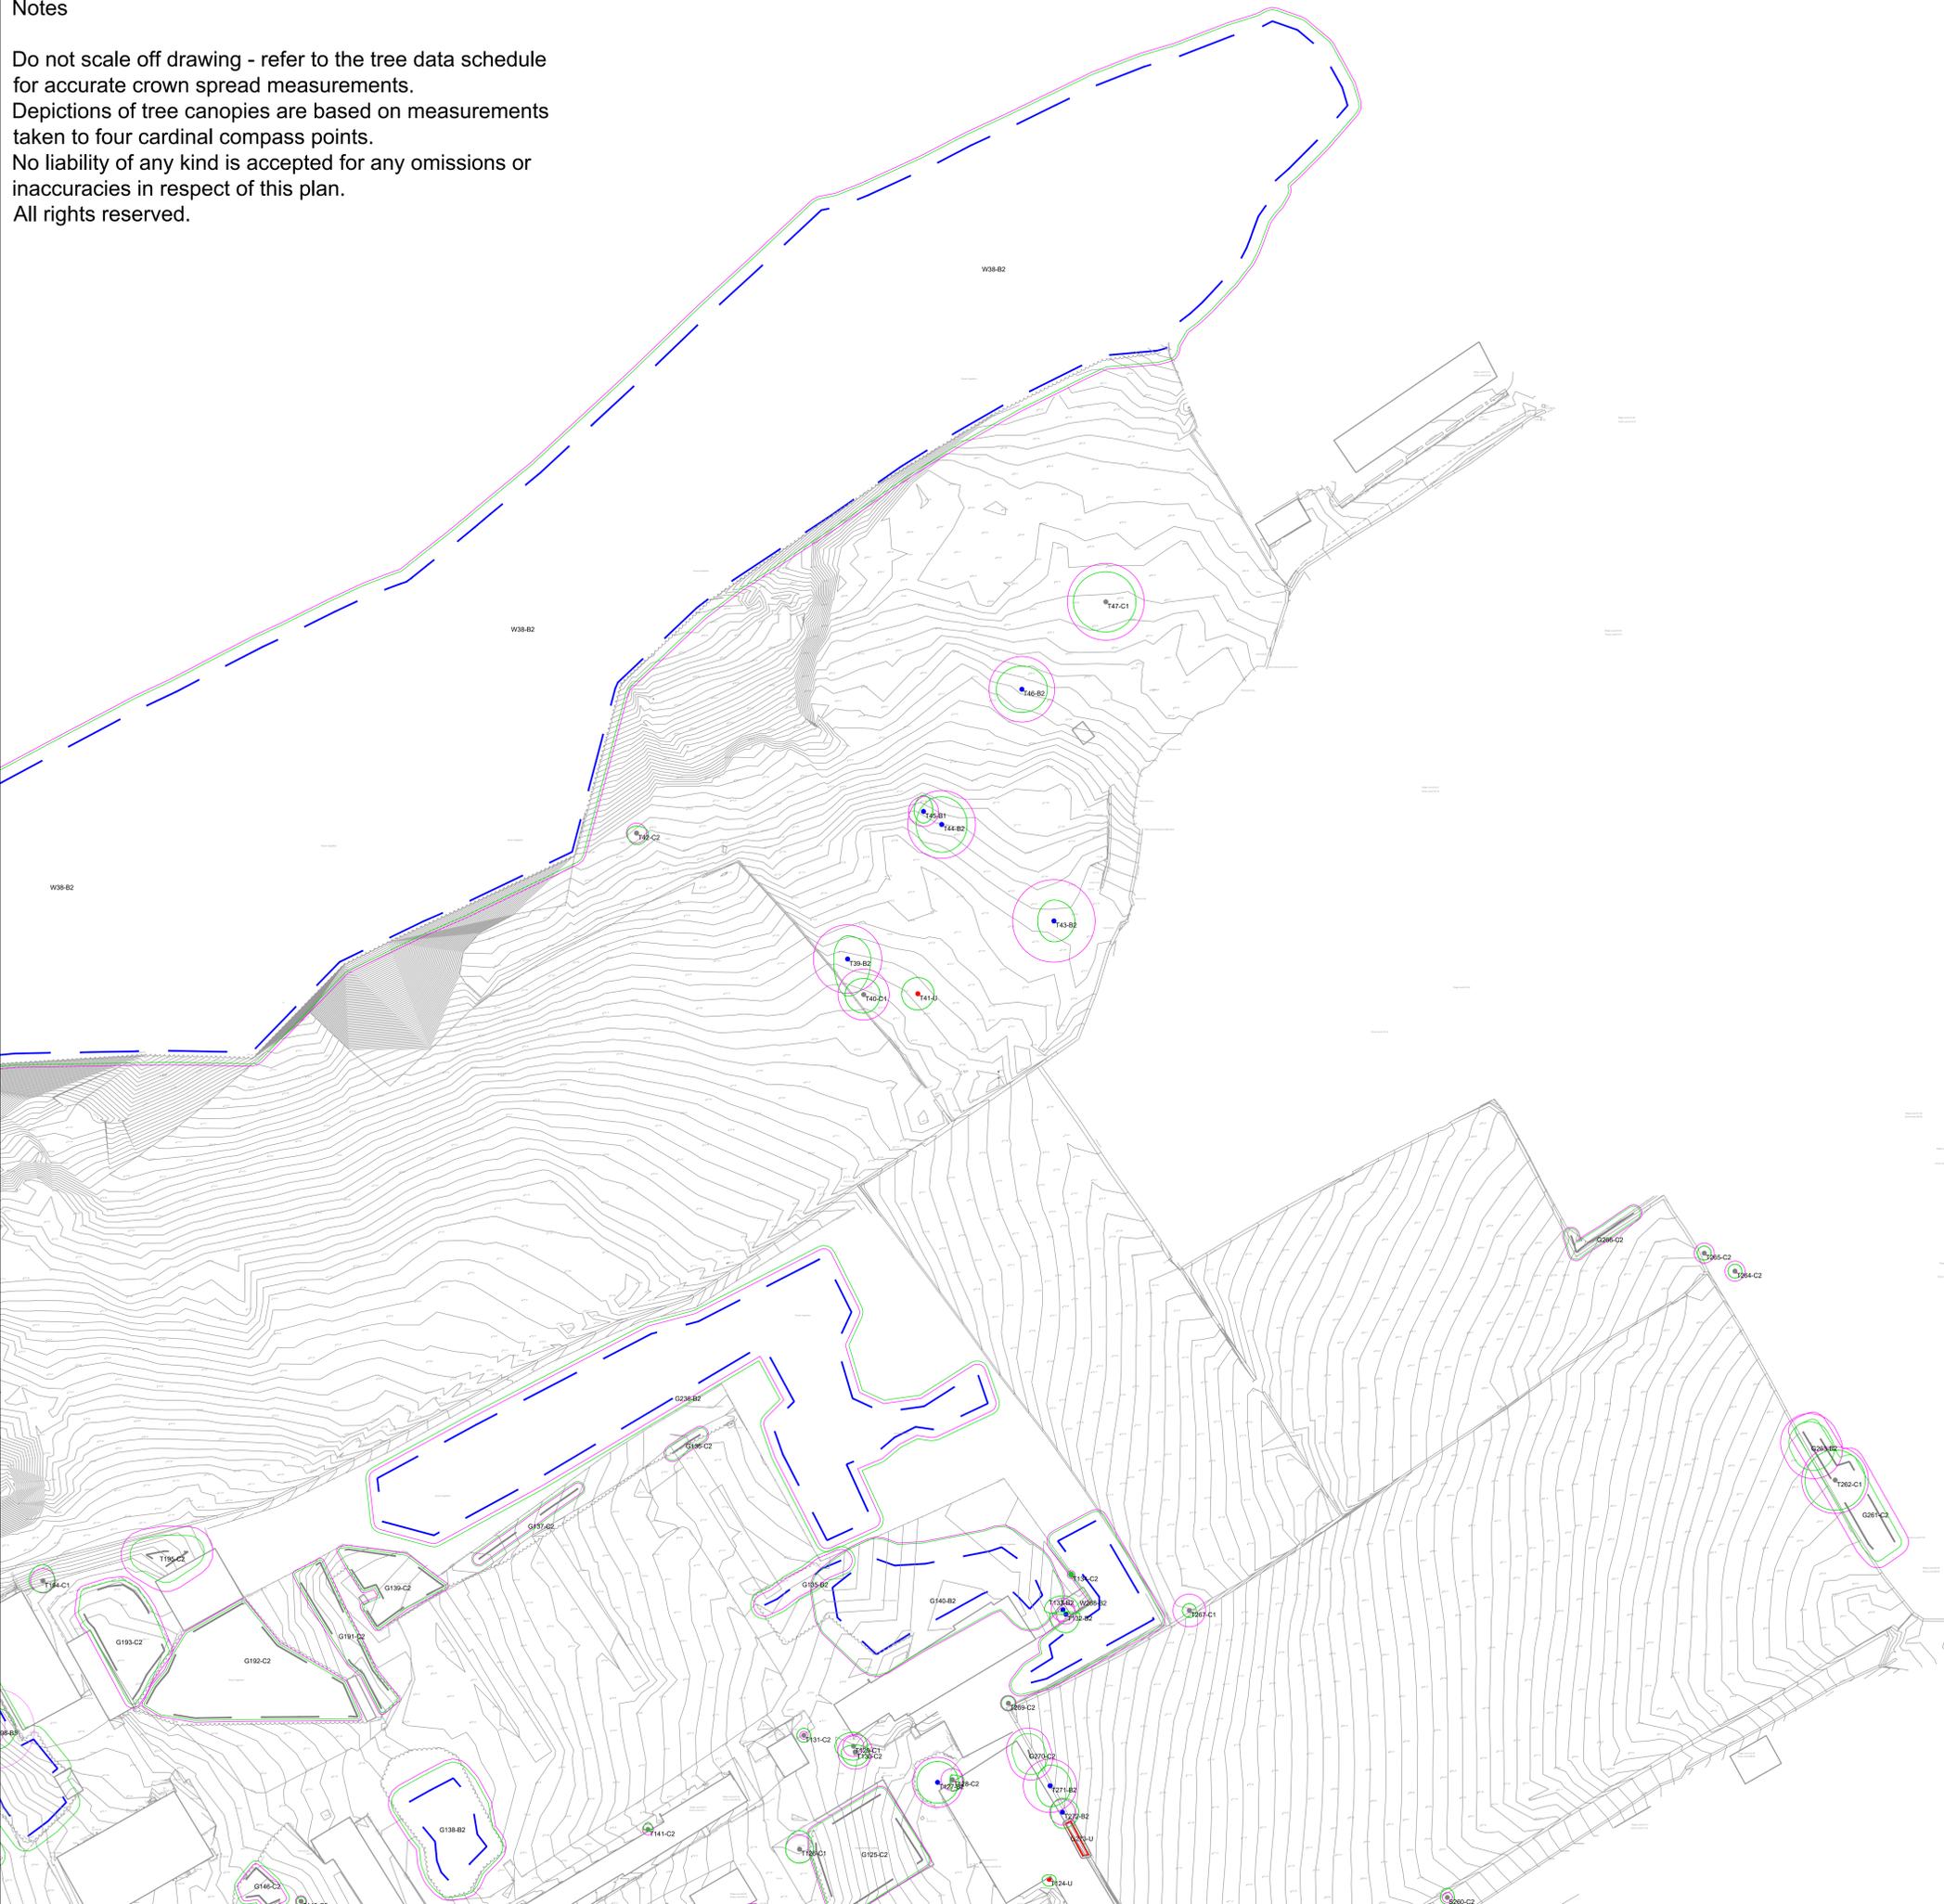
Tree Constraints Plan

-

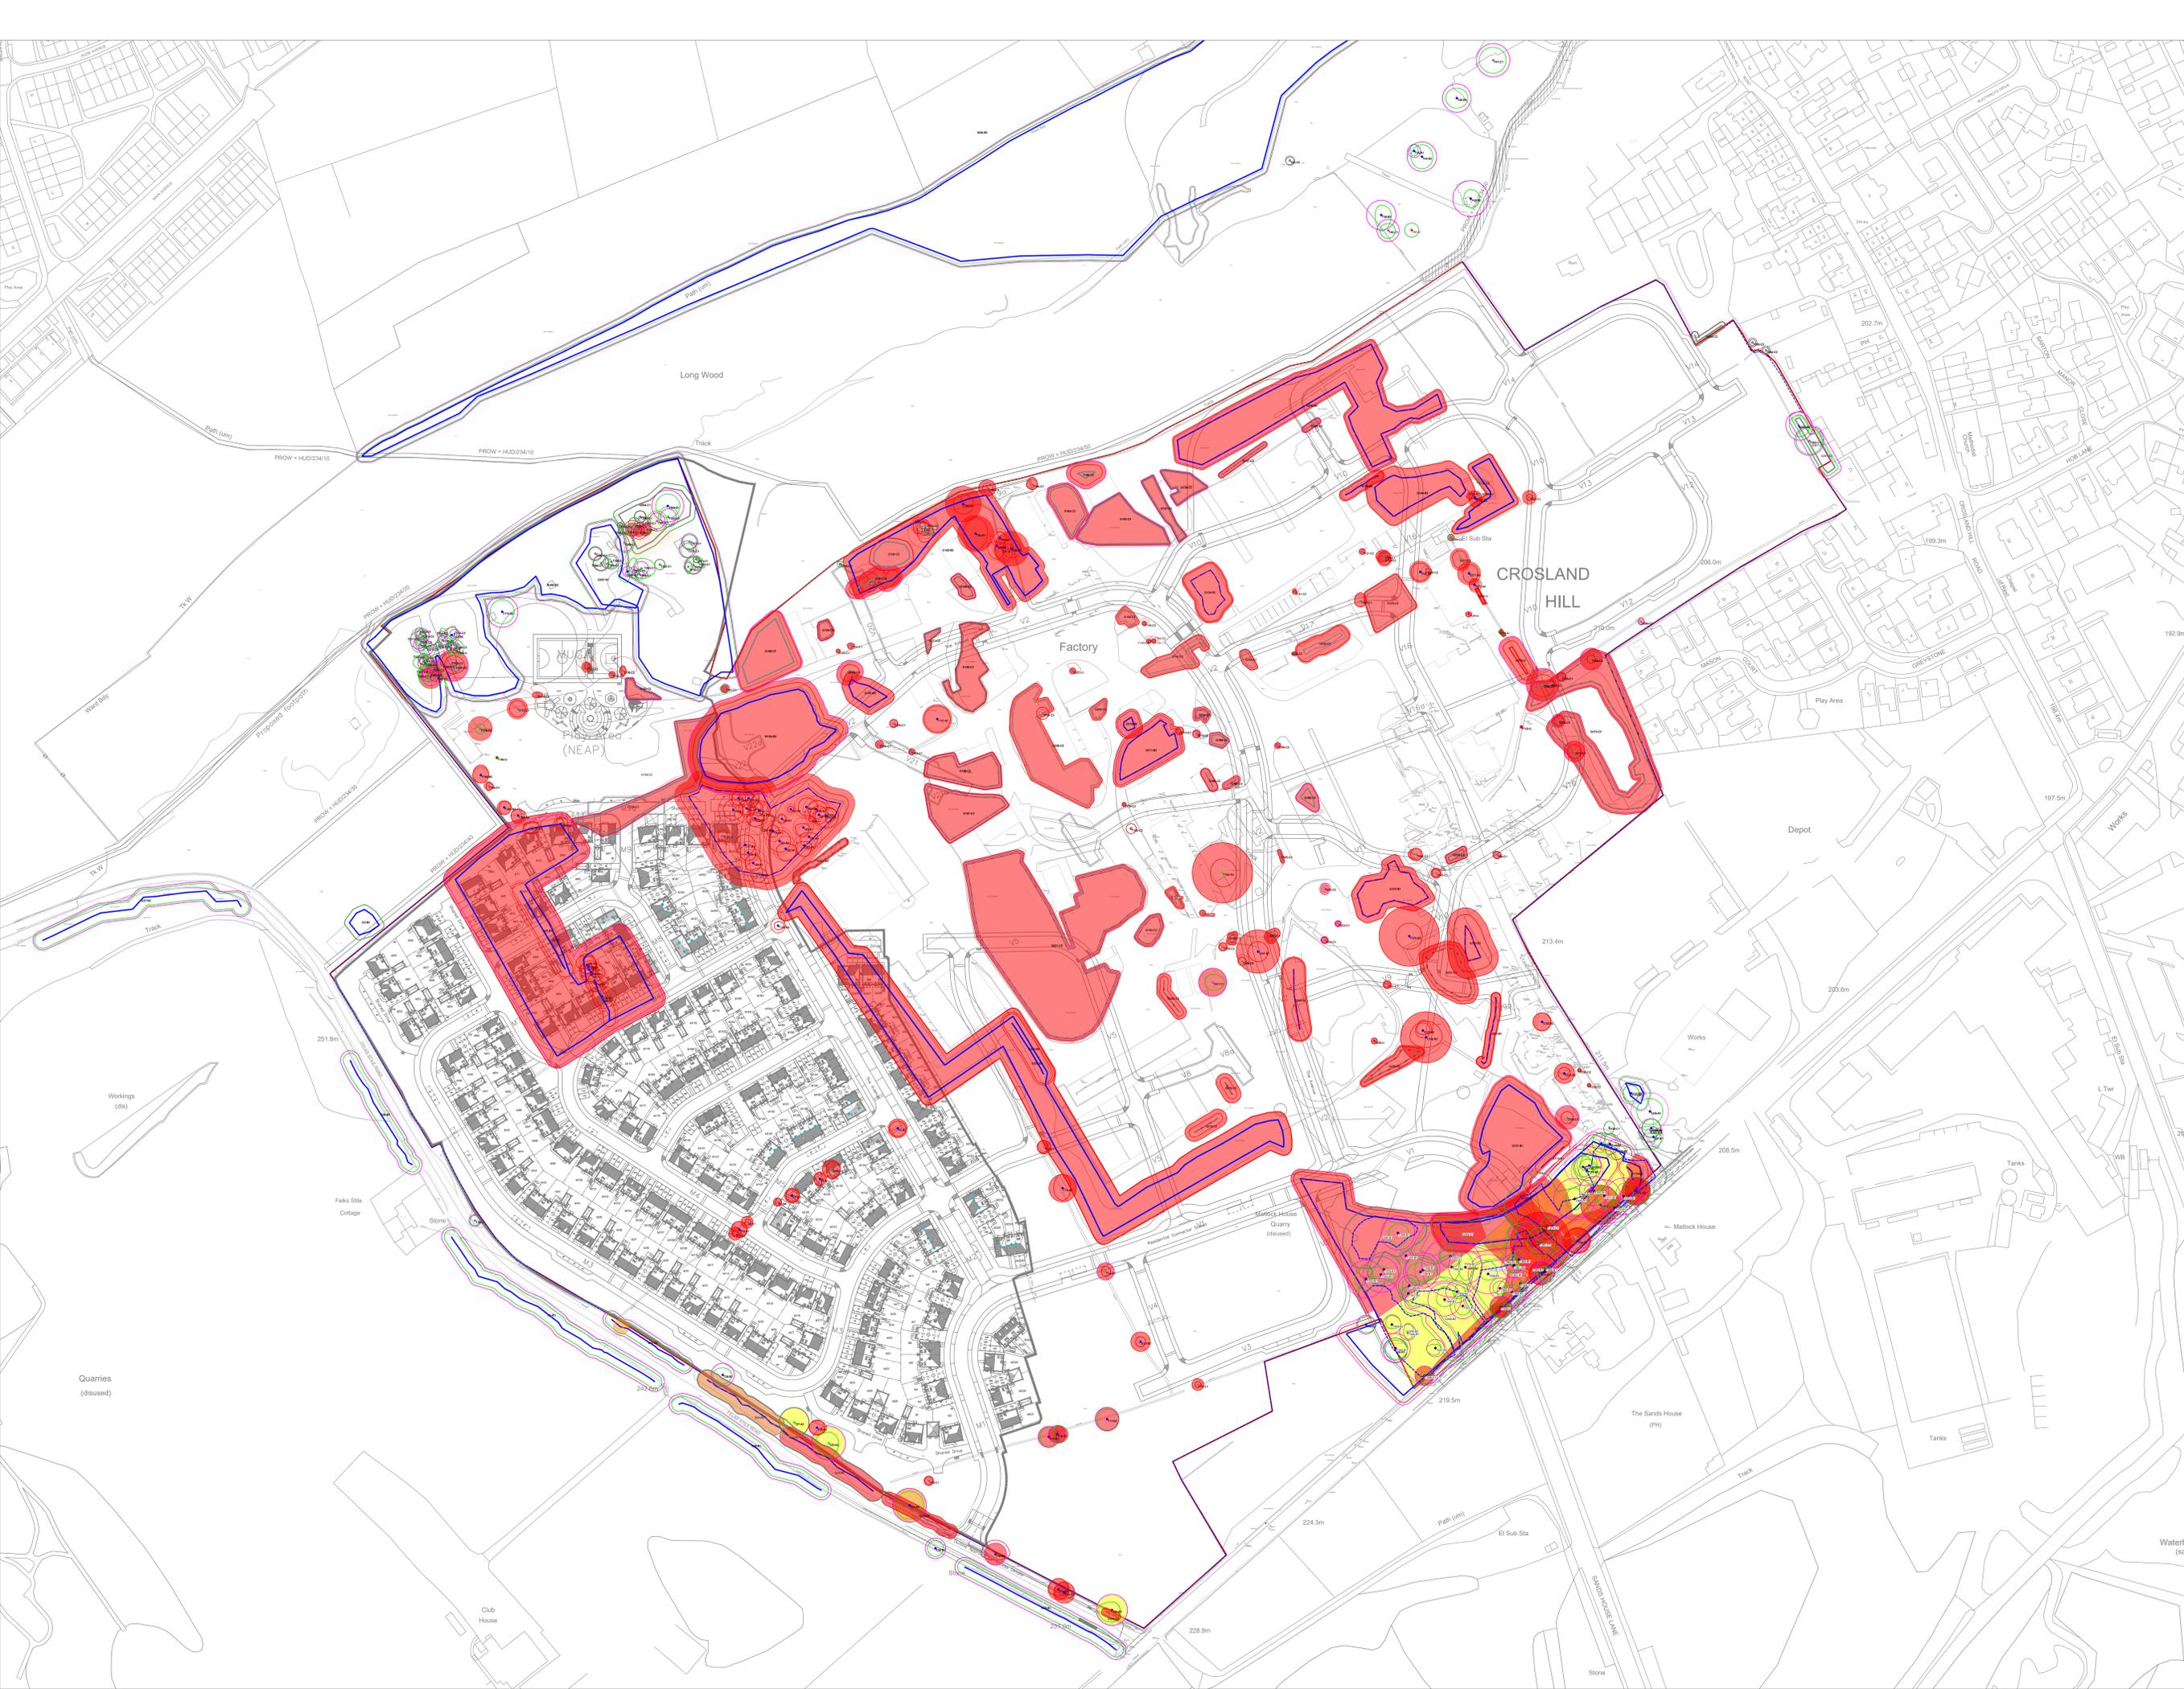
APPENDIX 2: Tree Impact Plan

- Trees Showing Canopy extents, category colour and tag number (with category)
- Category A
Trees of high quality with an estimated remaining life expectancy of at least 40 years.
- Category B
Trees of moderate quality with an estimated remaining life expectancy of at least 20 years.
- Category C
Trees of low quality with an estimated remaining life expectancy of at least 10 years, or young trees with a stem diameter below 150 mm.
- Category U
Trees in such a condition that they can not realistically be retained as living trees in the context of the current land use for longer than 10 years.
- Tree Groups
Shown as dashed centreboundary line
Colour represents category (see above)
- BS 5837:2012 Root Protection Area
- Trees to be removed to facilitate development
- Trees to be crown lifted to facilitate development
- Retained trees under Tree Preservation Order (TPO)

- 2.26 We understand that for the western creation, site operators will dig down by circa 0.5m to form the base and cover the with 2m of fill. Post the necessary removals identified above and prior to the excavation works, pre-emptive root pruning is recommended for retained trees **T307** and **T329** at the outer extents of their RPA.

cover will be provided. No preemptive root pruning is deemed necessary in this locale but once the base is formed, the potential exists for limited level changes within the RPA of **T292, T295, T297, T299, T301, T302, T300** and **T303**. As such, the following guidance must be employed to minimize damage potential to these trees and their rooting environments.

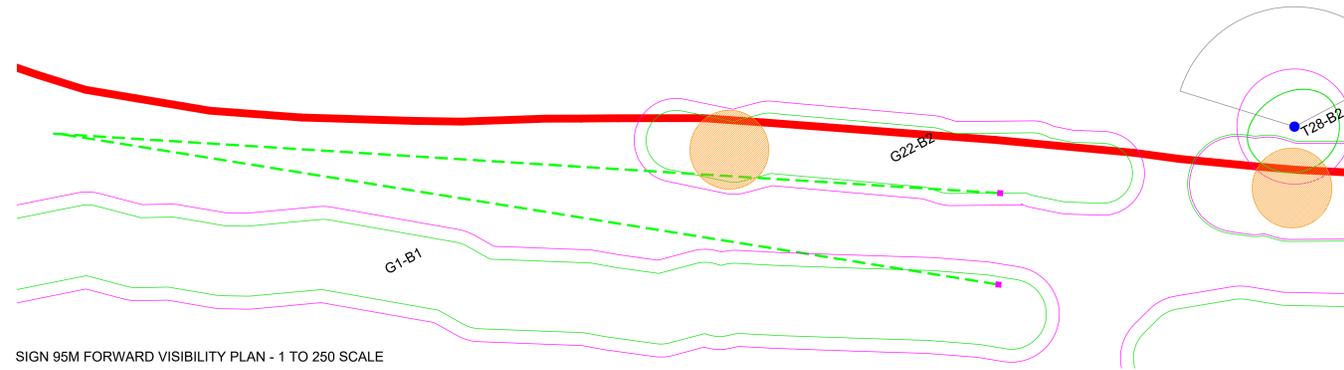
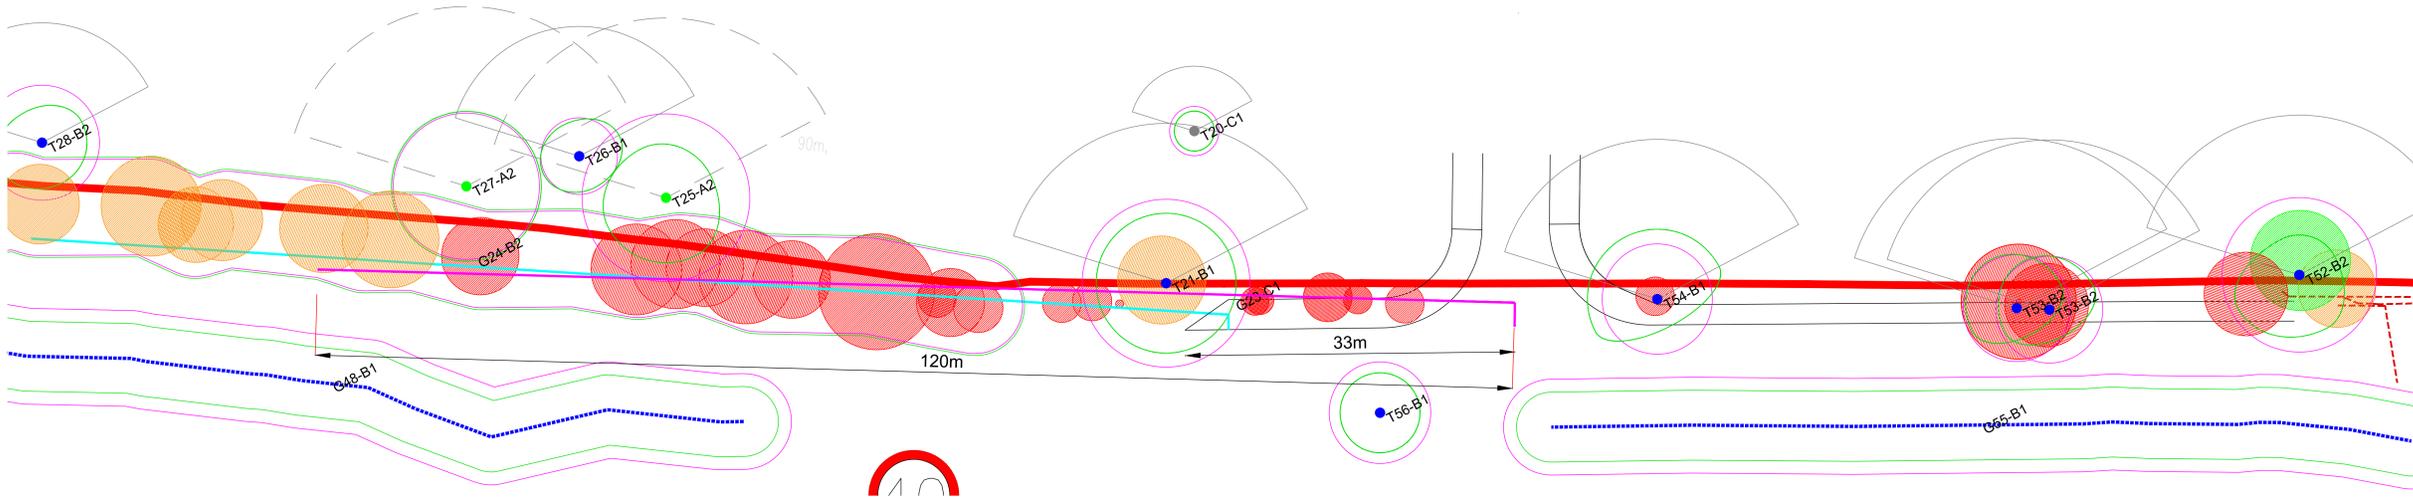
SIGN 95M FORWARD VISIBILITY PLAN - 1 TO 250 SCALE

PROPOSED 40 MPH SPEED SIGN 280M FROM JUNCTION

REV D (JB 04.02.24)
- T21 CHANGED TO CROWN LIFT

REV C (LA 03.02.24)
- ADDED T21 FOR REMOVAL
