Re: Development at Crosland Road, Lindley

Further to your request we have attended the above site to undertake an inspection of the gas membrane to confirm that the quality of the installation is satisfactory in plots 1-2, and 34-42 at the above site.

Inspection Checklist

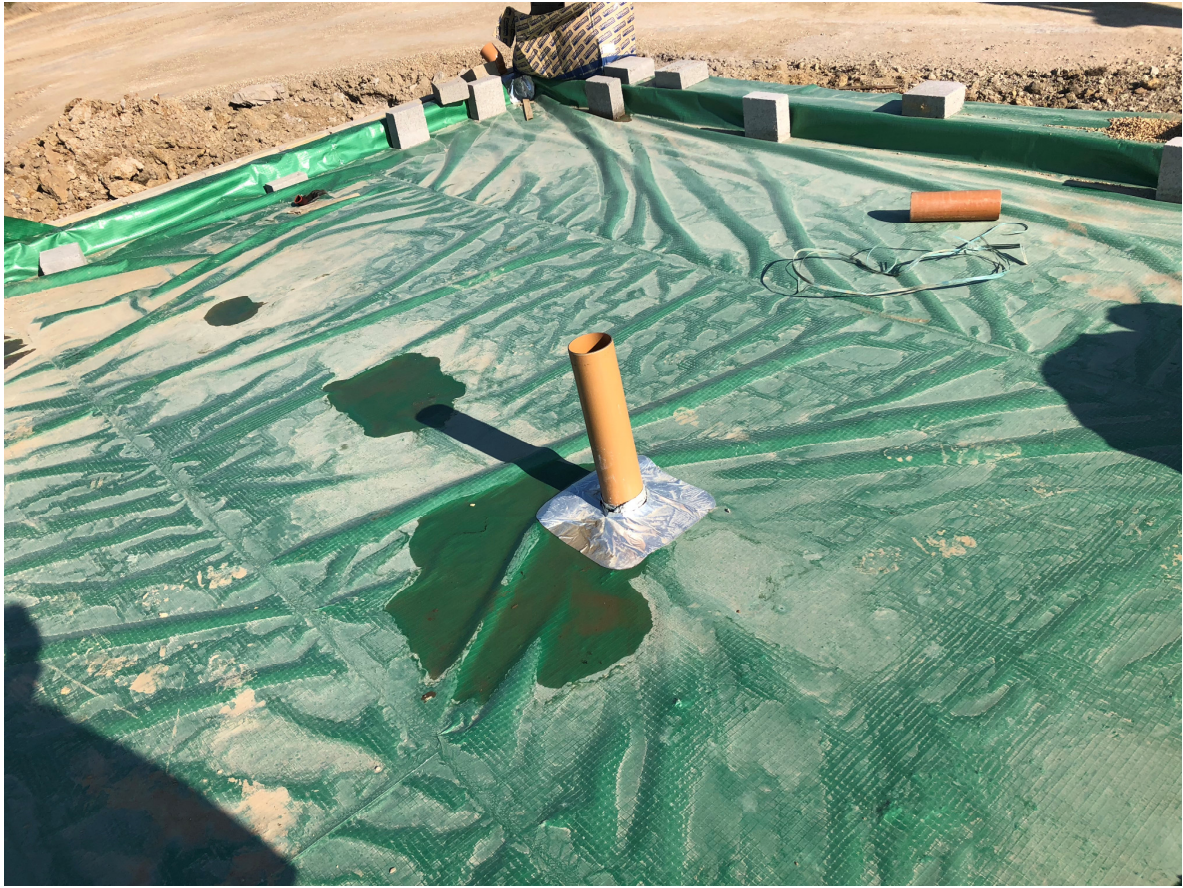
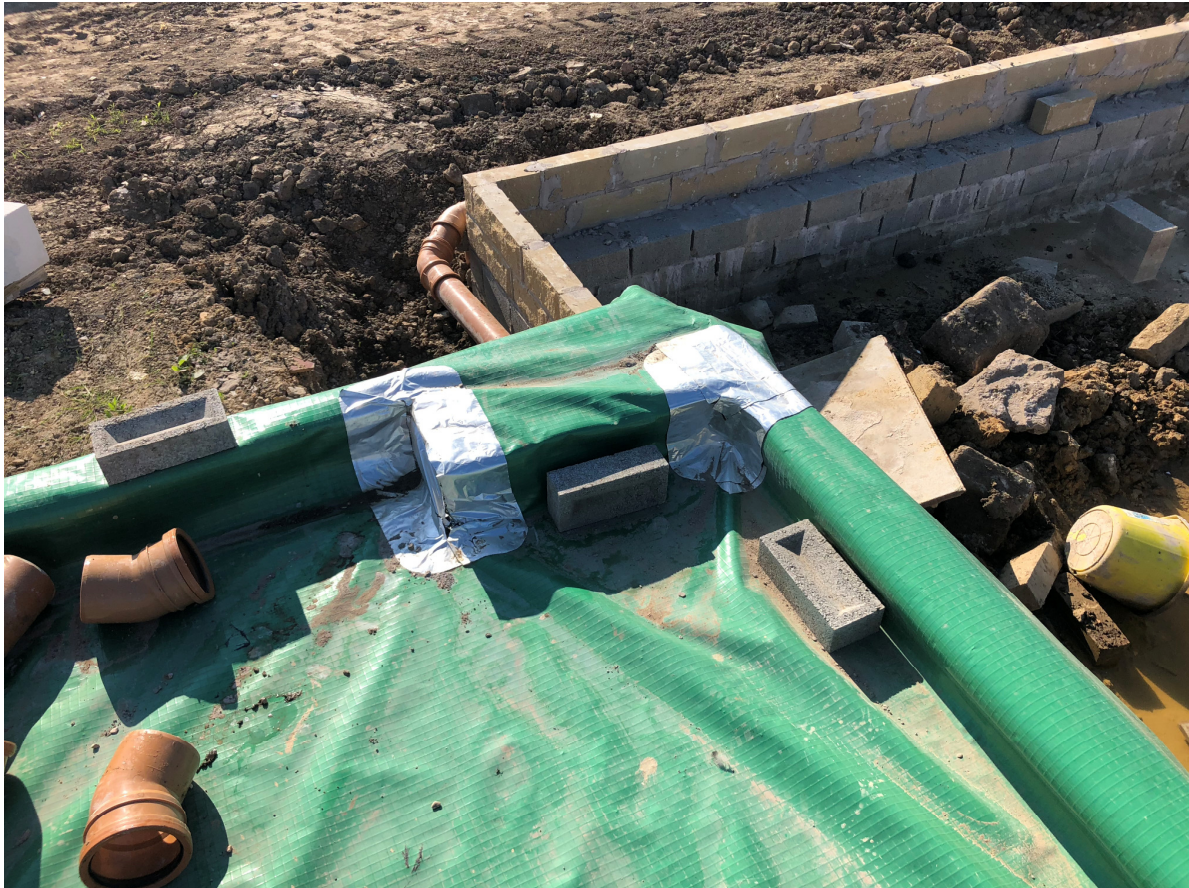
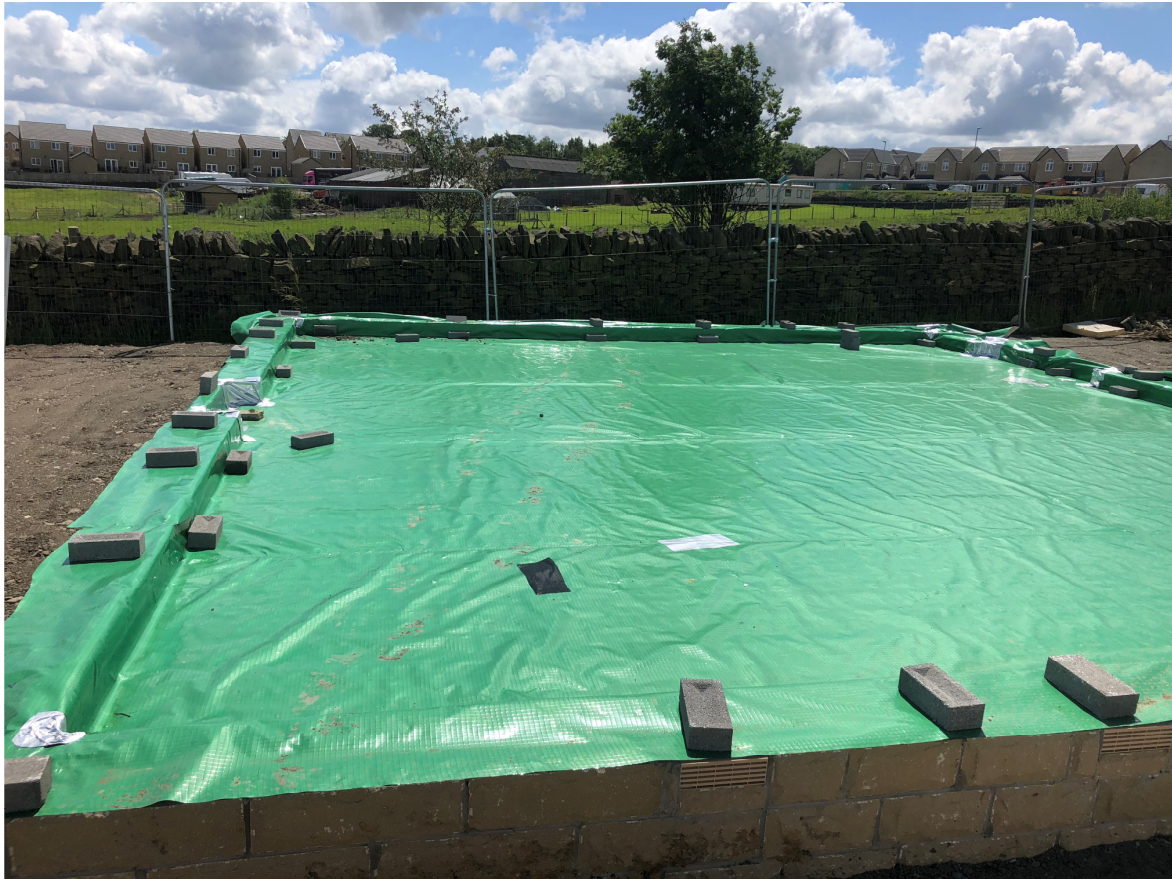
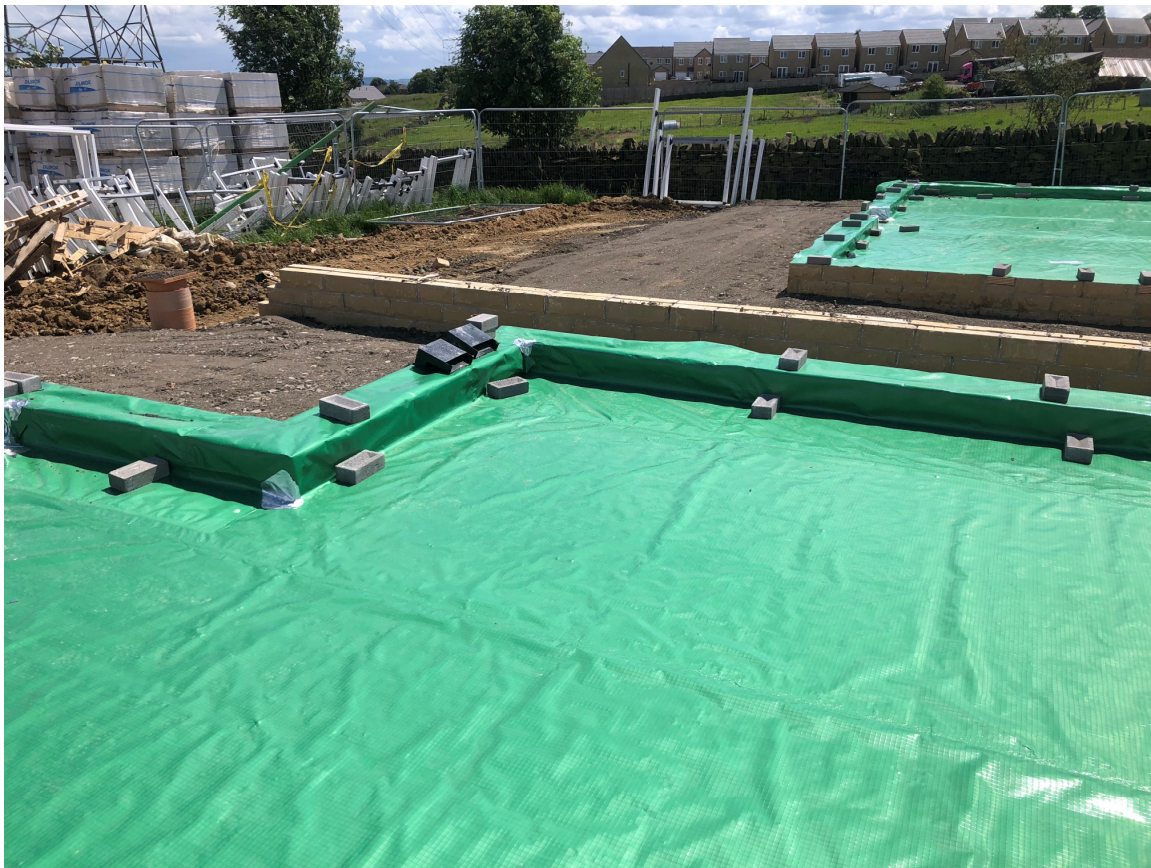
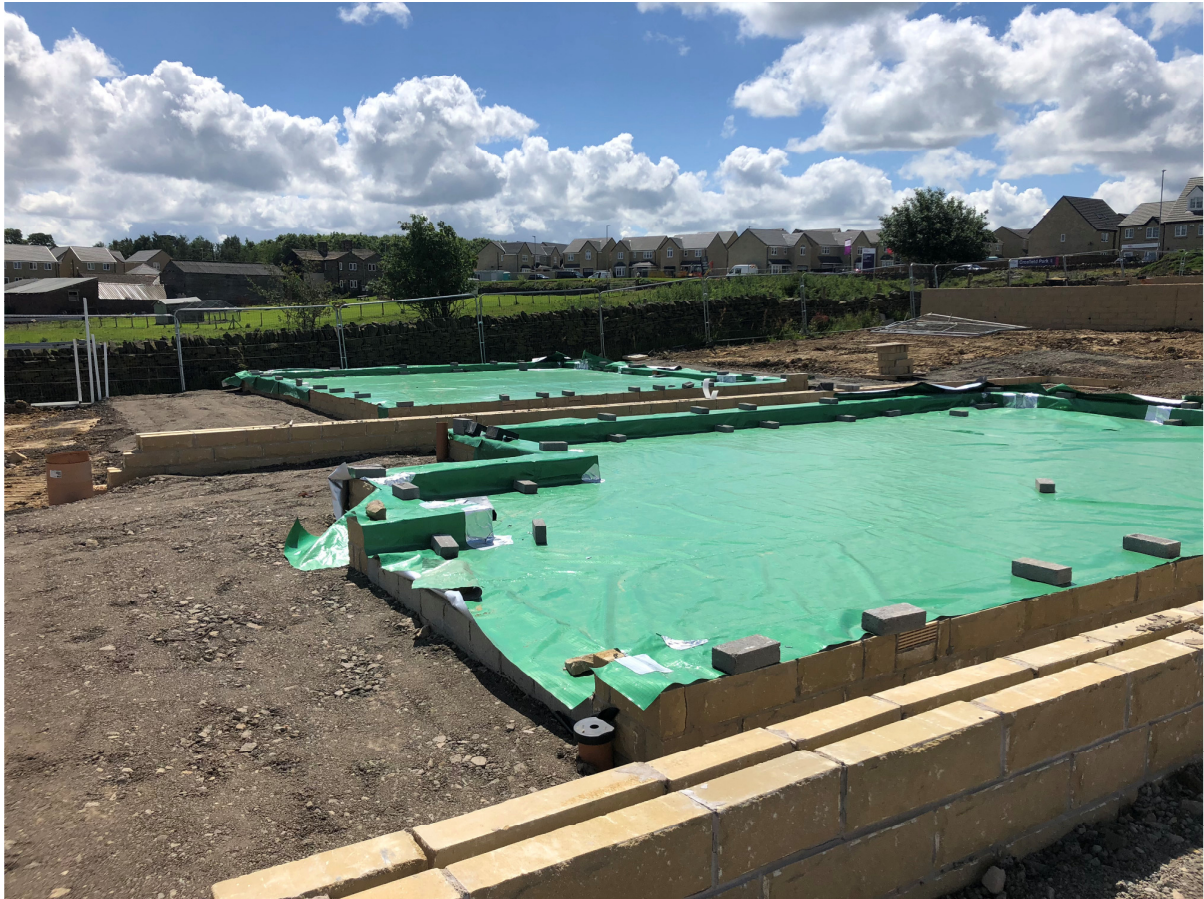
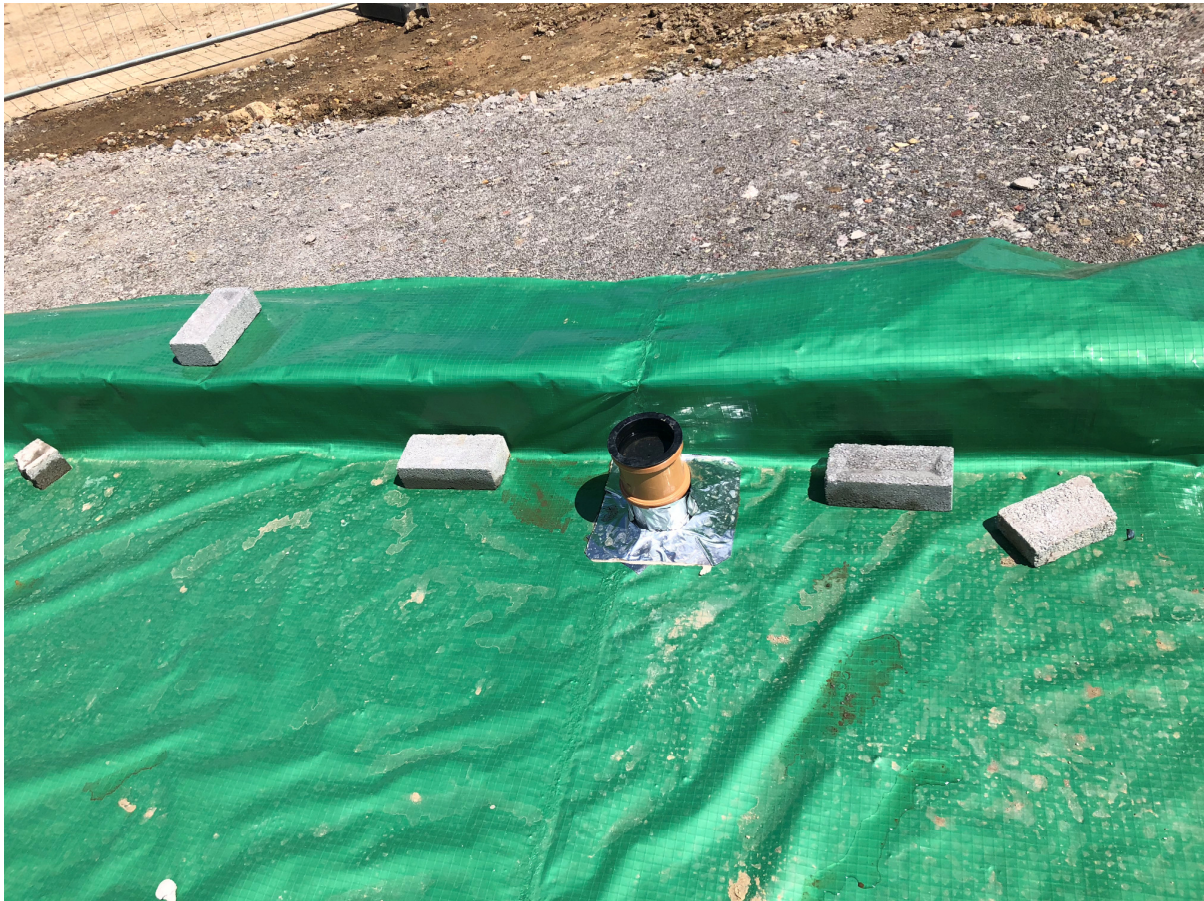
Photographs

Plots 1-2, and 34-42 at the above development have been inspected in accordance with the above procedure. Initial inspections on site found the membrane installation to be satisfactory, with only minor repair works being required on a number of plots.
