Our Ref: E15/6378/JF/012

**Re: Development at Crosland Road, Lindley**

Further to your request we have attended the above site to undertake an inspection of the gas membrane to confirm that the quality of the installation is satisfactory in plots 56-58, and 69-91 at the above site.

# Inspection Checklist

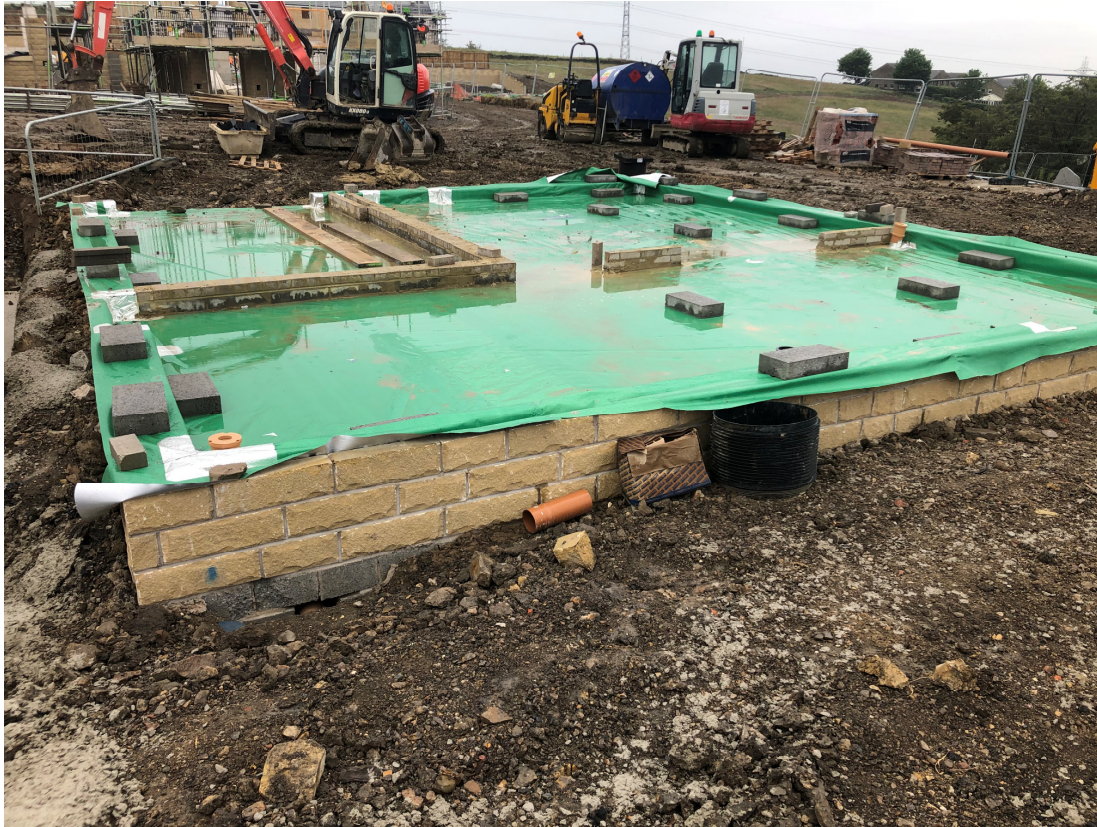
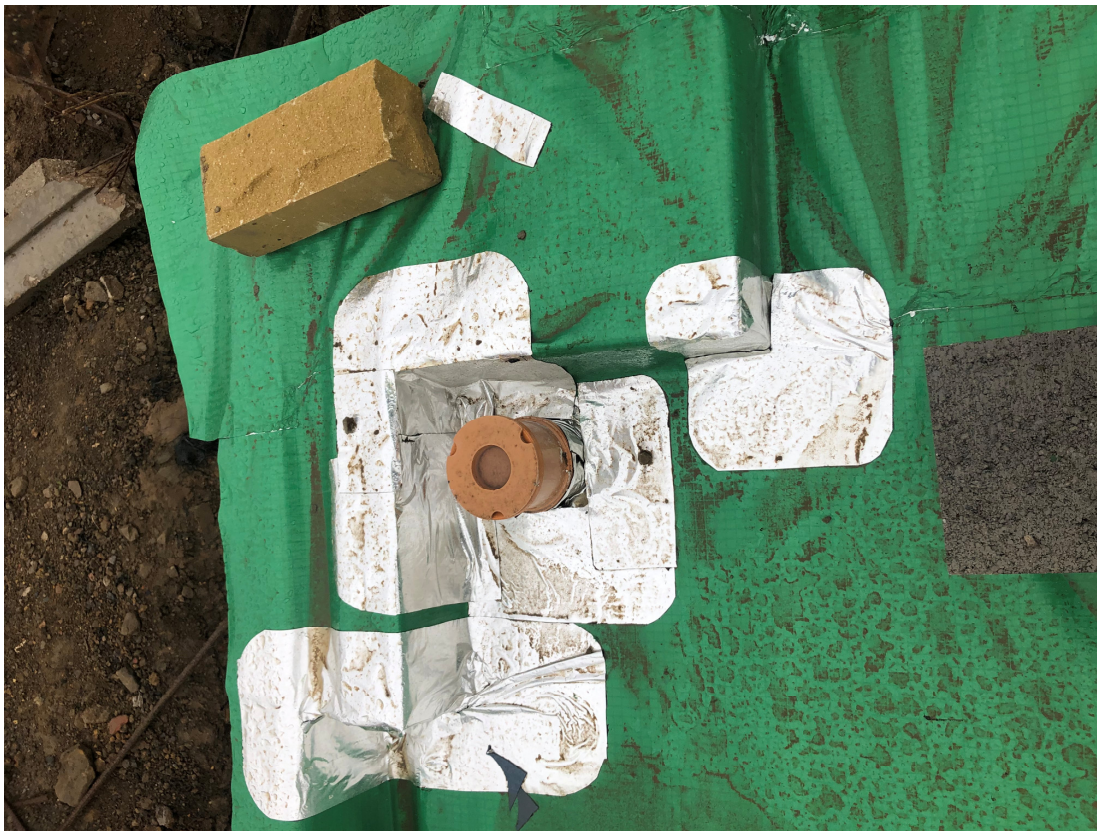
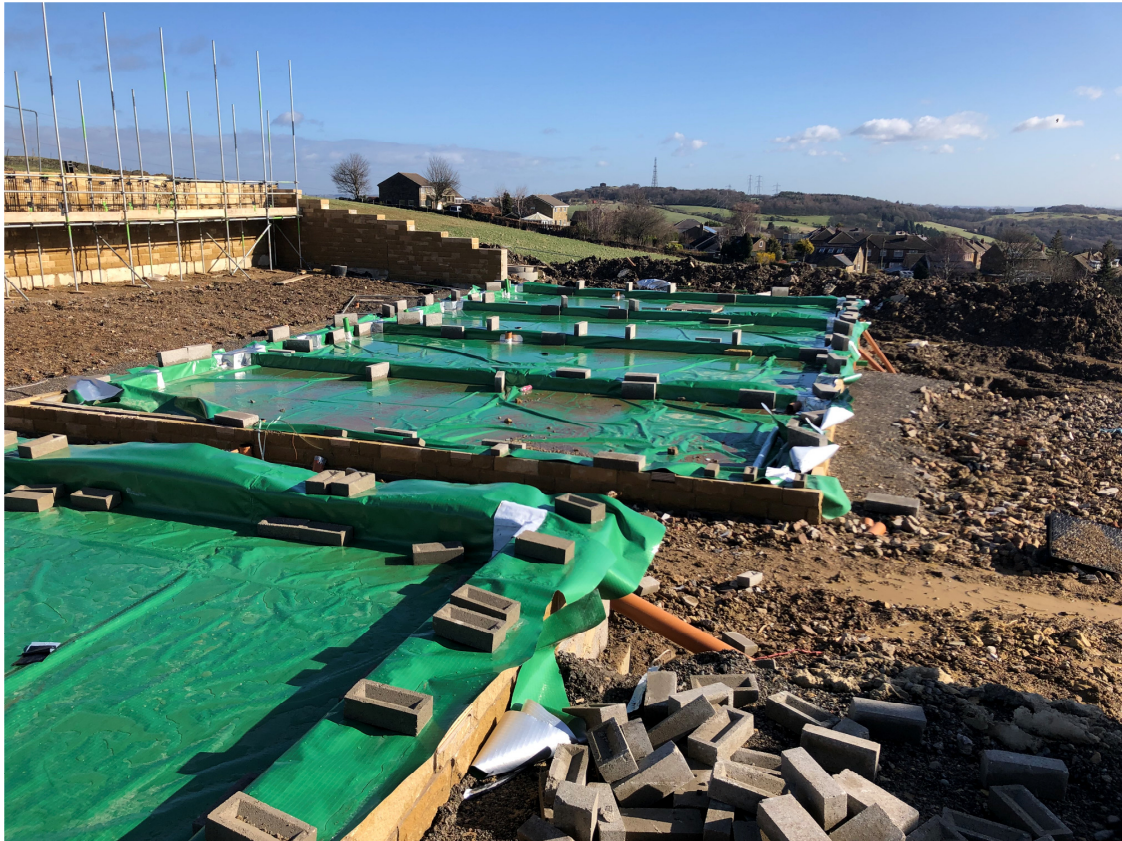
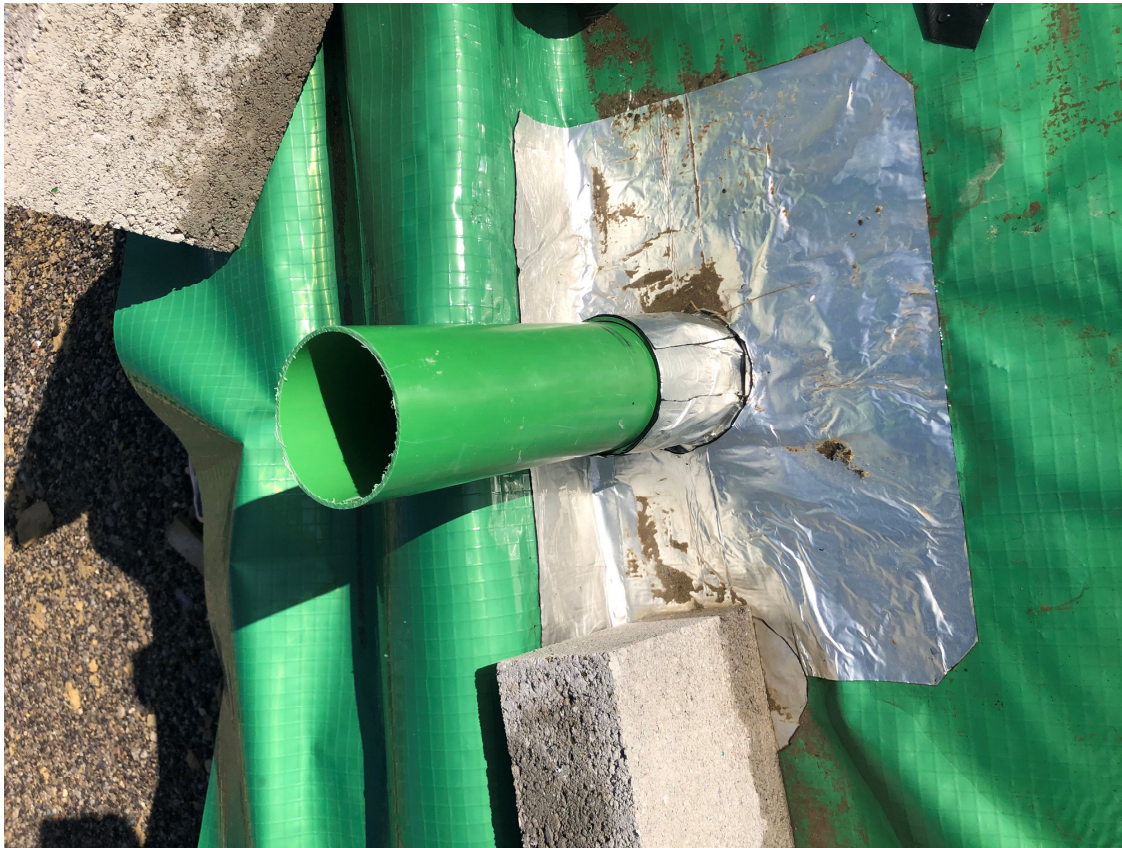
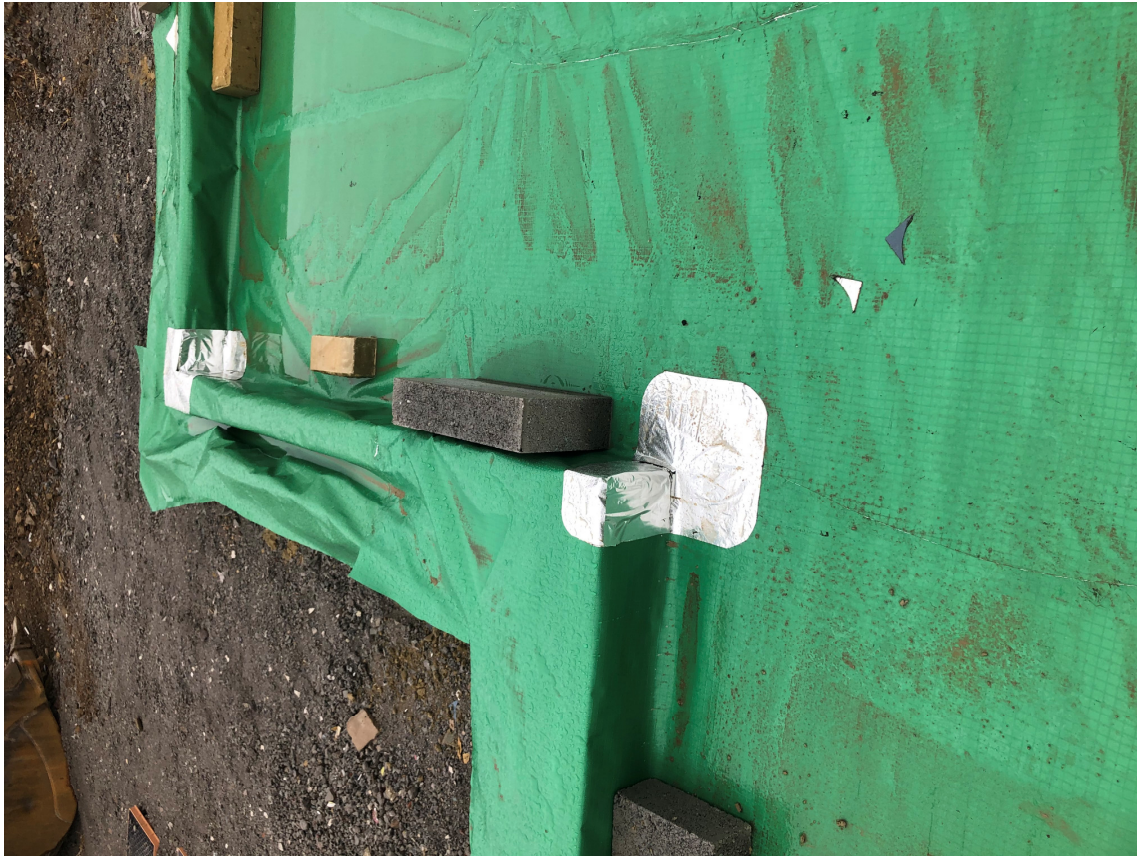
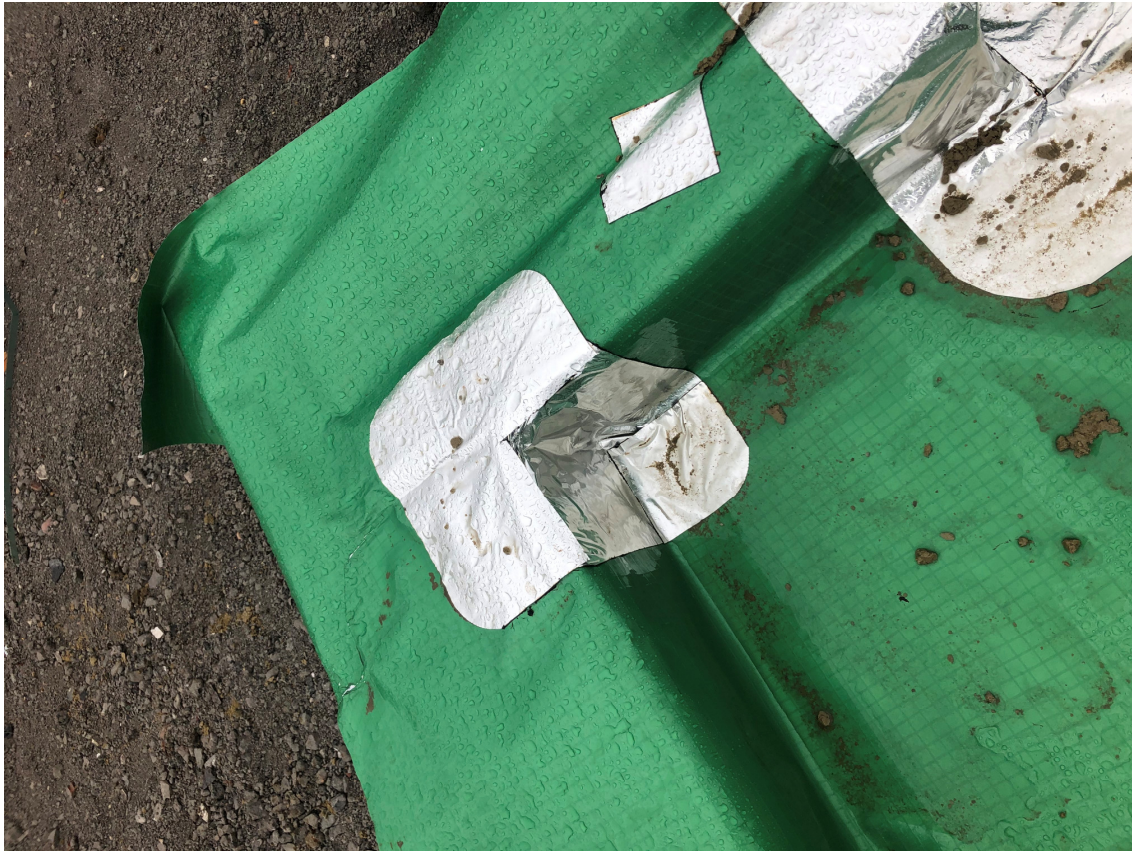
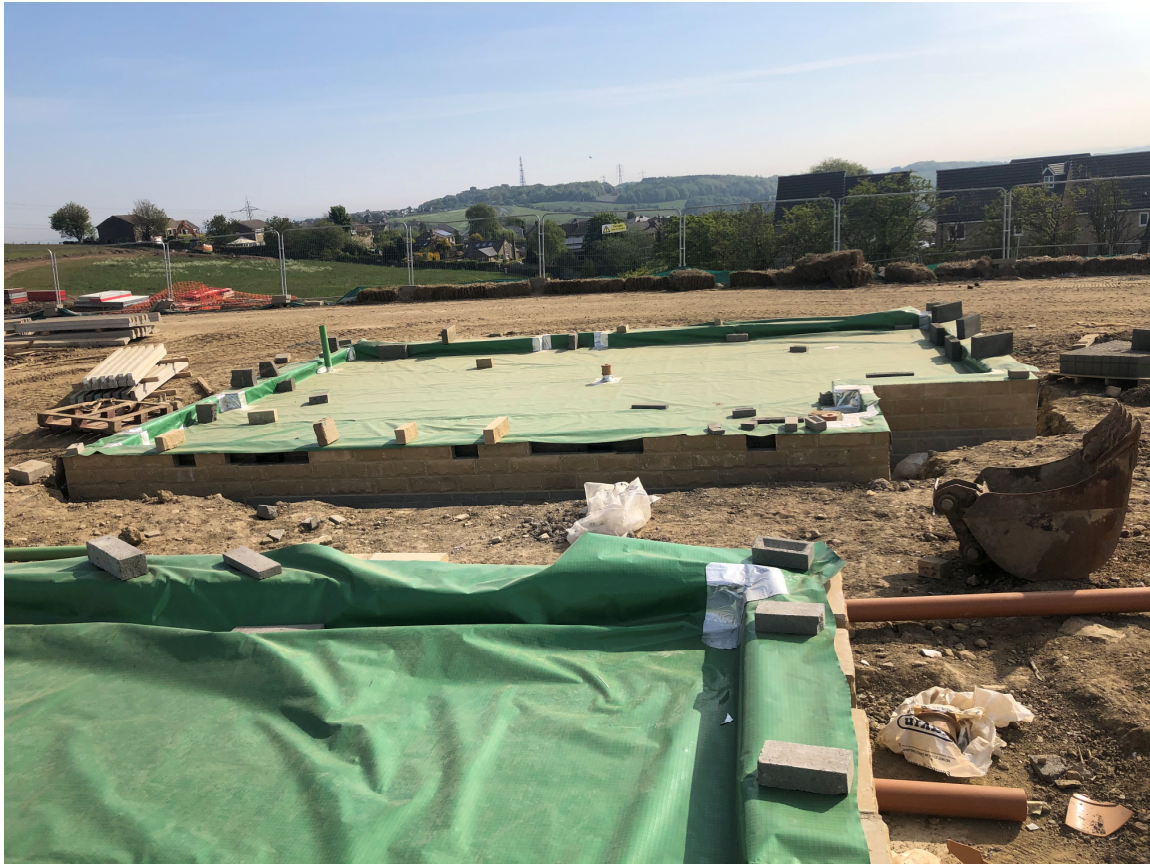
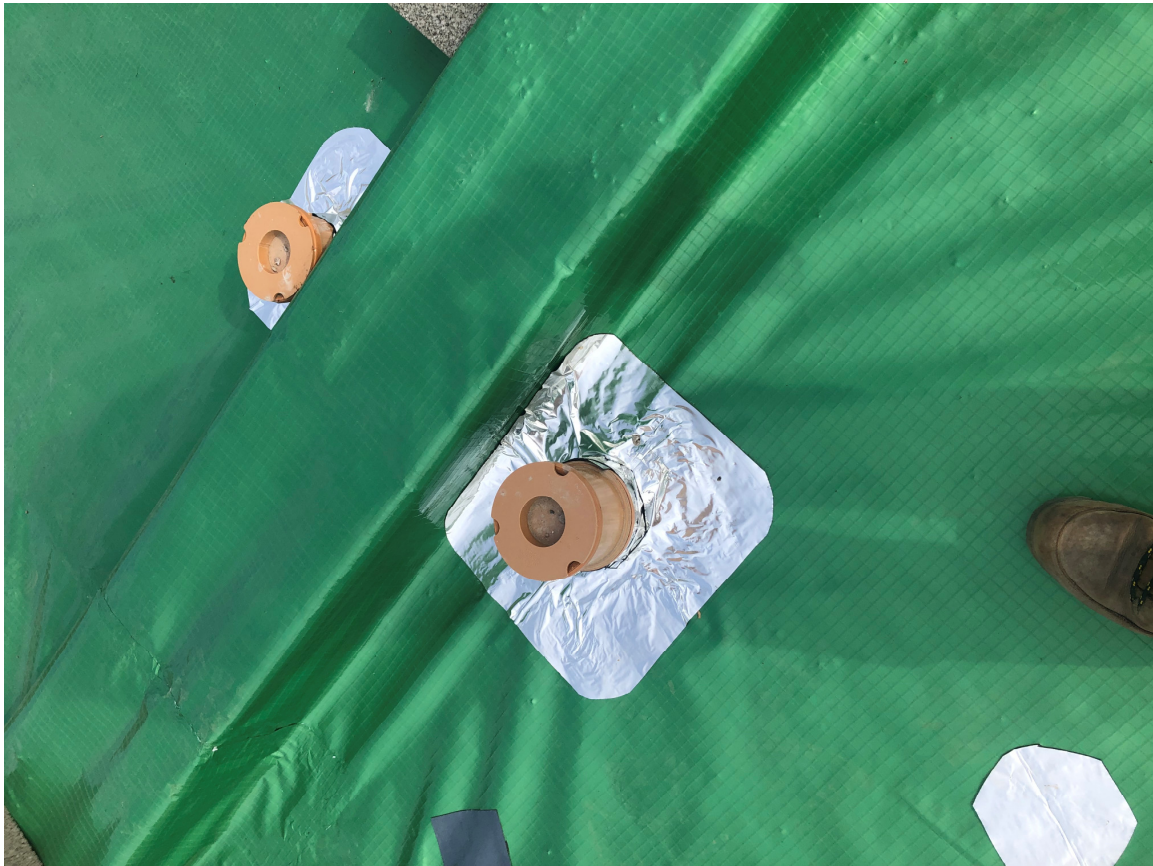
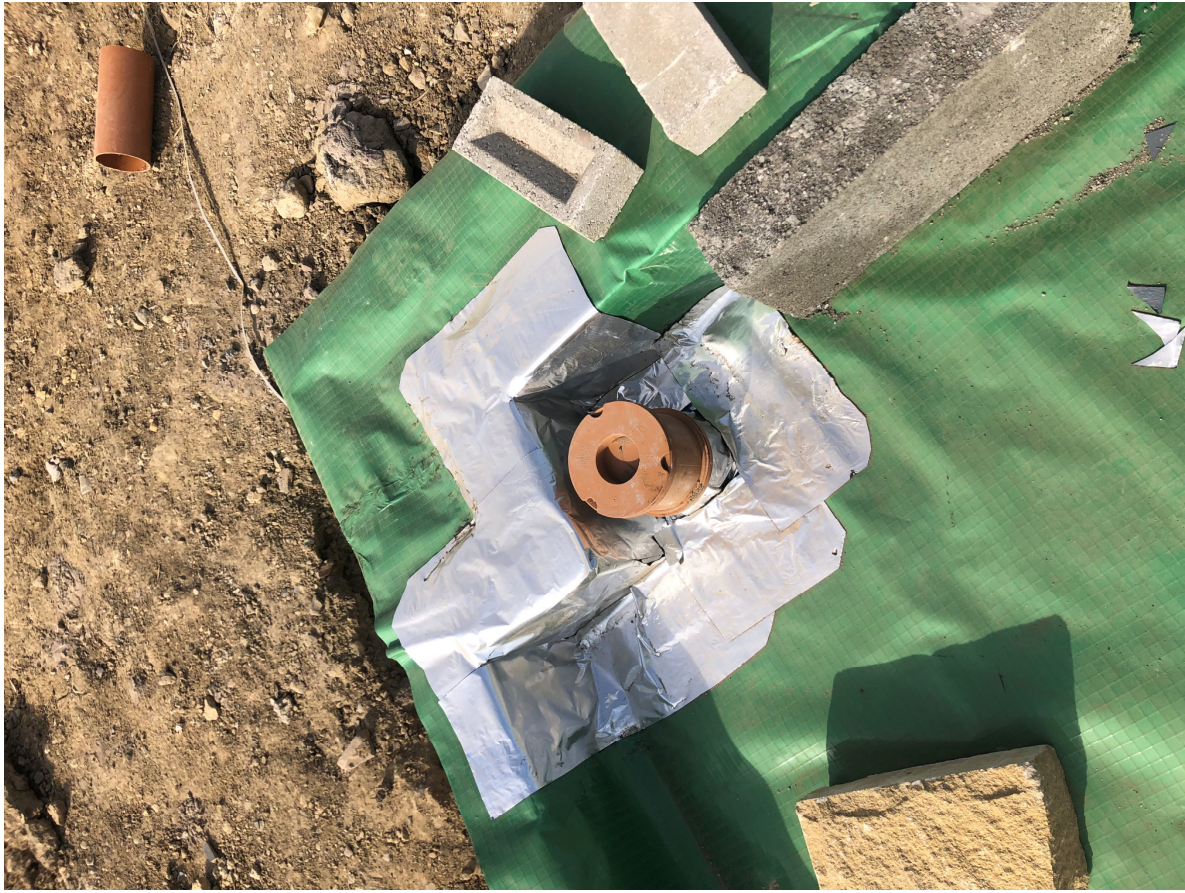
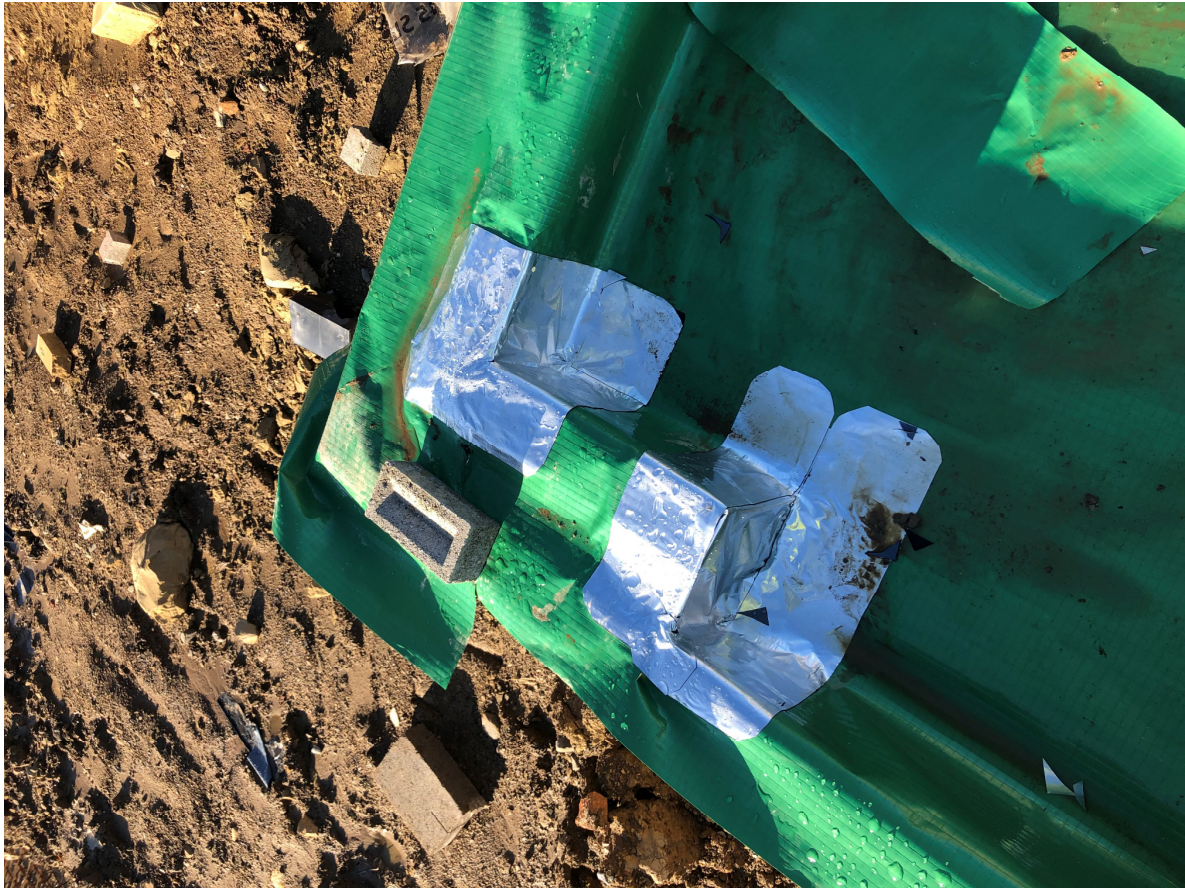
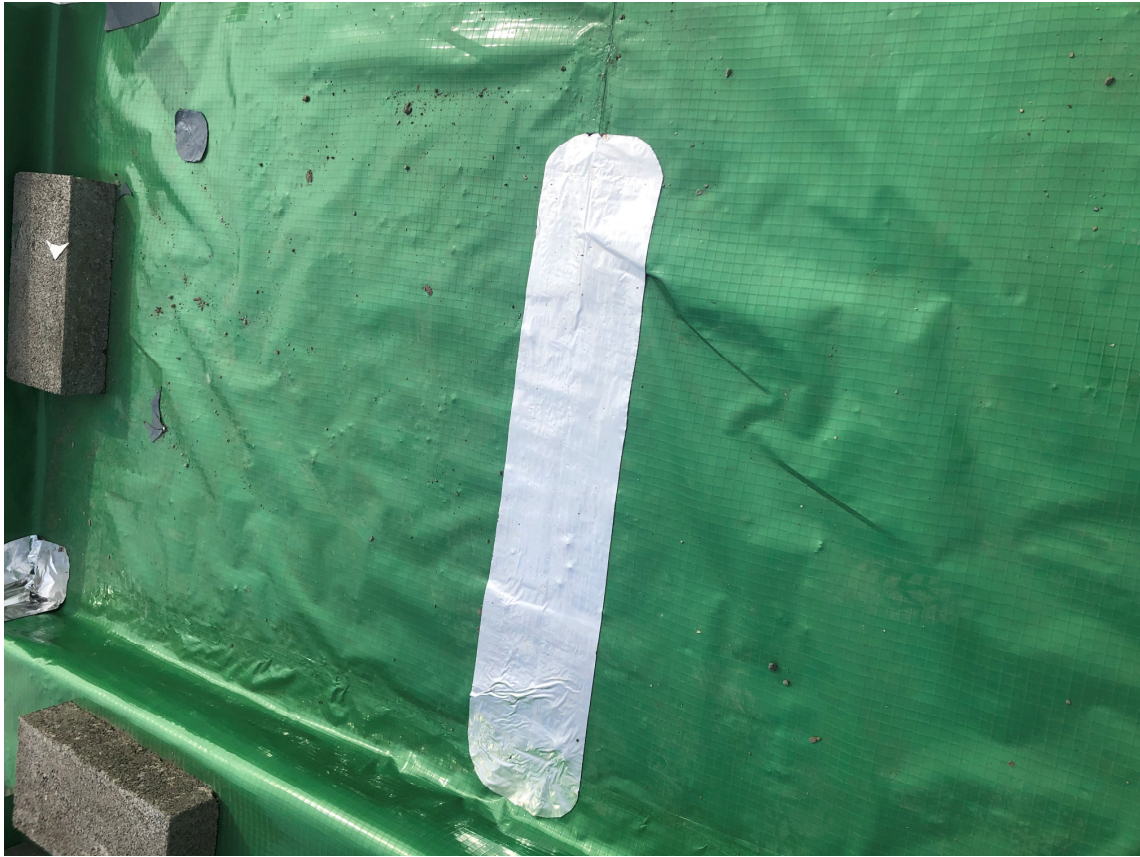
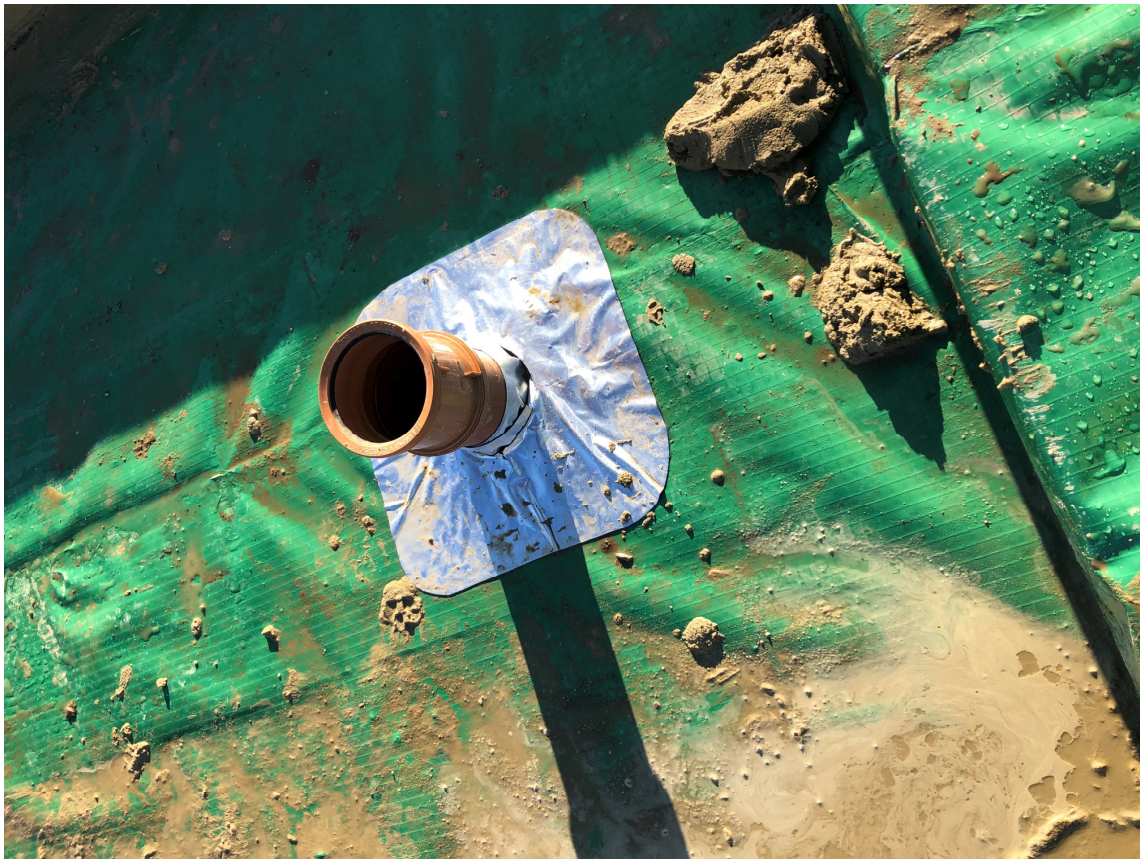
# Photographs

Inspection of the membrane was undertaken in a single stage process to suit the installation of the membrane. The property was inspected at DPC level once the full floor membrane has been laid and sealed prior to the insulation being laid. Air brick spacing and sub-floor void were also inspected.

Plots 56-58, and 69-91 at the above development have been inspected in accordance with the above procedure. Initial inspections on site found the membrane installation to be satisfactory, with only minor repair works being required on a number of plots.
