Merchant Fields, Cleckheaton – Gas risk assessment

Further to issue of our Geoenvironmental Appraisal Report (No. 2828/1a, dated July 19), gas monitoring at the above site has now been completed and we are able to issue this supplementary letter report, together with copies of the monitoring results. This letter, which should be read in conjunction with Report No 2828/1a, reviews soil-gas conditions, assesses risks and details any mitigation measures required to render the site suitable for the proposed development.

MONITORING WELL LOCATIONS

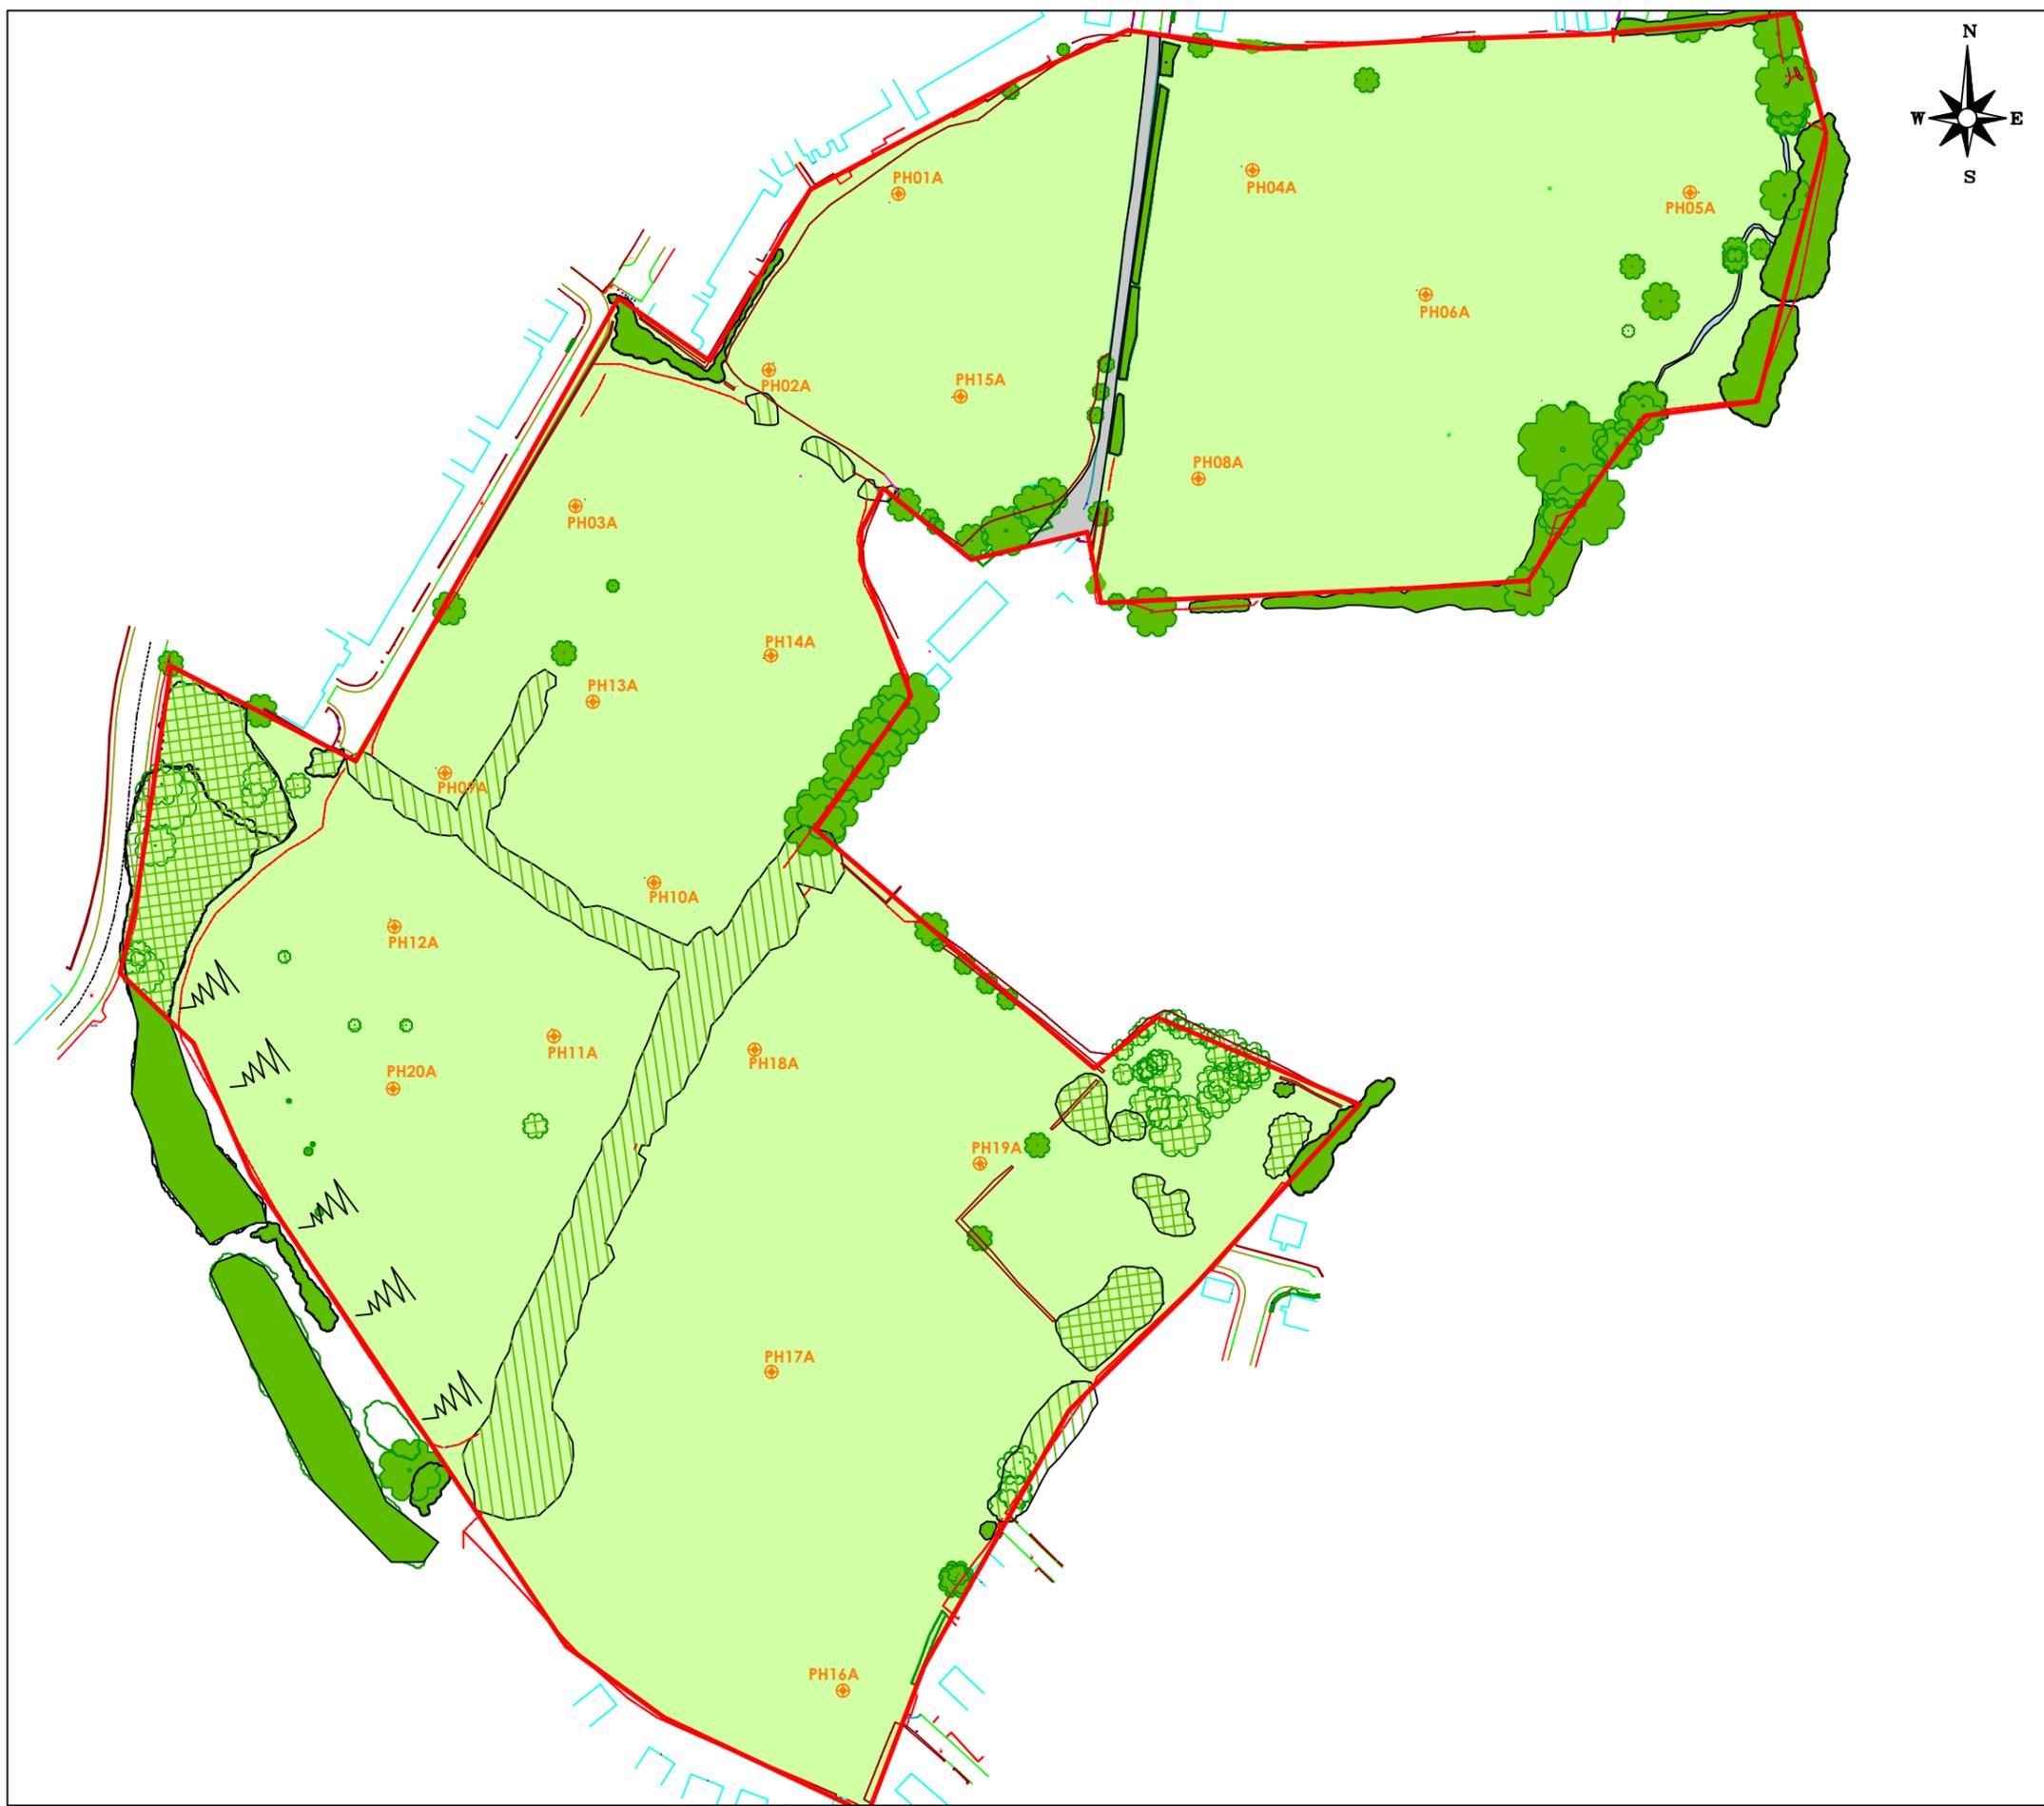
DRAWN	CC/LEW	DATE	05 04 19	STATUS	FOR COMMENT <input type="checkbox"/>
CHECKED	MJT	DATE	05 04 19	FOR APPROVAL	DRAFT <input type="checkbox"/>
					FINAL <input checked="" type="checkbox"/>
SCALE	1:2000	SHEET	A3	DRAWING NO.	2828/13
				REVISION

- MONITORING WELL LOCATION
- GRASS & OVERGROWN AREAS
- TREES/DENSE VEGETATION
- CLEARED TREES/DENSE VEGETATION
- CUT HEDGEROW/TREES
- TARMAC HARDSTAND
- SURFACE WATER FEATURE
- APPROXIMATE SITE BOUNDARY

Based on the above, it was considered that the site might be at risk from hazardous gas and therefore monitoring wells were installed in 19 boreholes. Details of the individual installations are provided in Report No 2828/1A and the exploratory logs appended to this letter report.
