**Former Deighton Centre, Deighton**

## **Arboricultural Method Statement**

February 2025

**FPCR Environment and Design Ltd**

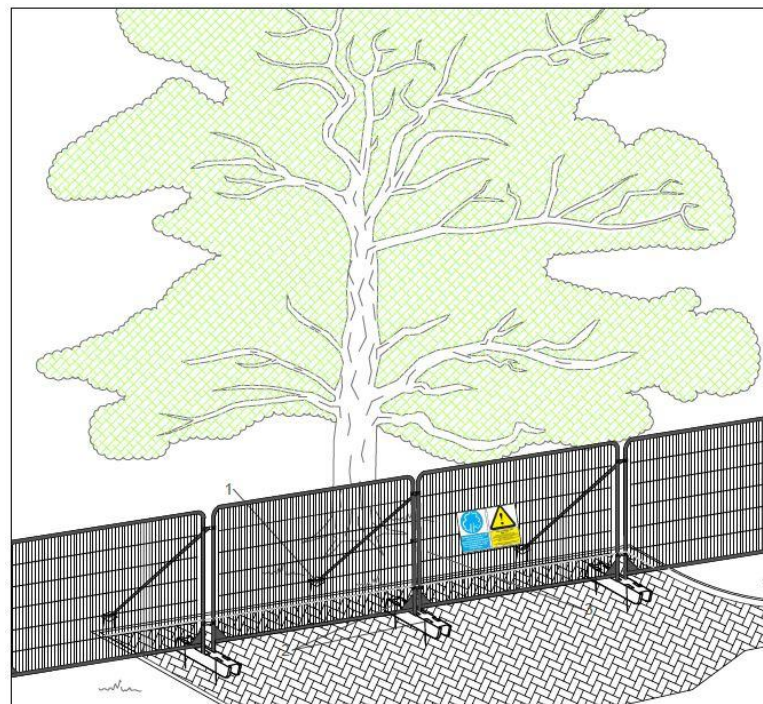
**Figure 1: Tree Protection Fencing Specification**

Standard Specification for Above Ground Stabilizing Systems  
 1. Stabiliser strut with base plate secured with ground pins  
 2. Feet blocks secured with ground pins  
 3. Construction Exclusion Zone signs

- 5.1 Tree protection fencing will be installed prior to any construction works on site, in the positions shown on the Tree Protection Plan (11376-T-03, 11376-T-04 & 11376-T-05) and will remain in situ throughout the construction phase.
- 5.2 The position of the Tree Protective Fencing shall be measured out using the dimensions indicated and marked with highly visible fluorescent paint and / or marker pegs / stakes, where deemed necessary.
- 5.3 This Tree Protection Fencing will comprise a Heras HSG151 panel framework on feet blocks with a stabilising strut secured with ground pins. An example of this has been illustrated below in Figure 1 and a specification provided as Appendix B.

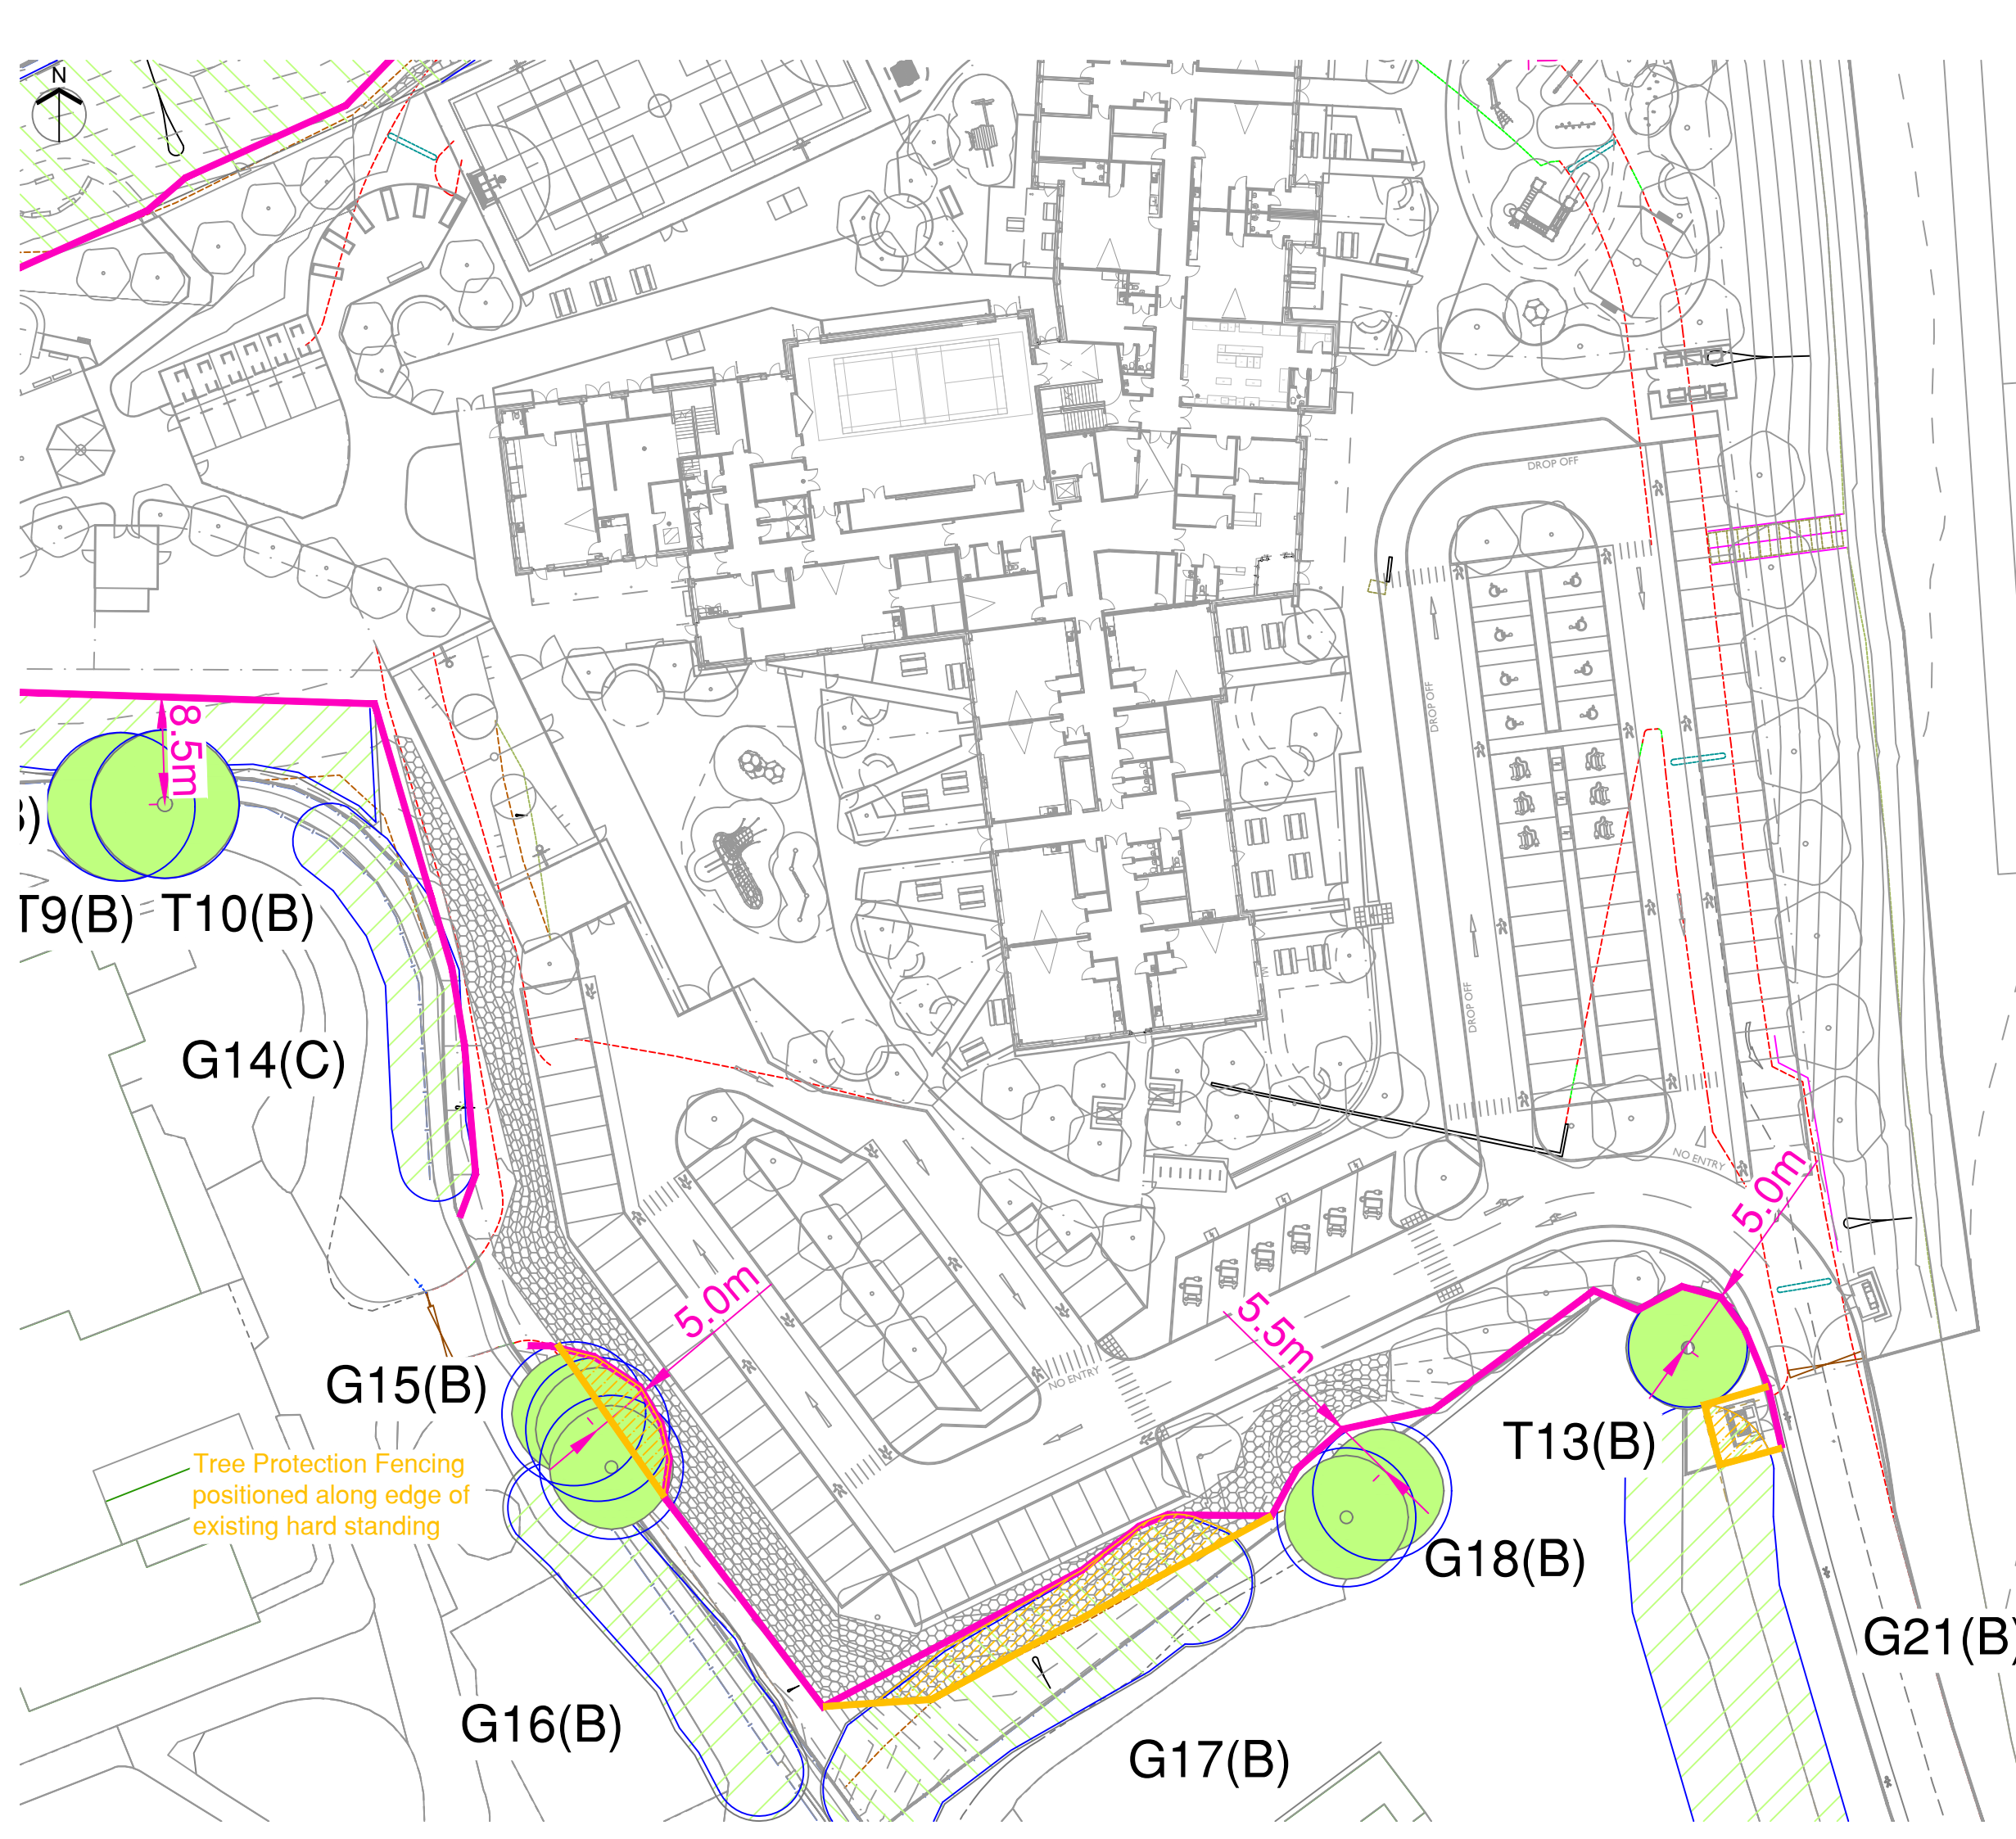
| drawing number<br><b>11376-T-03</b> | rev<br><b>F</b> |

- Tree/Group to be Retained
- Woodland to be Retained
- Root Protection Area (Shown for retained trees only)
- Individual / Group Number and BS Category
- Line of Protective Barriers (and distance from tree or structure)
- Line of Secondary Protective Barriers (and distance from tree or structure)
- Arboricultural Supervision Zone (see AMS for details)

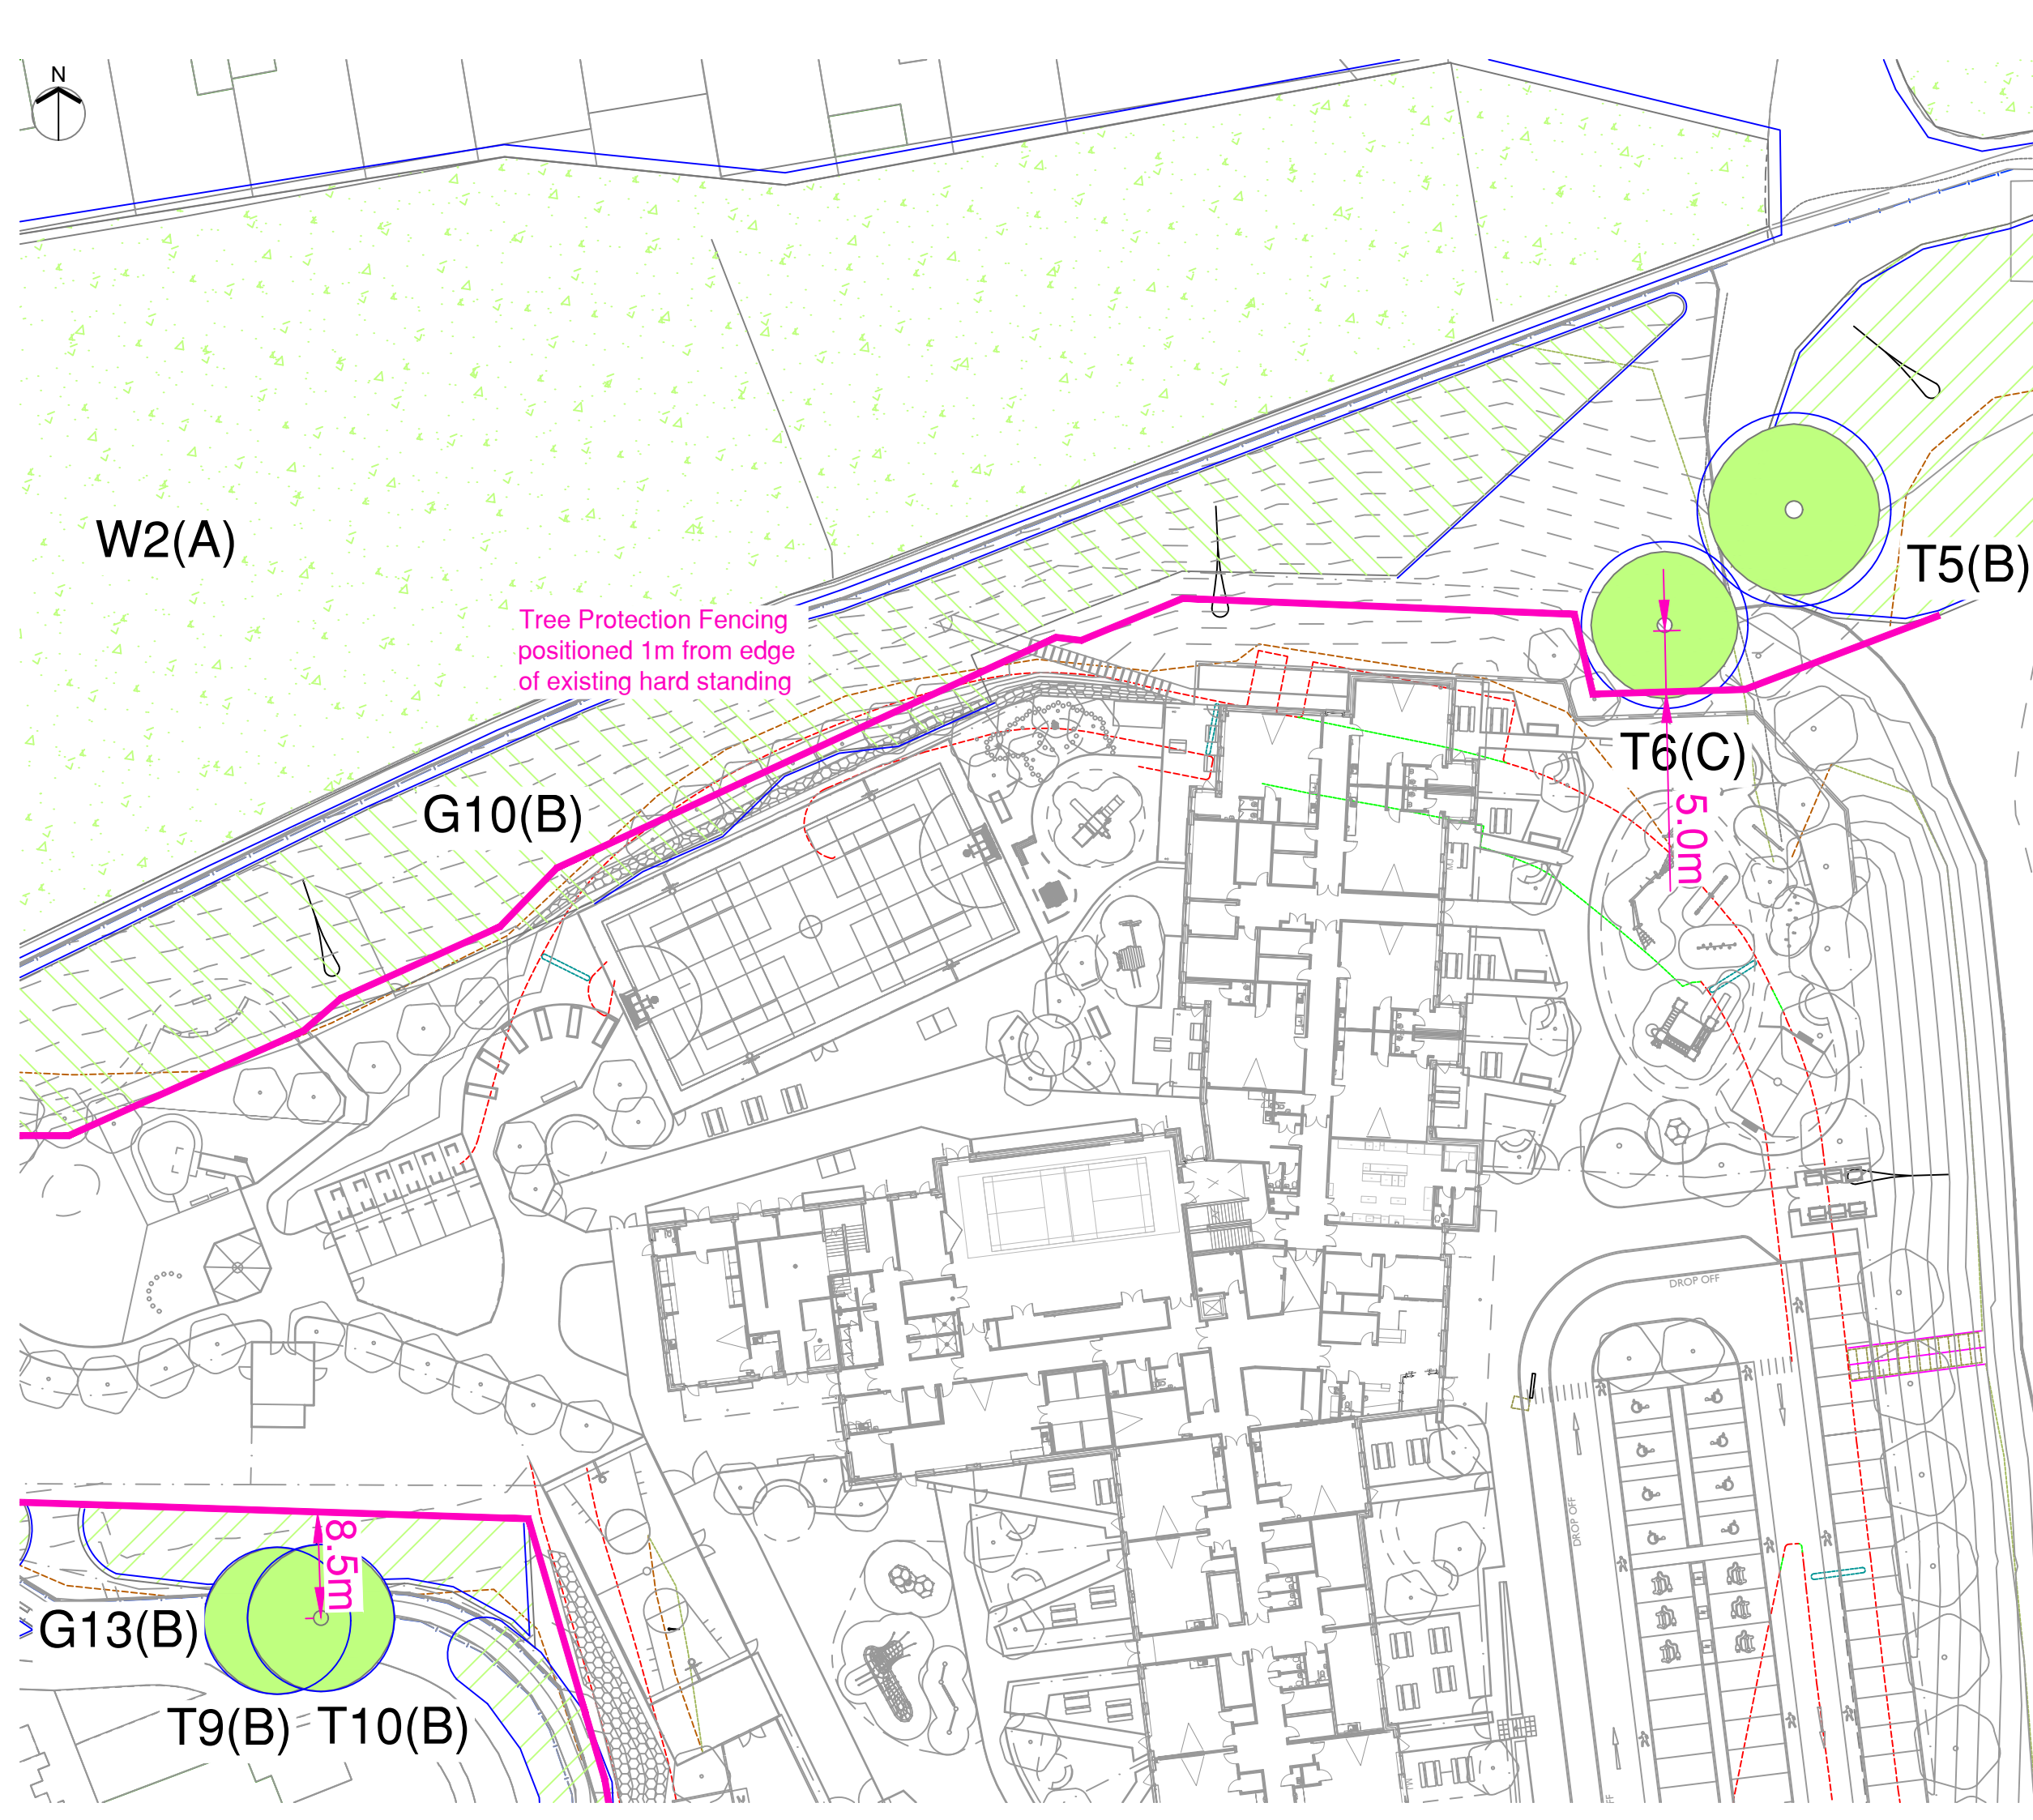
drawing number  
**11376-T-04**

Tree/Group to be Retained

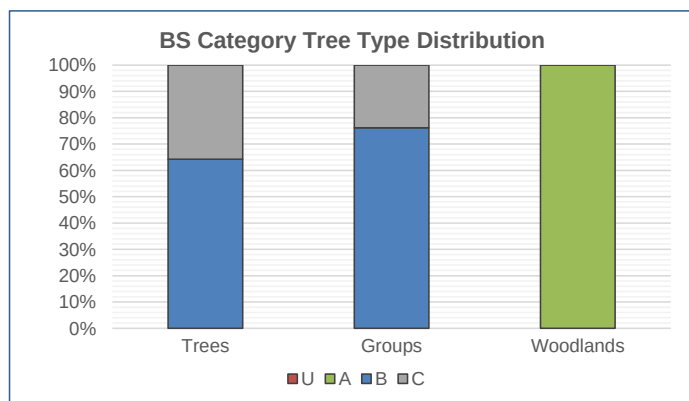
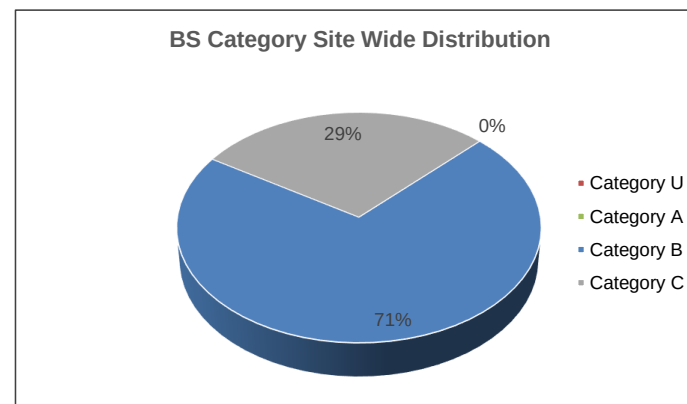
**BS Category Tree Type Distribution** displays the proportion of trees assessed in each type to enable a better understanding of the category distribution.

**BS Category Site Wide Distribution** shows the proportion of trees assessed in each category across the whole site which allows an interpretation of the site's overall quality.

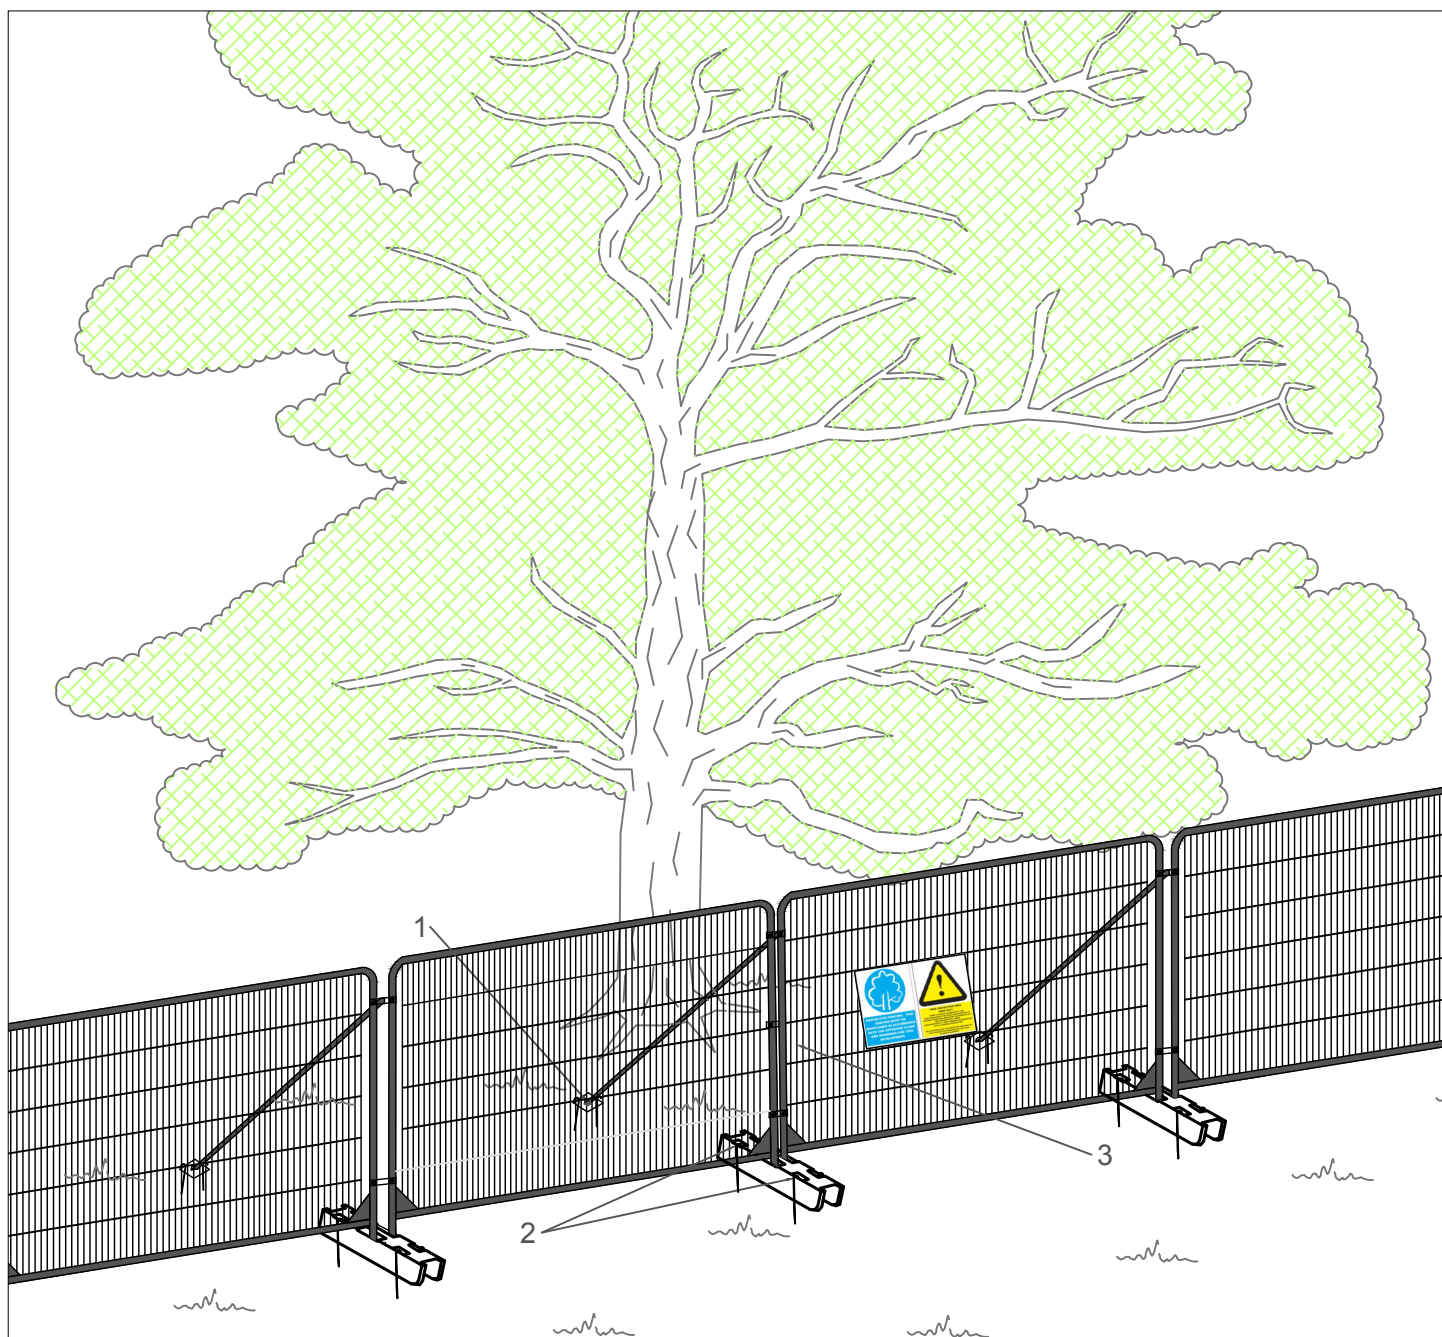
### Standard Specification for Above Ground Stabilizing Systems

1. Stabiliser strut with base plate secured with ground pins
2. Feet blocks secured with ground pins
3. Construction Exclusion Zone signs
