**ARBORICULTURAL IMPACT ASSESSMENT
to BS 5837:2012
at
Land At Bretton Street
Dewsbury
West Yorkshire
WF12 9DB**

Client:
A & K Properties

JCA Ref:
22726-D/AJB

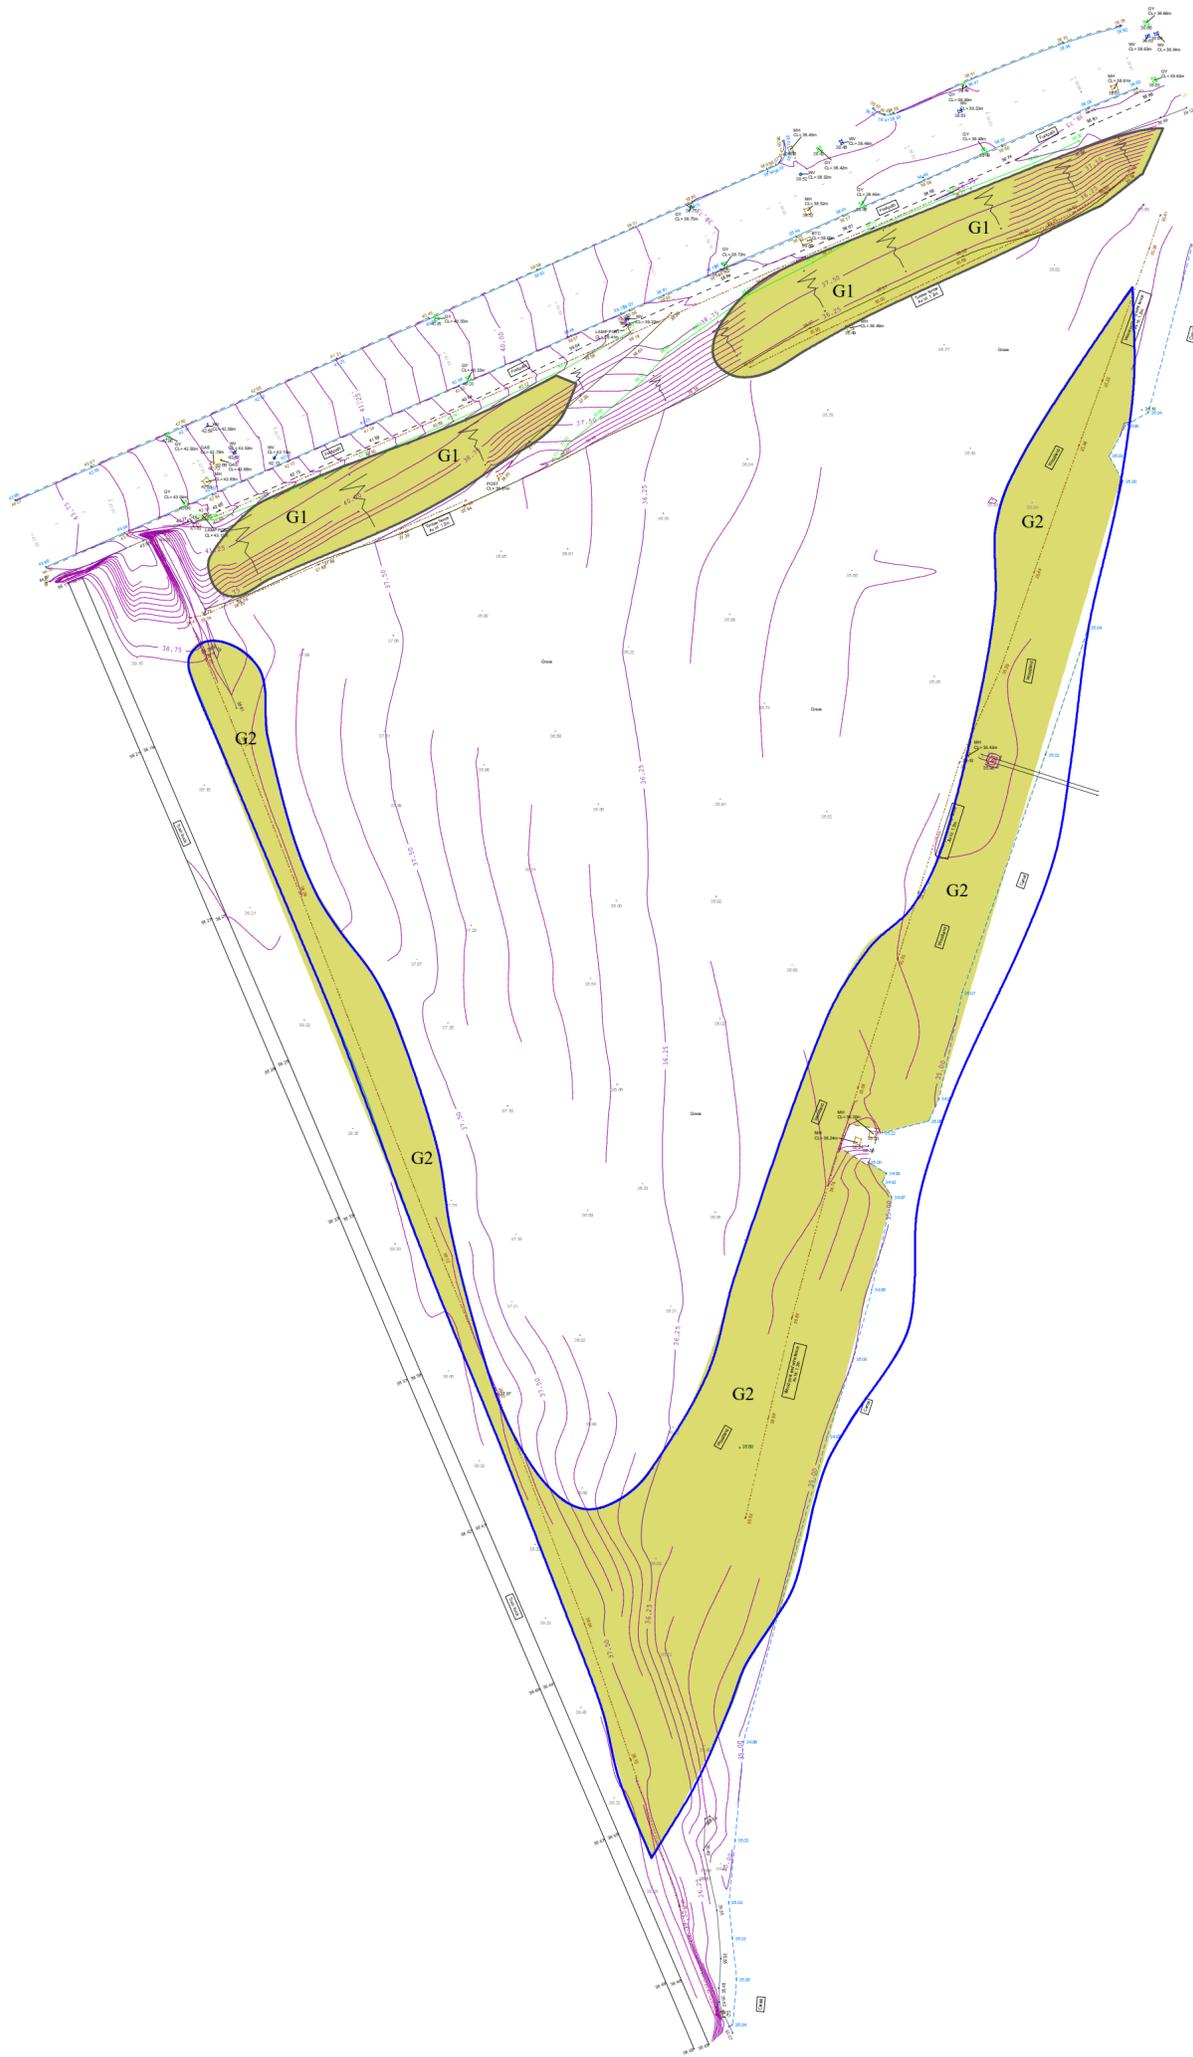
**Appendix 5:
Tree Constraints Plan**

THE ROOT PROTECTION AREA SHOULD IDEALLY REMAIN UNDISTURBED IF THE TREE IS TO BE RETAINED.

THE DEVELOPMENT PROPOSALS SHOULD THEREFORE BE DESIGNED TO AVOID THE RPA OF ANY TREE WHICH IS TO BE RETAINED.

IF IT IS NECESSARY FOR THE DEVELOPMENT TO ENCROACH INTO THE RPA OF A TREE WHICH IS TO BE RETAINED THEN SPECIALIST CONSTRUCTION TECHNIQUES AND MATERIALS MUST BE CONSIDERED.

- 2.1 The tree information recorded during the original survey is detailed in the tables at **Appendix 1**. A full explanation of the tables can be found at **Appendix 2**.
- 2.2 Please refer also to the Tree Constraints Plan at **Appendix 5** for tree locations.

- 4.6 The protection of retained trees can be achieved by the creation of a Construction Exclusion Zone based on the Root Protection Area of a tree. The Root Protection Area of each tree or group is marked on the Tree Constraints Plan at **Appendix 5**.

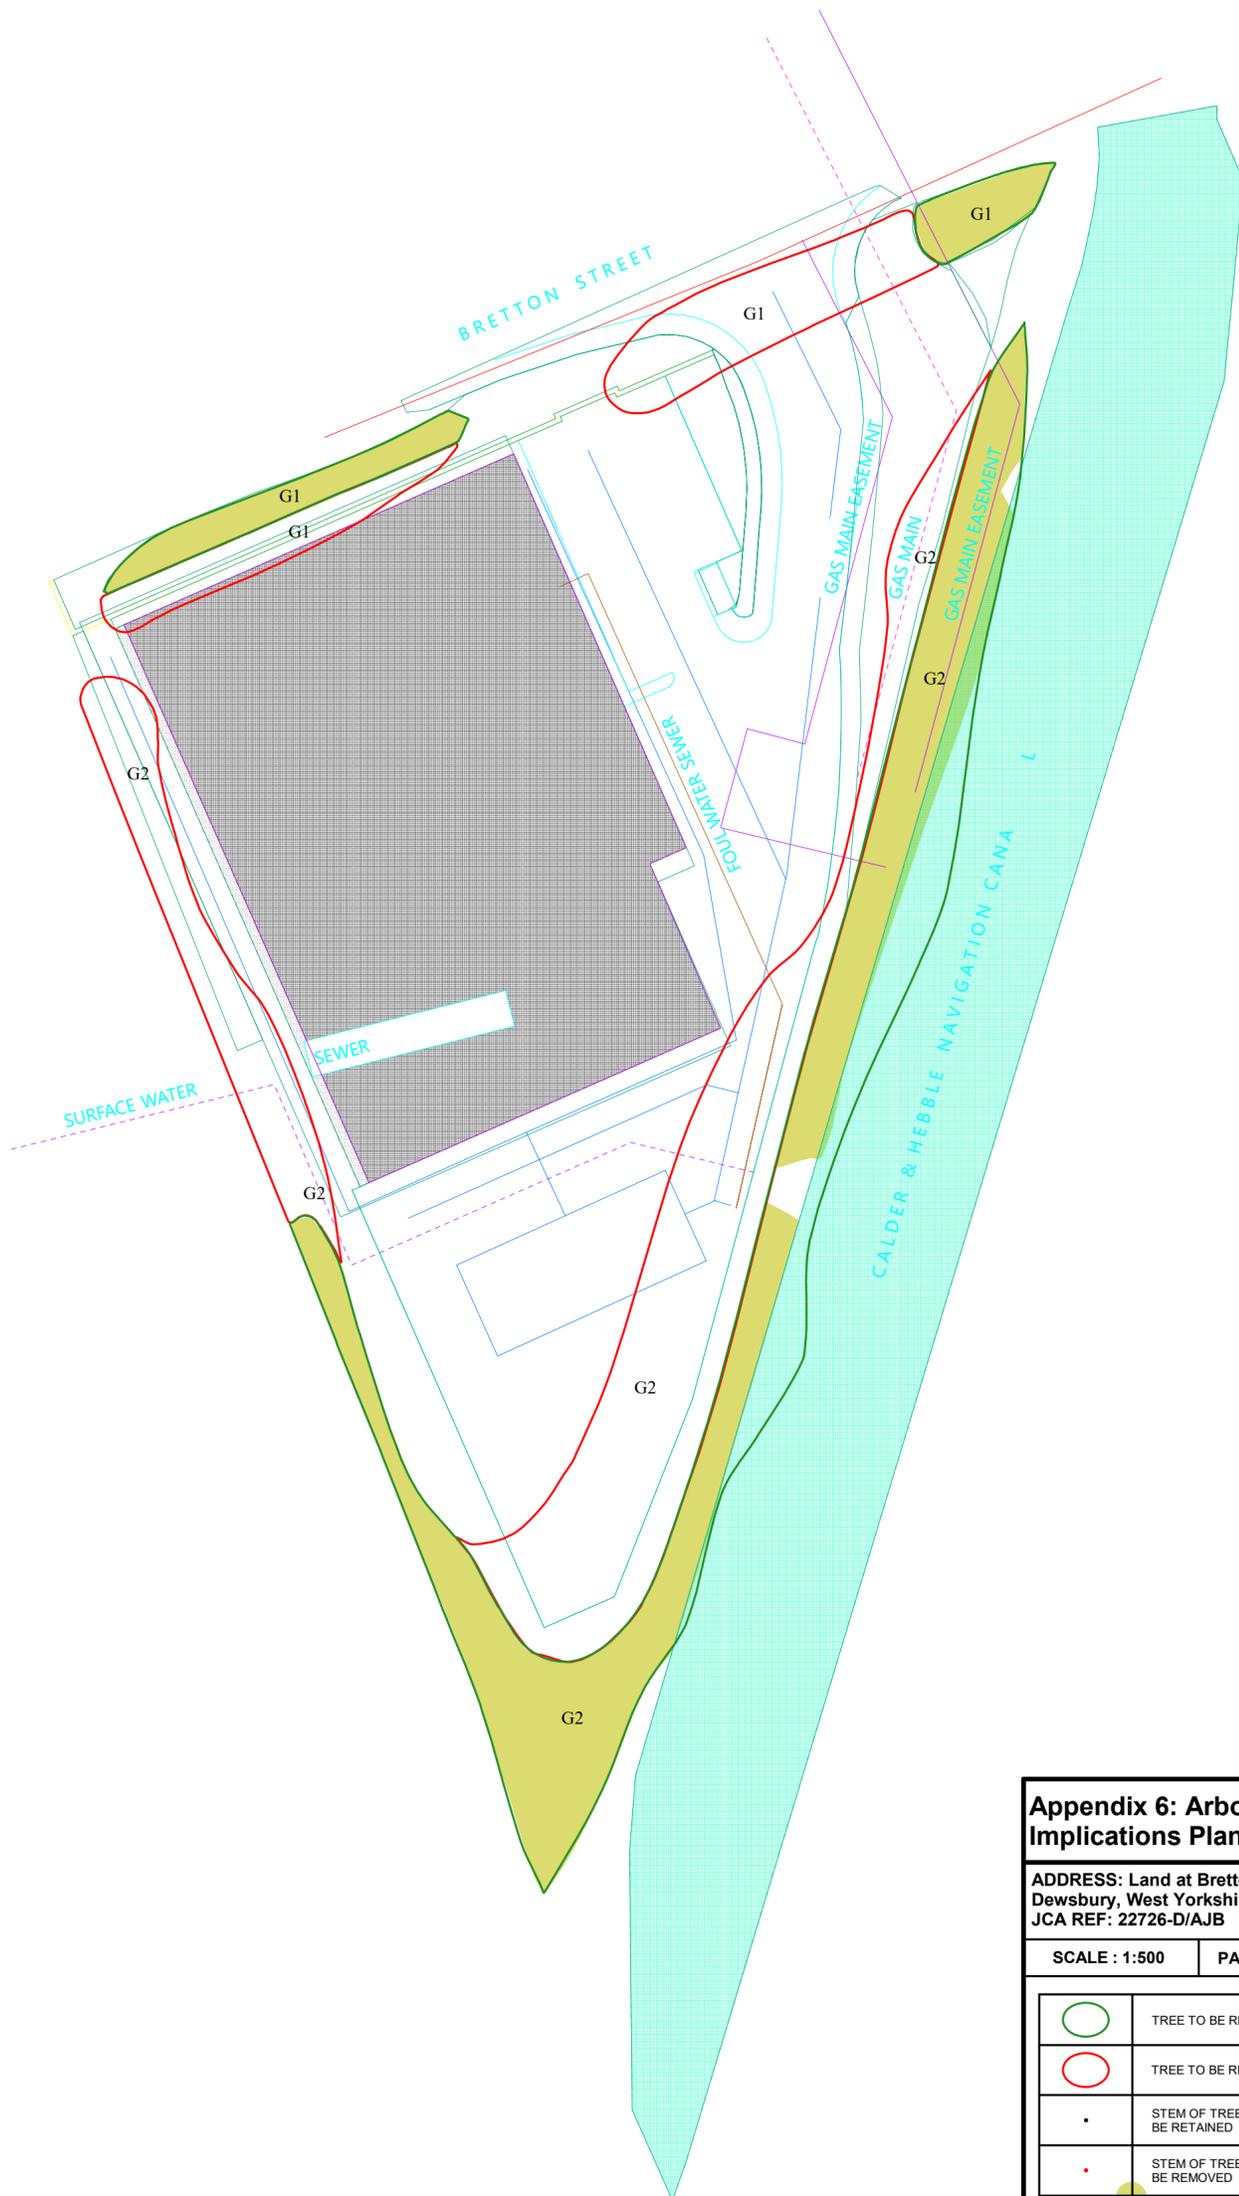
Appendix 6: Arboricultural Implications Plan

TREE TO BE RETAINED
	TREE TO BE REMOVED
	STEM OF TREE TO BE RETAINED
	STEM OF TREE TO BE REMOVED
	ROOT PROTECTION AREA

- 3.2.1 In order to facilitate the proposed development, it will be necessary to remove two sections of **G1** and two sections of **G2**, as shown indicatively on the plan at **Appendix 6**. Of these, **G1** falls into retention category ‘C’ and **G2** falls into retention category ‘B’.

- 4.4 two sections of **G1** and two sections of **G2** require removal in order to facilitate the proposed development. Tree works required to accommodate the proposals are detailed in *italics* in the tables at **Appendix 1**. Those trees requiring removal are shown in red on the Arboricultural Implications Plan at **Appendix 6**, where the proposals can also be viewed.
