FLOOD RISK ASSESSMENT

**LAND SOUTH OF GYNN LANE,
HONLEY**

VIVLY LIVING

E24/8017/FR01

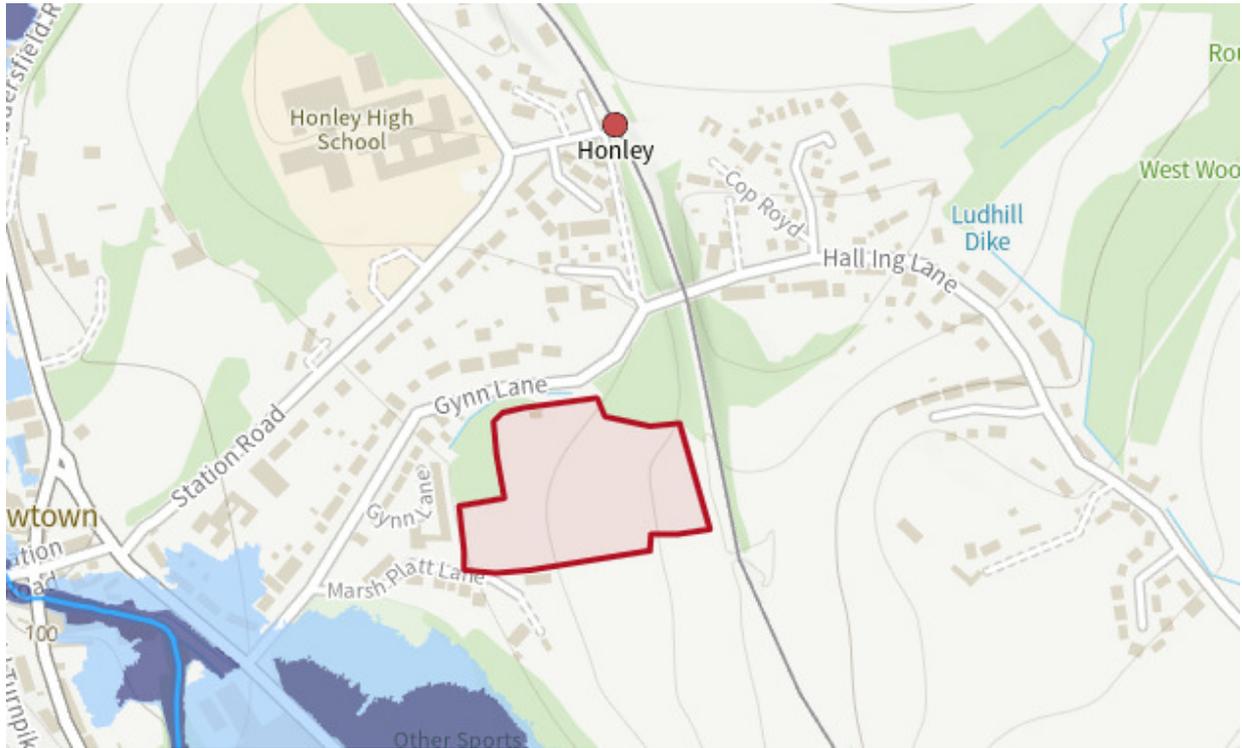
Fig 1 Flood Risk Map – Environment Agency

4.1 On reviewing the Environment Agency websites flood risk maps, the site currently falls within flood zone 1: which is designated as low probability of flooding from sea or rivers less than 0.1% (ie 1 in 1000 year) probability of flooding see Fig 1.

5.1.1 The proposed development area does not fall within the 0.1% or the 1% probability Flood Risk Maps (Zone 2 and 3) as published by the Environment Agency. The site is therefore considered not to be at risk from fluvial flooding for the once in 100 year flood event. We therefore consider the risk of flooding of the site from River and Sea is acceptable for this type of development on this site.

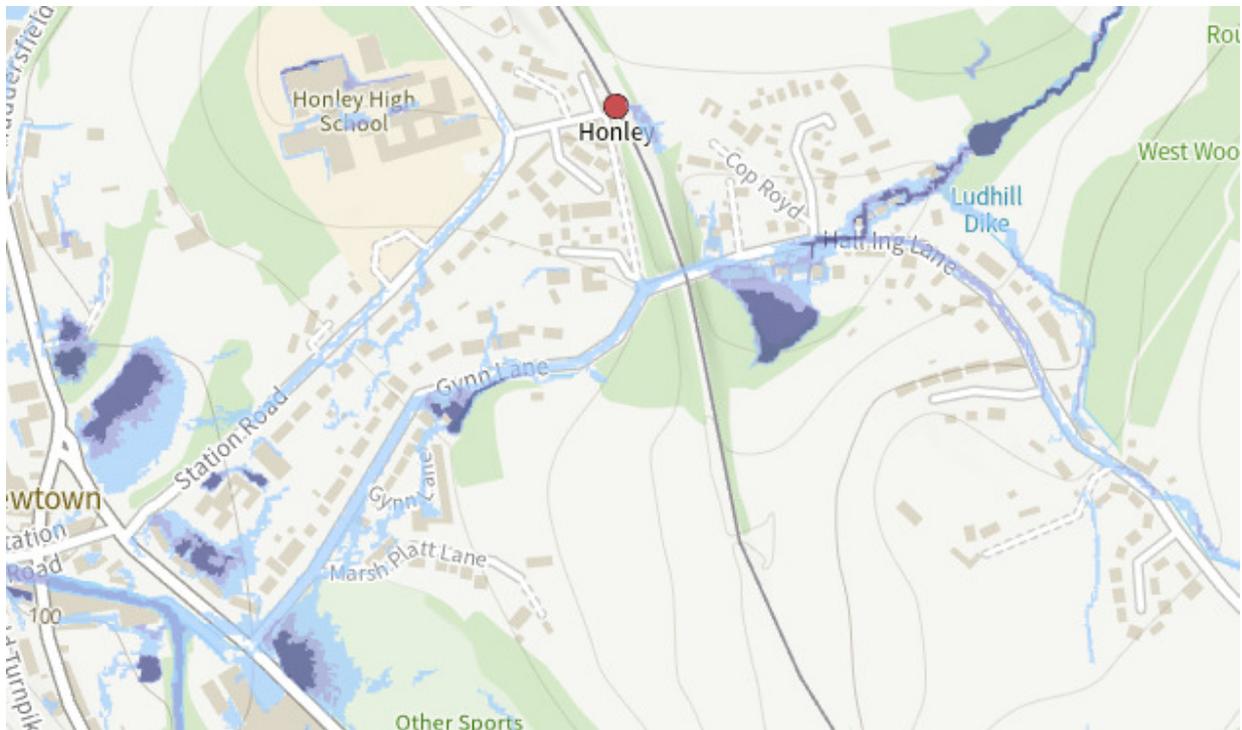
Fig 2 Surface Water Flood Risk Map – Fluvial Flow

4.2 The available EA plans indicate that the majority of the site is not affected by overland surface water flood water (Fig 2 – Surface water flood risk map). The surface water exceedance flows are only shown within the existing Ludhill Dyke crossing the site from east to west on the northern boundary.

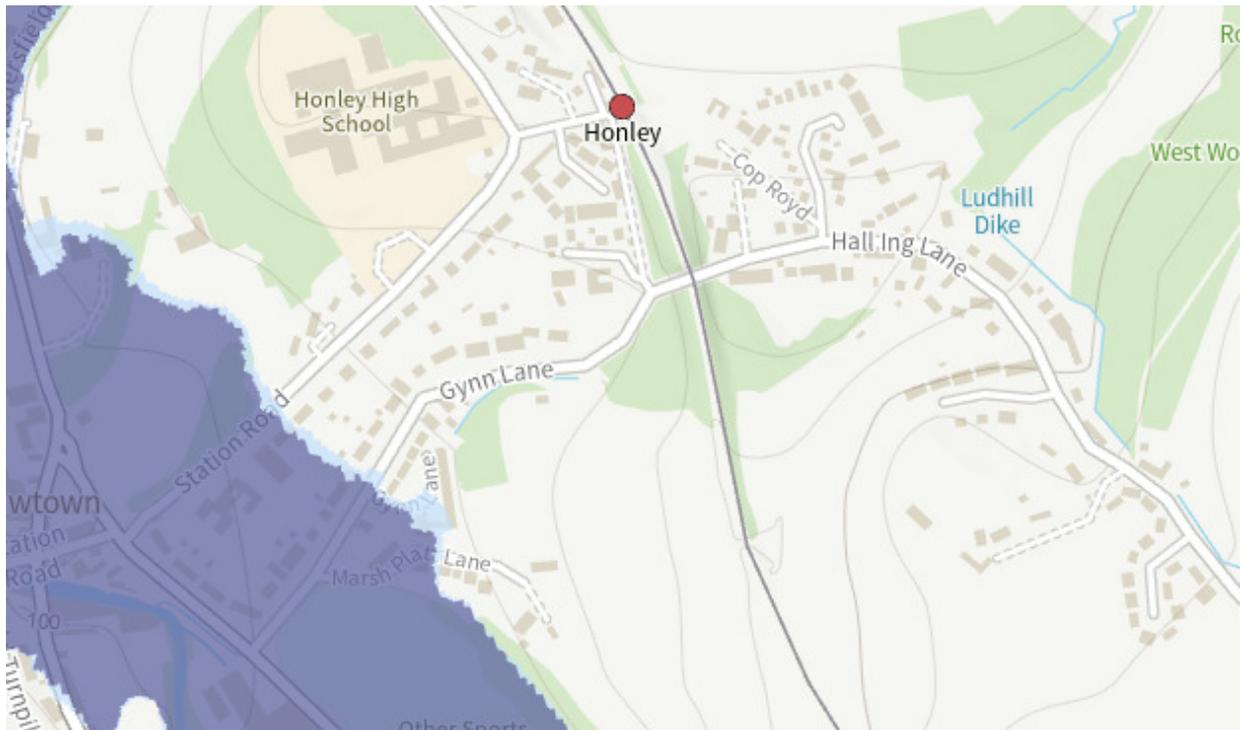
Fig 3 Reservoir Breach Flood Risk Map

4.3 The site does not appear to fall within an area subject to flooding from reservoirs according to the EA maps (Fig 3). We consider the risk of such a source of flooding would be low. The site does not fall within a flood warning zone.

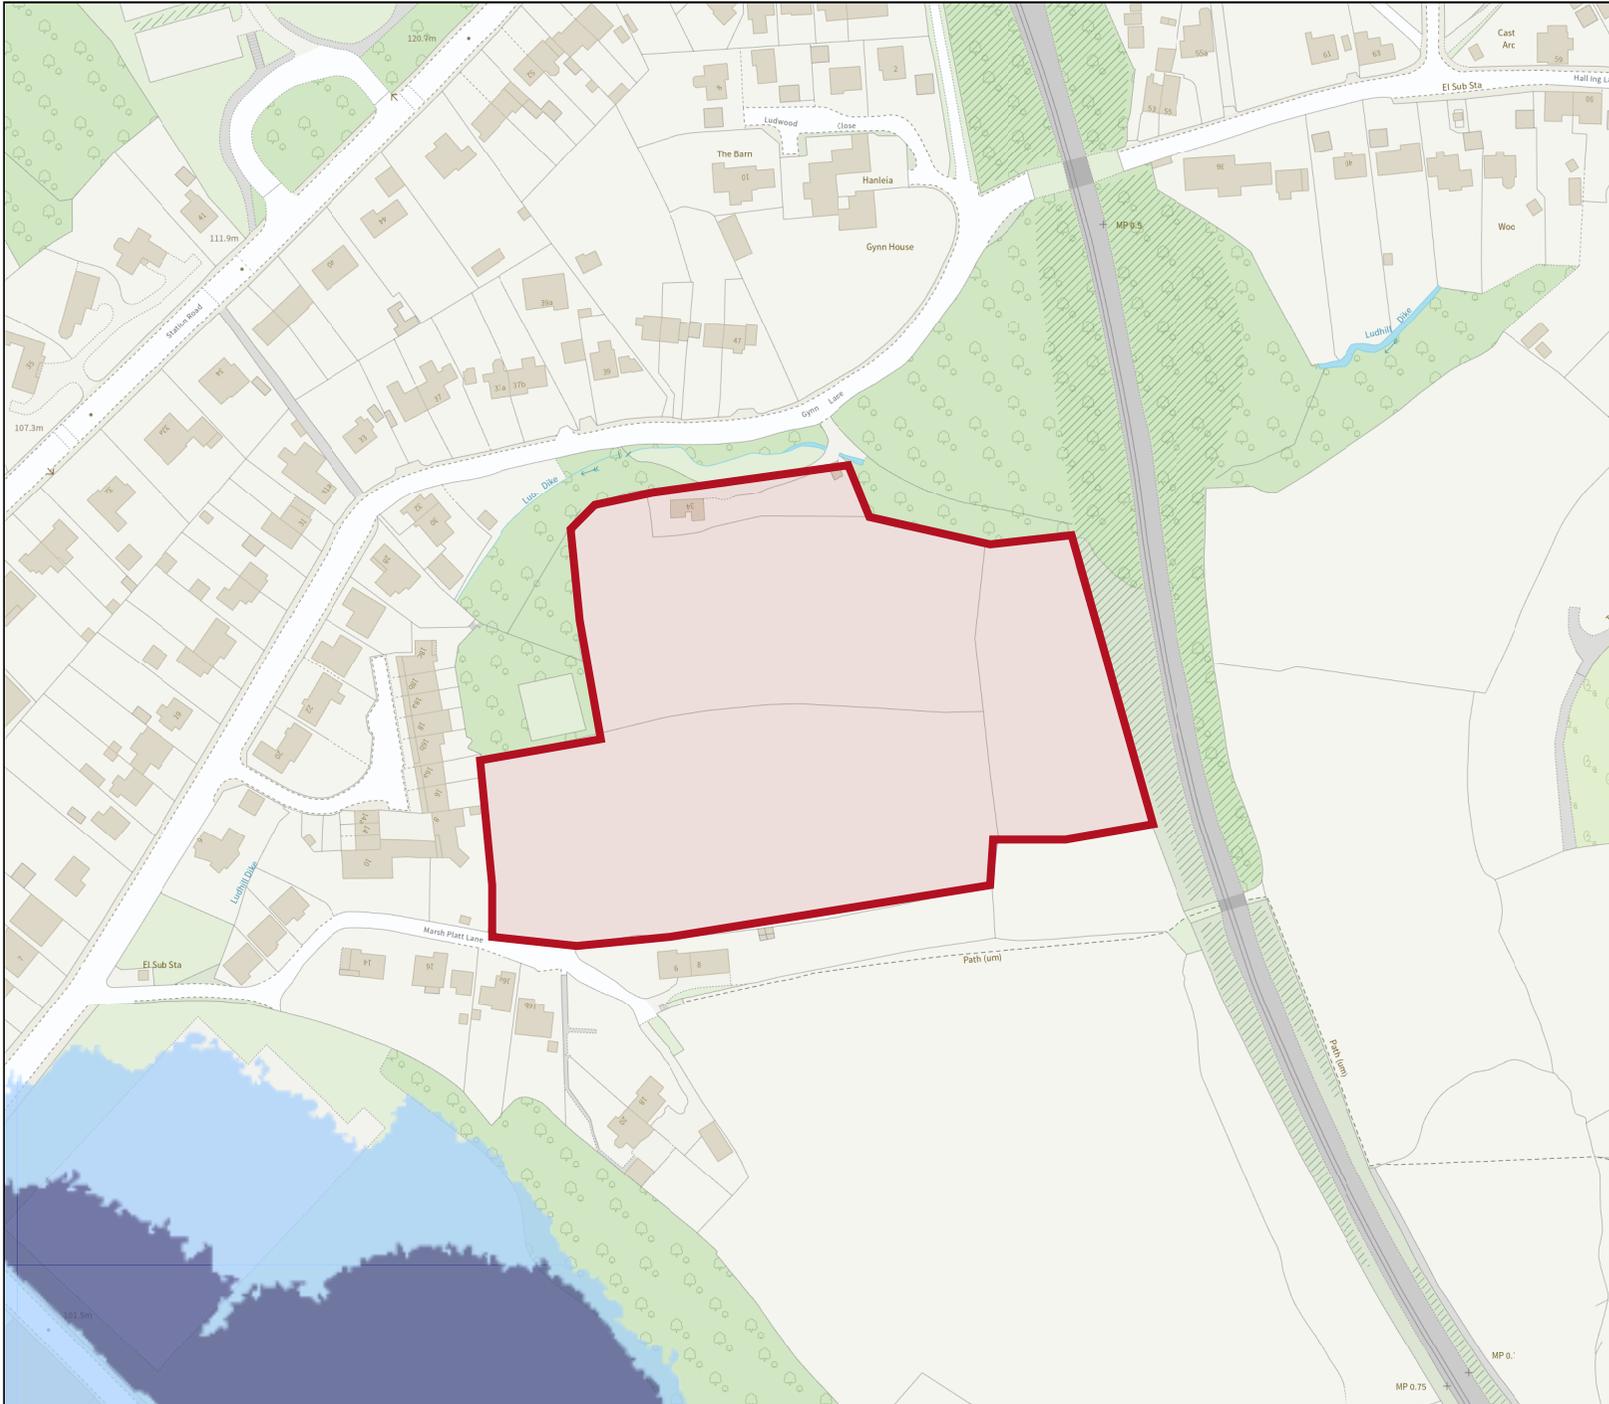
Your selected location is in flood zone 1, an area with a low probability of flooding.

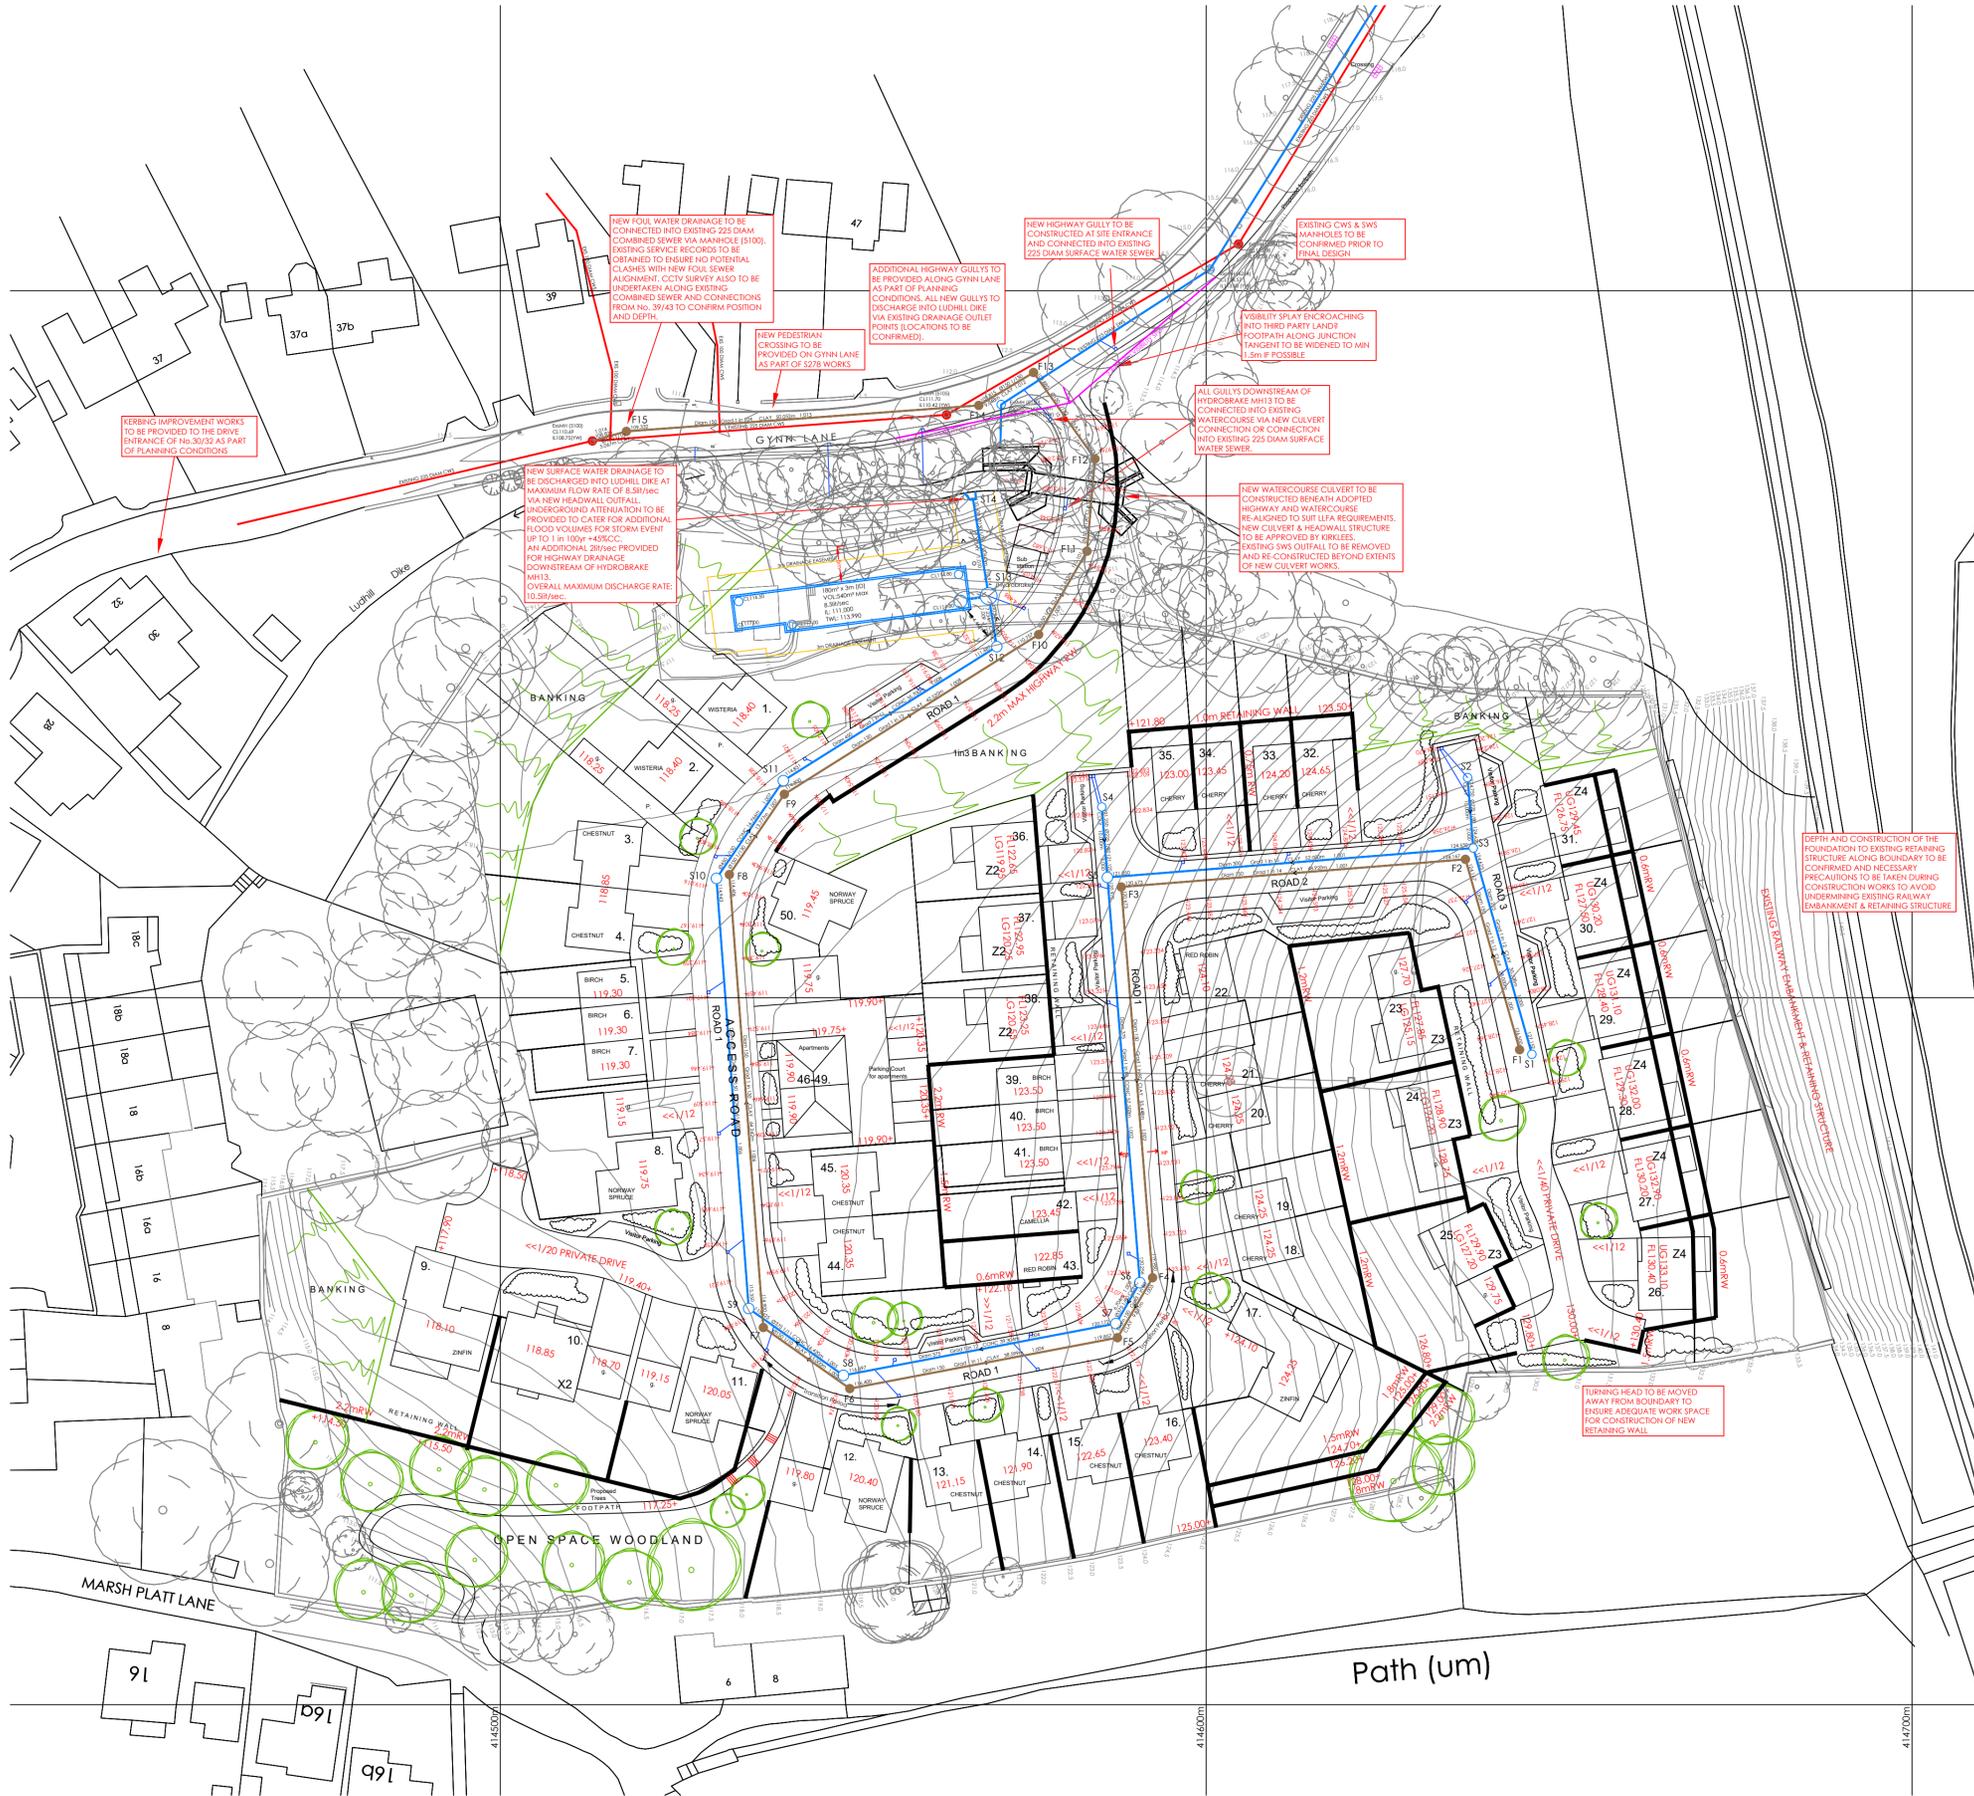
Detail
PRELIMINARY FEASIBILITY PLAN

- Rev E Updated to suit planning layout 2479-0301-R05 received 19.11.24. 10.12.24 HH
- Attenuation tank & SWS outfall moved east. Sub Station amended to suit.
- Rev D Attenuation tank amended to suit tree stand-off distance. 14.11.24 HH
- Plot 1 amended back to original position.
- Rev C Updated to suit planning layout 2479-0301-R04 received 05.11.24. 13.11.24 HH
- Attenuation tank amended to suit clients instruction. Plot 1 moved to suit.
- Rev B Updated to suit planning layout 2436-9901-P06C received 15.07.24. 18.07.24 HH
- Attenuation tank amended.
- Rev A Updated to suit planning layout 2436-9910-P06C. FFL's amended to suit clients instructions. 11.06.24 HH

- 5.3.9 The position and levels of the attenuation has been considered to ensure that any failure or blockage of the outfall will result in above ground flooding to the open section of watercourse to the northern boundary of the site and not affect any of the new or existing properties. Finally, the position of the attenuation tank has been determined to allow accessibility for future maintenance.

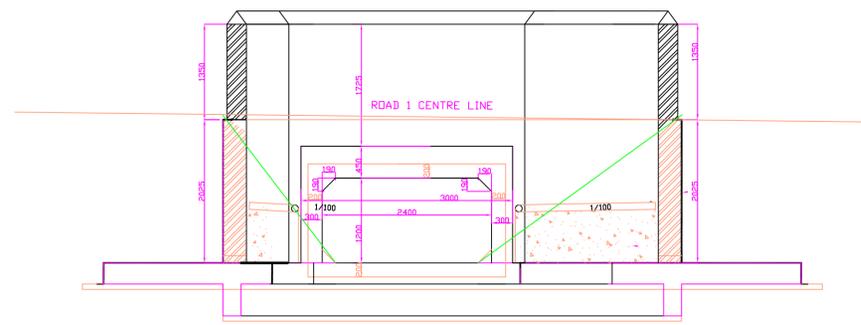
ELEVATION B-B

Pre-cast concrete box sections by others with modified end units.

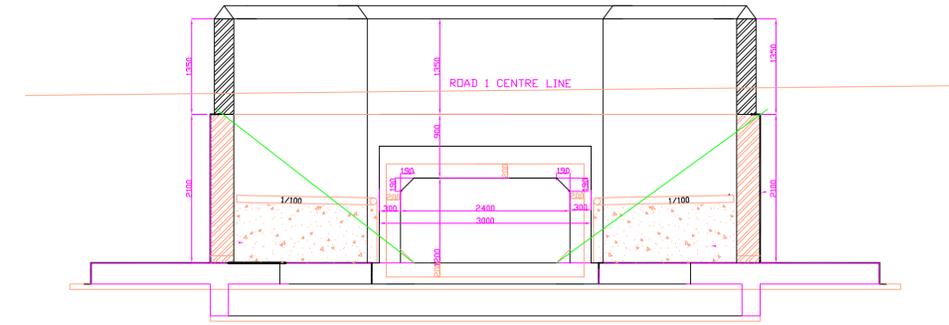
ELEVATION A-A

Pre-cast concrete box sections by others with modified end units.
