# Structural Appraisal Report for Proposed Conversion of an Agricultural Building to a Dwelling (Class Q) - Barn 1

Meltham Grange Farm, Deer Hill End Road, off Slaithwaite  
Road, Meltham, HD9 5PT

**MDL Job Number: 11510**

## **Survey Report**

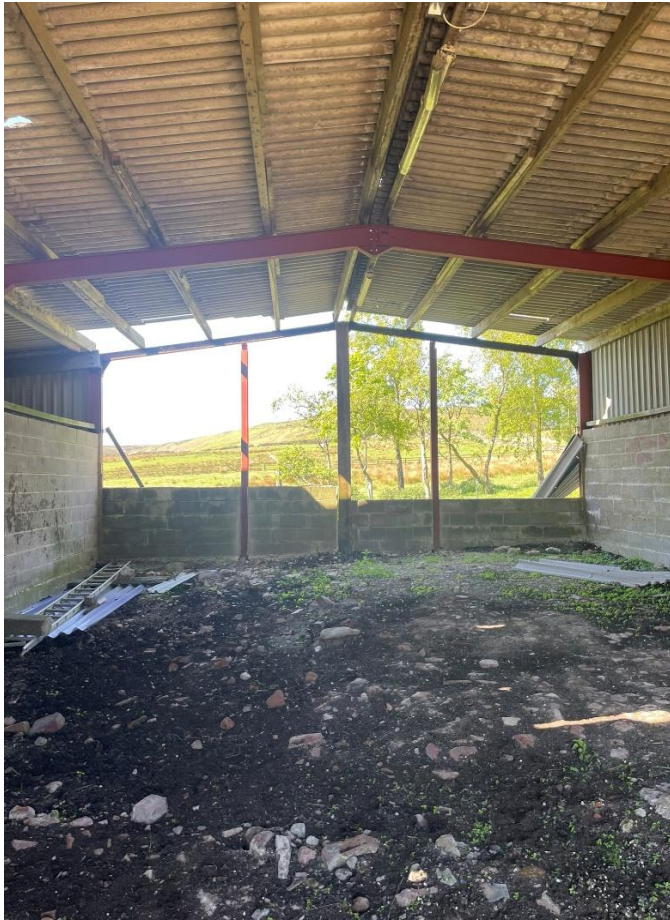
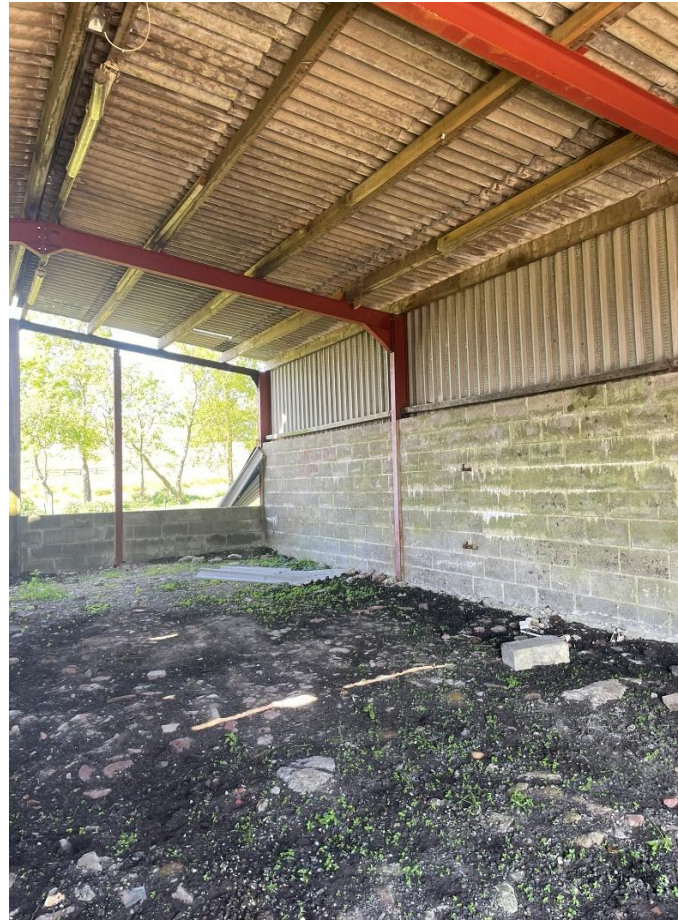
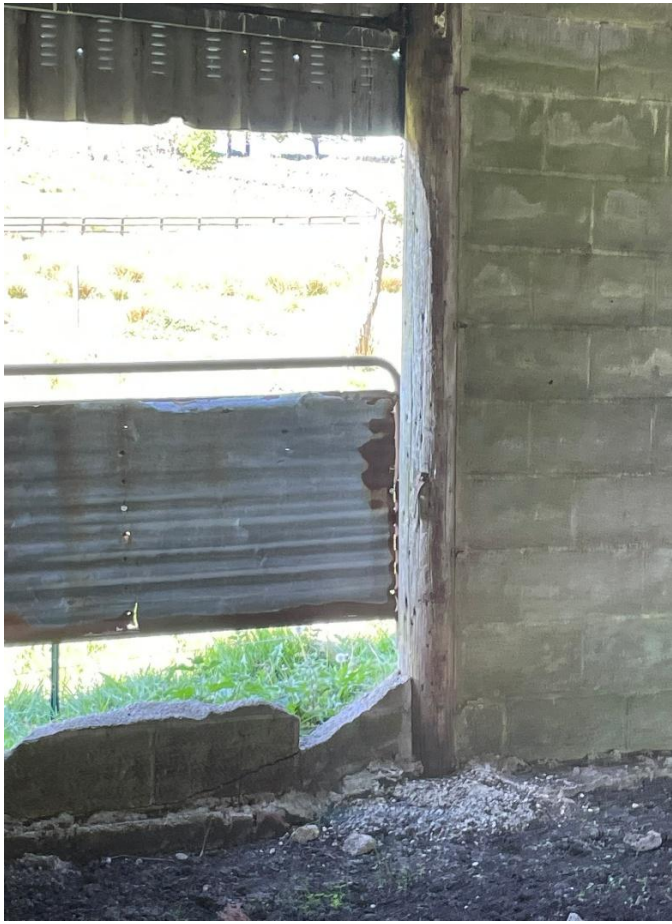
Areas of block walls have been removed. **Pic Ref: 1-2, 13 Internal Areas**

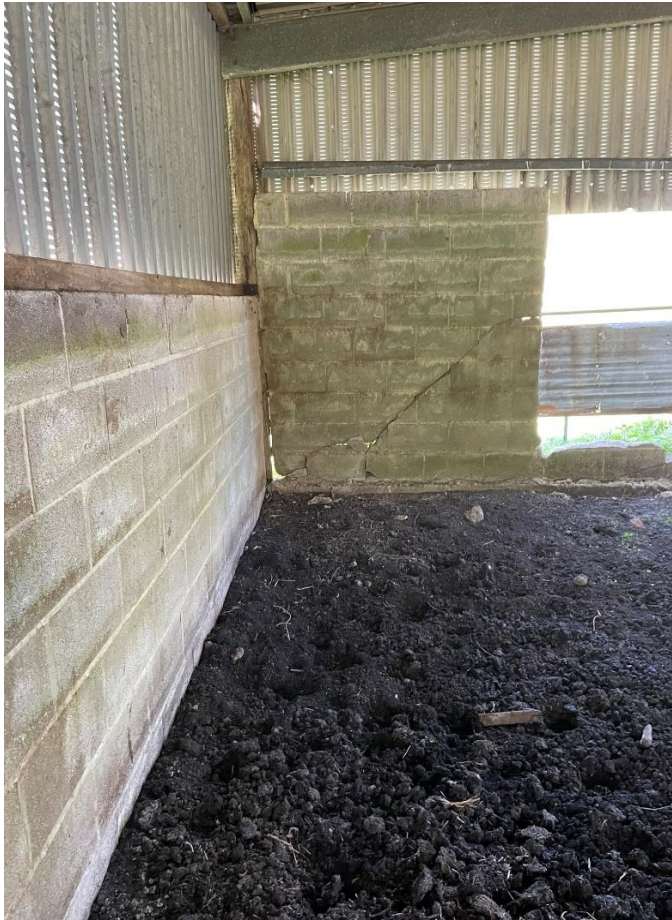
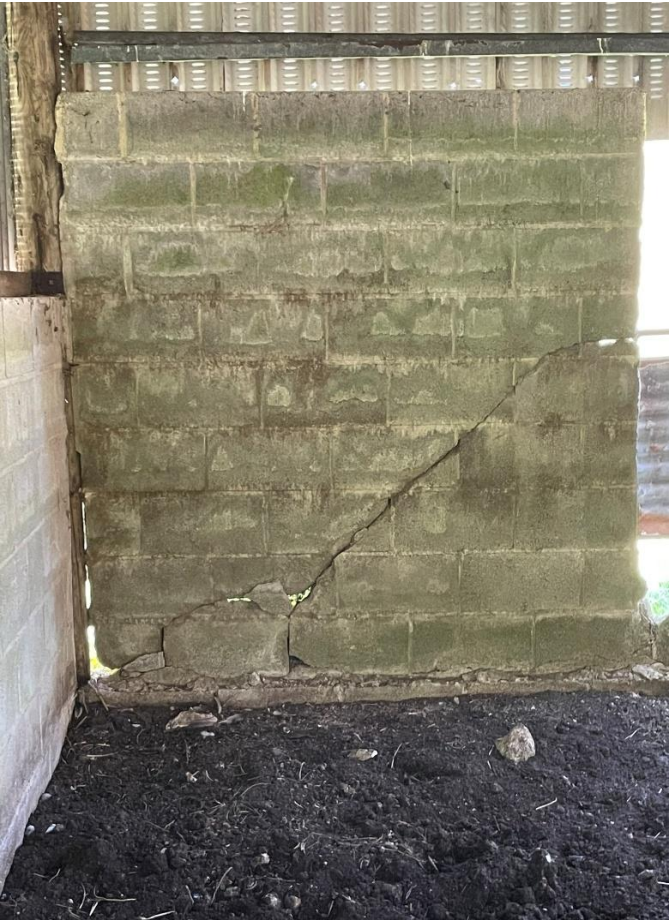
Defects due to impact damage, with general movement and lateral cracking defects being noted. This has had no detrimental effect to the structural steel elements. **Pic Ref: 11-12 Internal Areas**

There is no cause for concern with the slight cracks on all faces of the block walls. Generally where there any slight degree of lateral cracks up to 5mm some additional external repointing may be required.

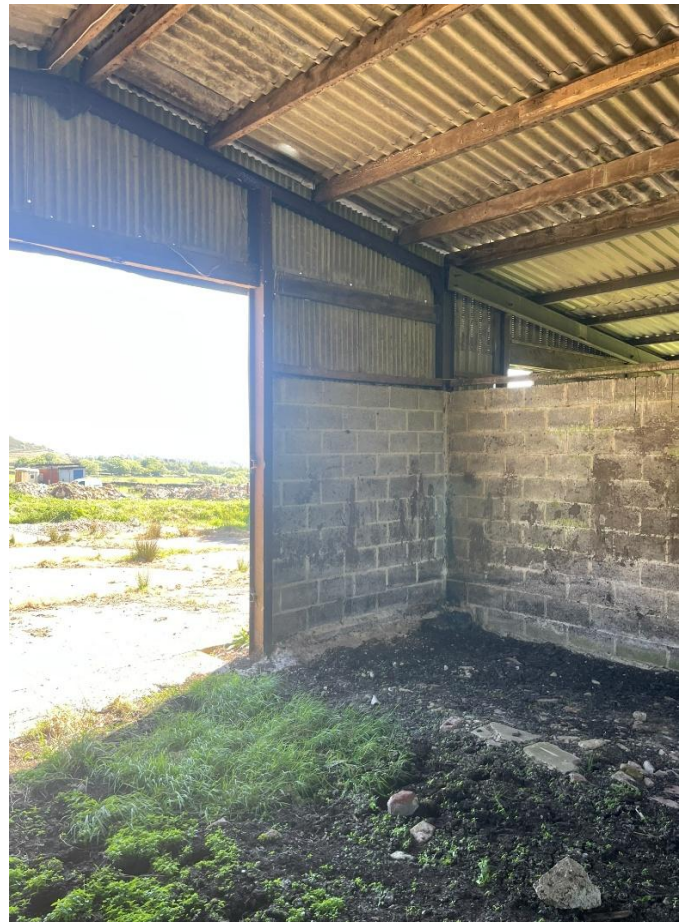
Slight impact damaged noted at low level to steel stanchions to the main entrance. Simple remedial fabricating required to enhance the structural integrity of the column. Seek further advice from structural engineer. **Pic Ref: 22 Internal Areas**
