Haigh lane Flockton

Haigh Lane, Flockton

Design Statement

DWG Ref. H25-hlf_004 | Drwn/Chckd By: CH | Scale - n/a | Date: 15/05/25

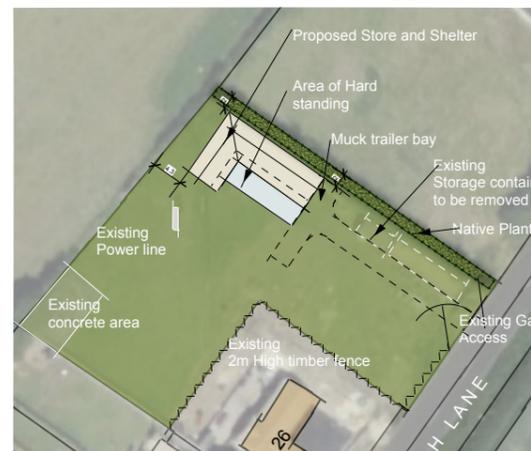
Proposed Site plan

The proposal shows the building positioned within the lowest part of the site and more than 2m away from any boundary.

The proposal is for a timber built unit with storage and stalls for small grazing animals such as sheep or goats.

Base to be compacted gravel with levelled paving

Ground screws to be placed at 2m intervals

Timber sole plate secured to the ground screws

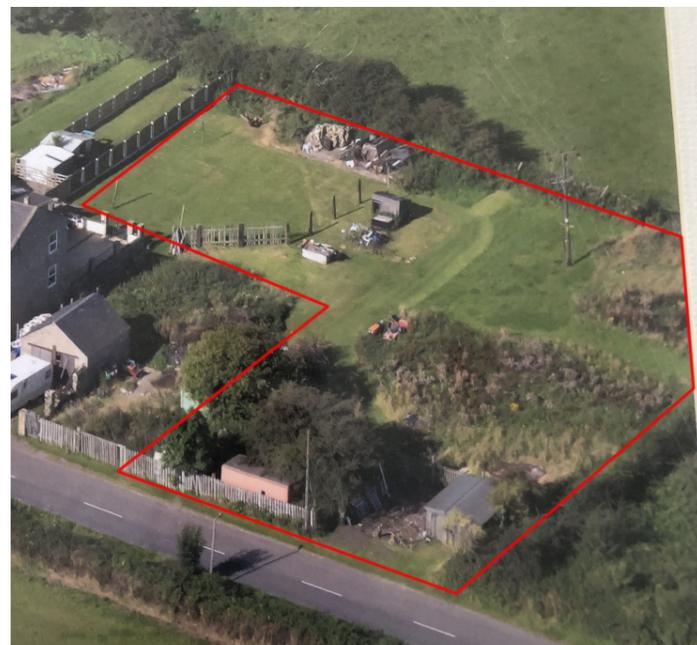
Figure A shows an archived aerial photograph of the site, the site has previously housed 2 storage units to the road side.
