Haigh lane Flockton

Haigh Lane, Flockton

Design Statement

DWG Ref. H25-hlf_004 | Drwn/Chckd By: CH | Scale - n/a | Date: 15/05/25

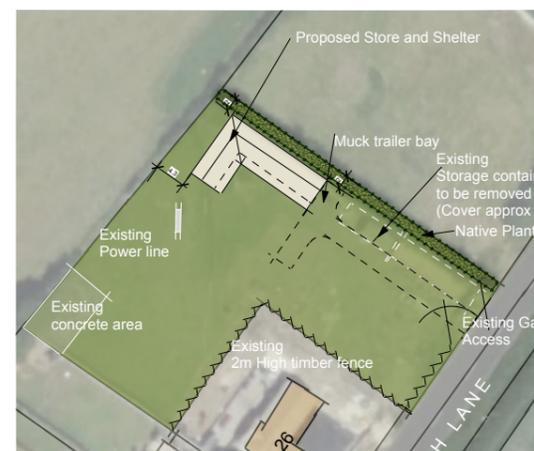
Proposed Site plan

The proposal shows the building positioned within the lowest part of the site and more than 2m away from any boundary.

The proposal is for a timber built unit with storage and stalls for small grazing animals such as sheep or goats.

Construction Method Statement

Removal of all existing storage containers

Base to be compacted gravel with levelled paving and Natural base in storage areas

Ground screws to be placed at 2m intervals

Timber sole plate secured to the ground using 300mm ground screws

Building to be treated timber with shiplap external cladding

Roof to be corrugated steel sheets

All rainwater to be harvested in water butts

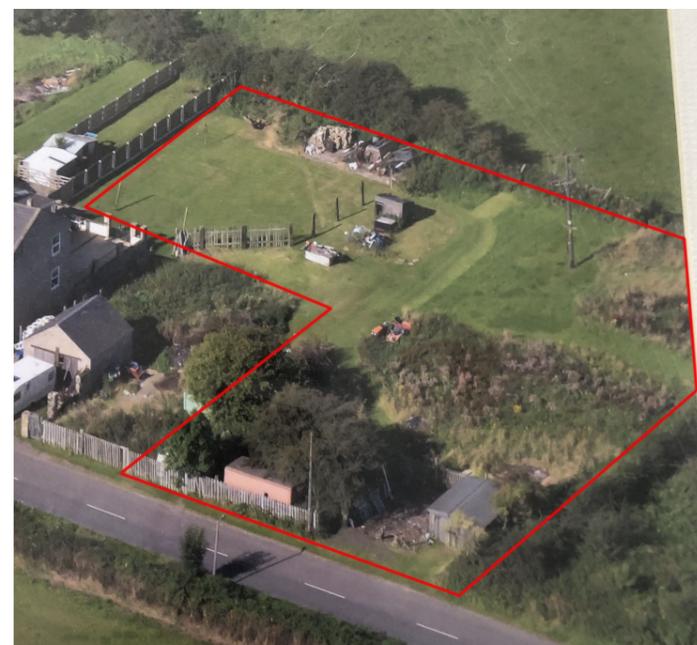
Figure A shows an archived aerial photograph of the site, the site has previously housed 2 storage units to the road side.

The site currently has 2 storage containers, which have been in situ for over 6 years, however these create an unwanted visual feature to the area
