SA 21376 Hermitage Park, Lepton

ARBORICULTURAL SURVEY REPORT | BS 5837:2012

Revision i - October 2025

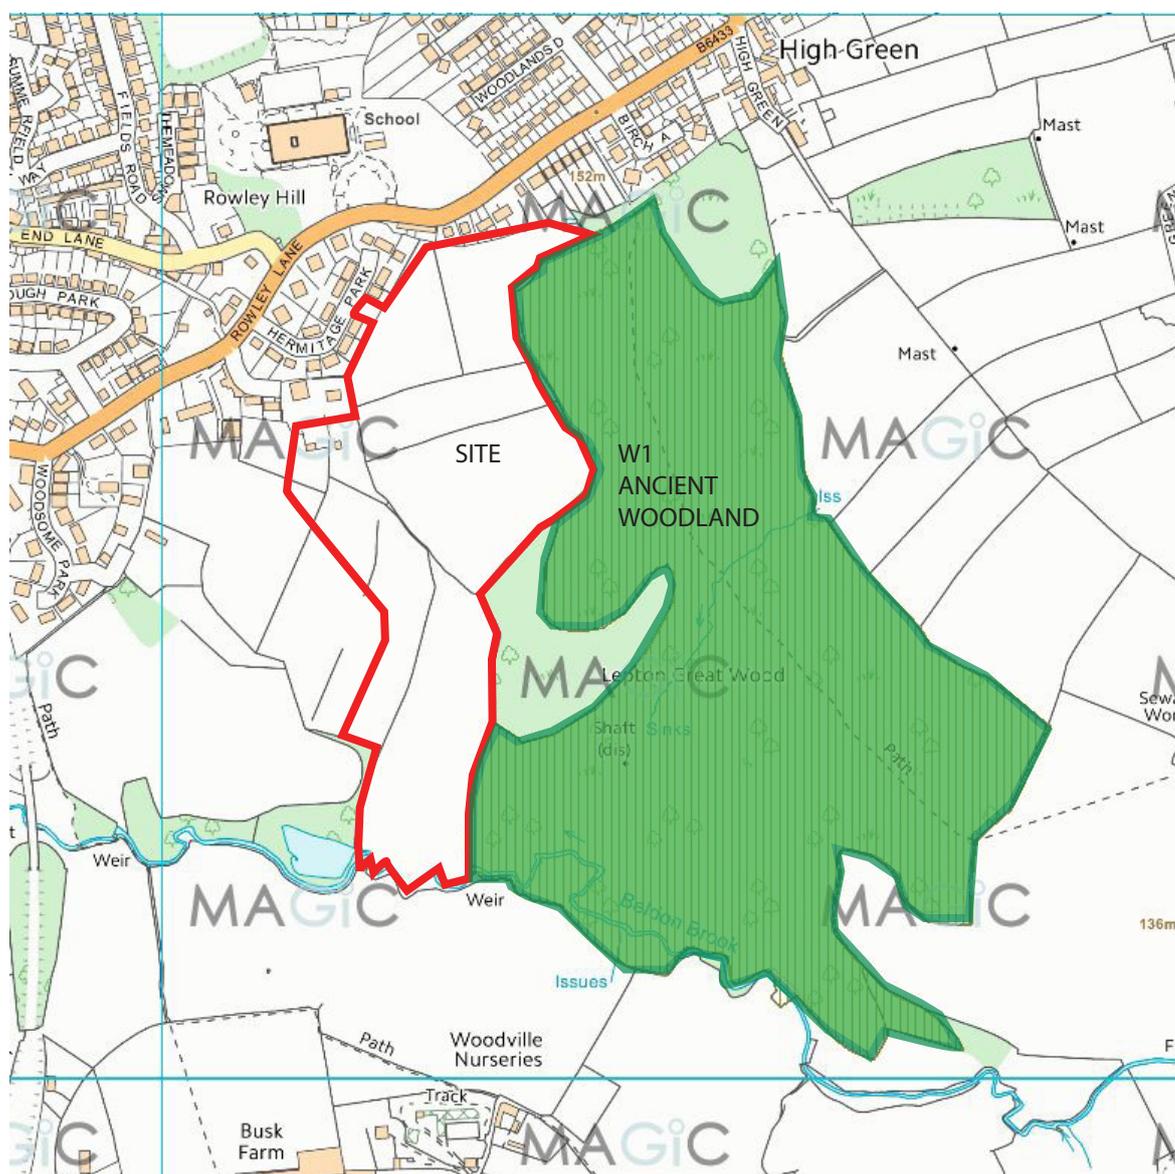
Figure 2- Extract from Ancient Woodlands Inventory adapted to show the site in relation to the Ancient Woodland.

1.5.3 The woodland comprises predominantly oak and silver birch, with some areas colonised by sycamore. There are several large mature and veteran beech trees located in the woodland which are in close proximity to the site, with branches which overhang the boundary and Root protection Areas (RPA) which lie within the buffer zone.

1.5.2 The standing advice from Natural England and the Forestry Commission is to leave a minimum 15m buffer zone of semi-natural habitat between a proposed development and a site of Ancient Woodland. The proposal should have a buffer zone of at least 15 metres from the boundary of the woodland.

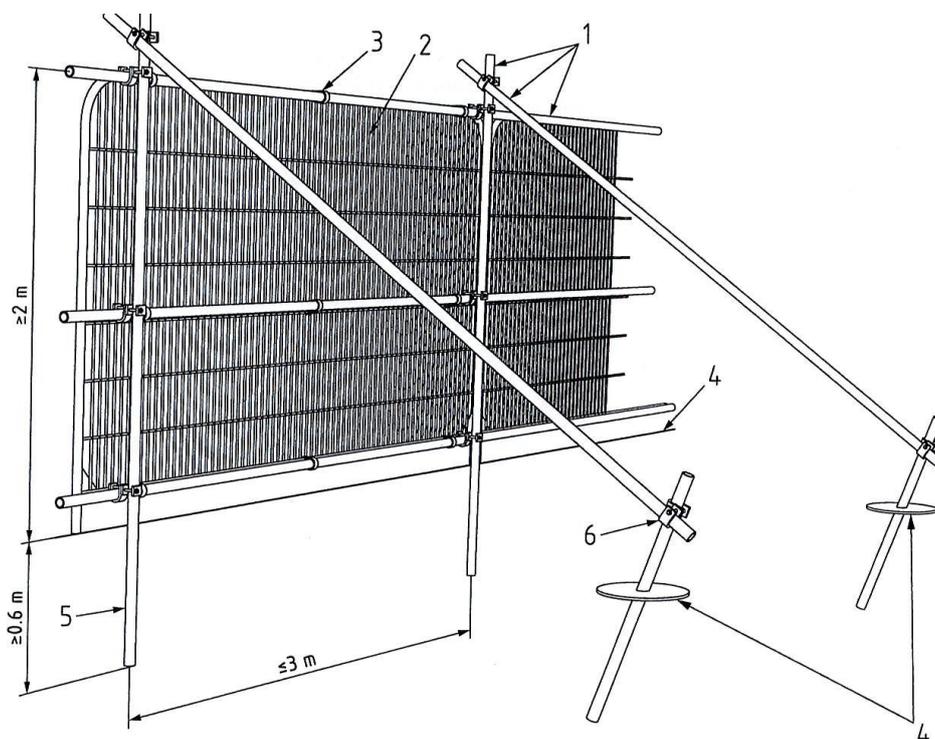
Figure 2 - Tree Protection Fencing

- 1 Standard scaffold poles
- 2 Heavy gauge 2 m tall galvanized tube and welded mesh infill panels
- 3 Panels secured to uprights and cross-members with wire ties
- 4 Ground level
- 5 Uprights driven into the ground until secure (minimum depth 0.6 m)
- 6 Standard scaffold clamps

6.3.3 See **Figure 2** for details of the protective fencing to be employed in all circumstances, where existing site conditions allow. Fencing is to be erected as shown on the drawing. All fencing must be fixed in position with driven scaffold poles so that they cannot be moved during the construction period.

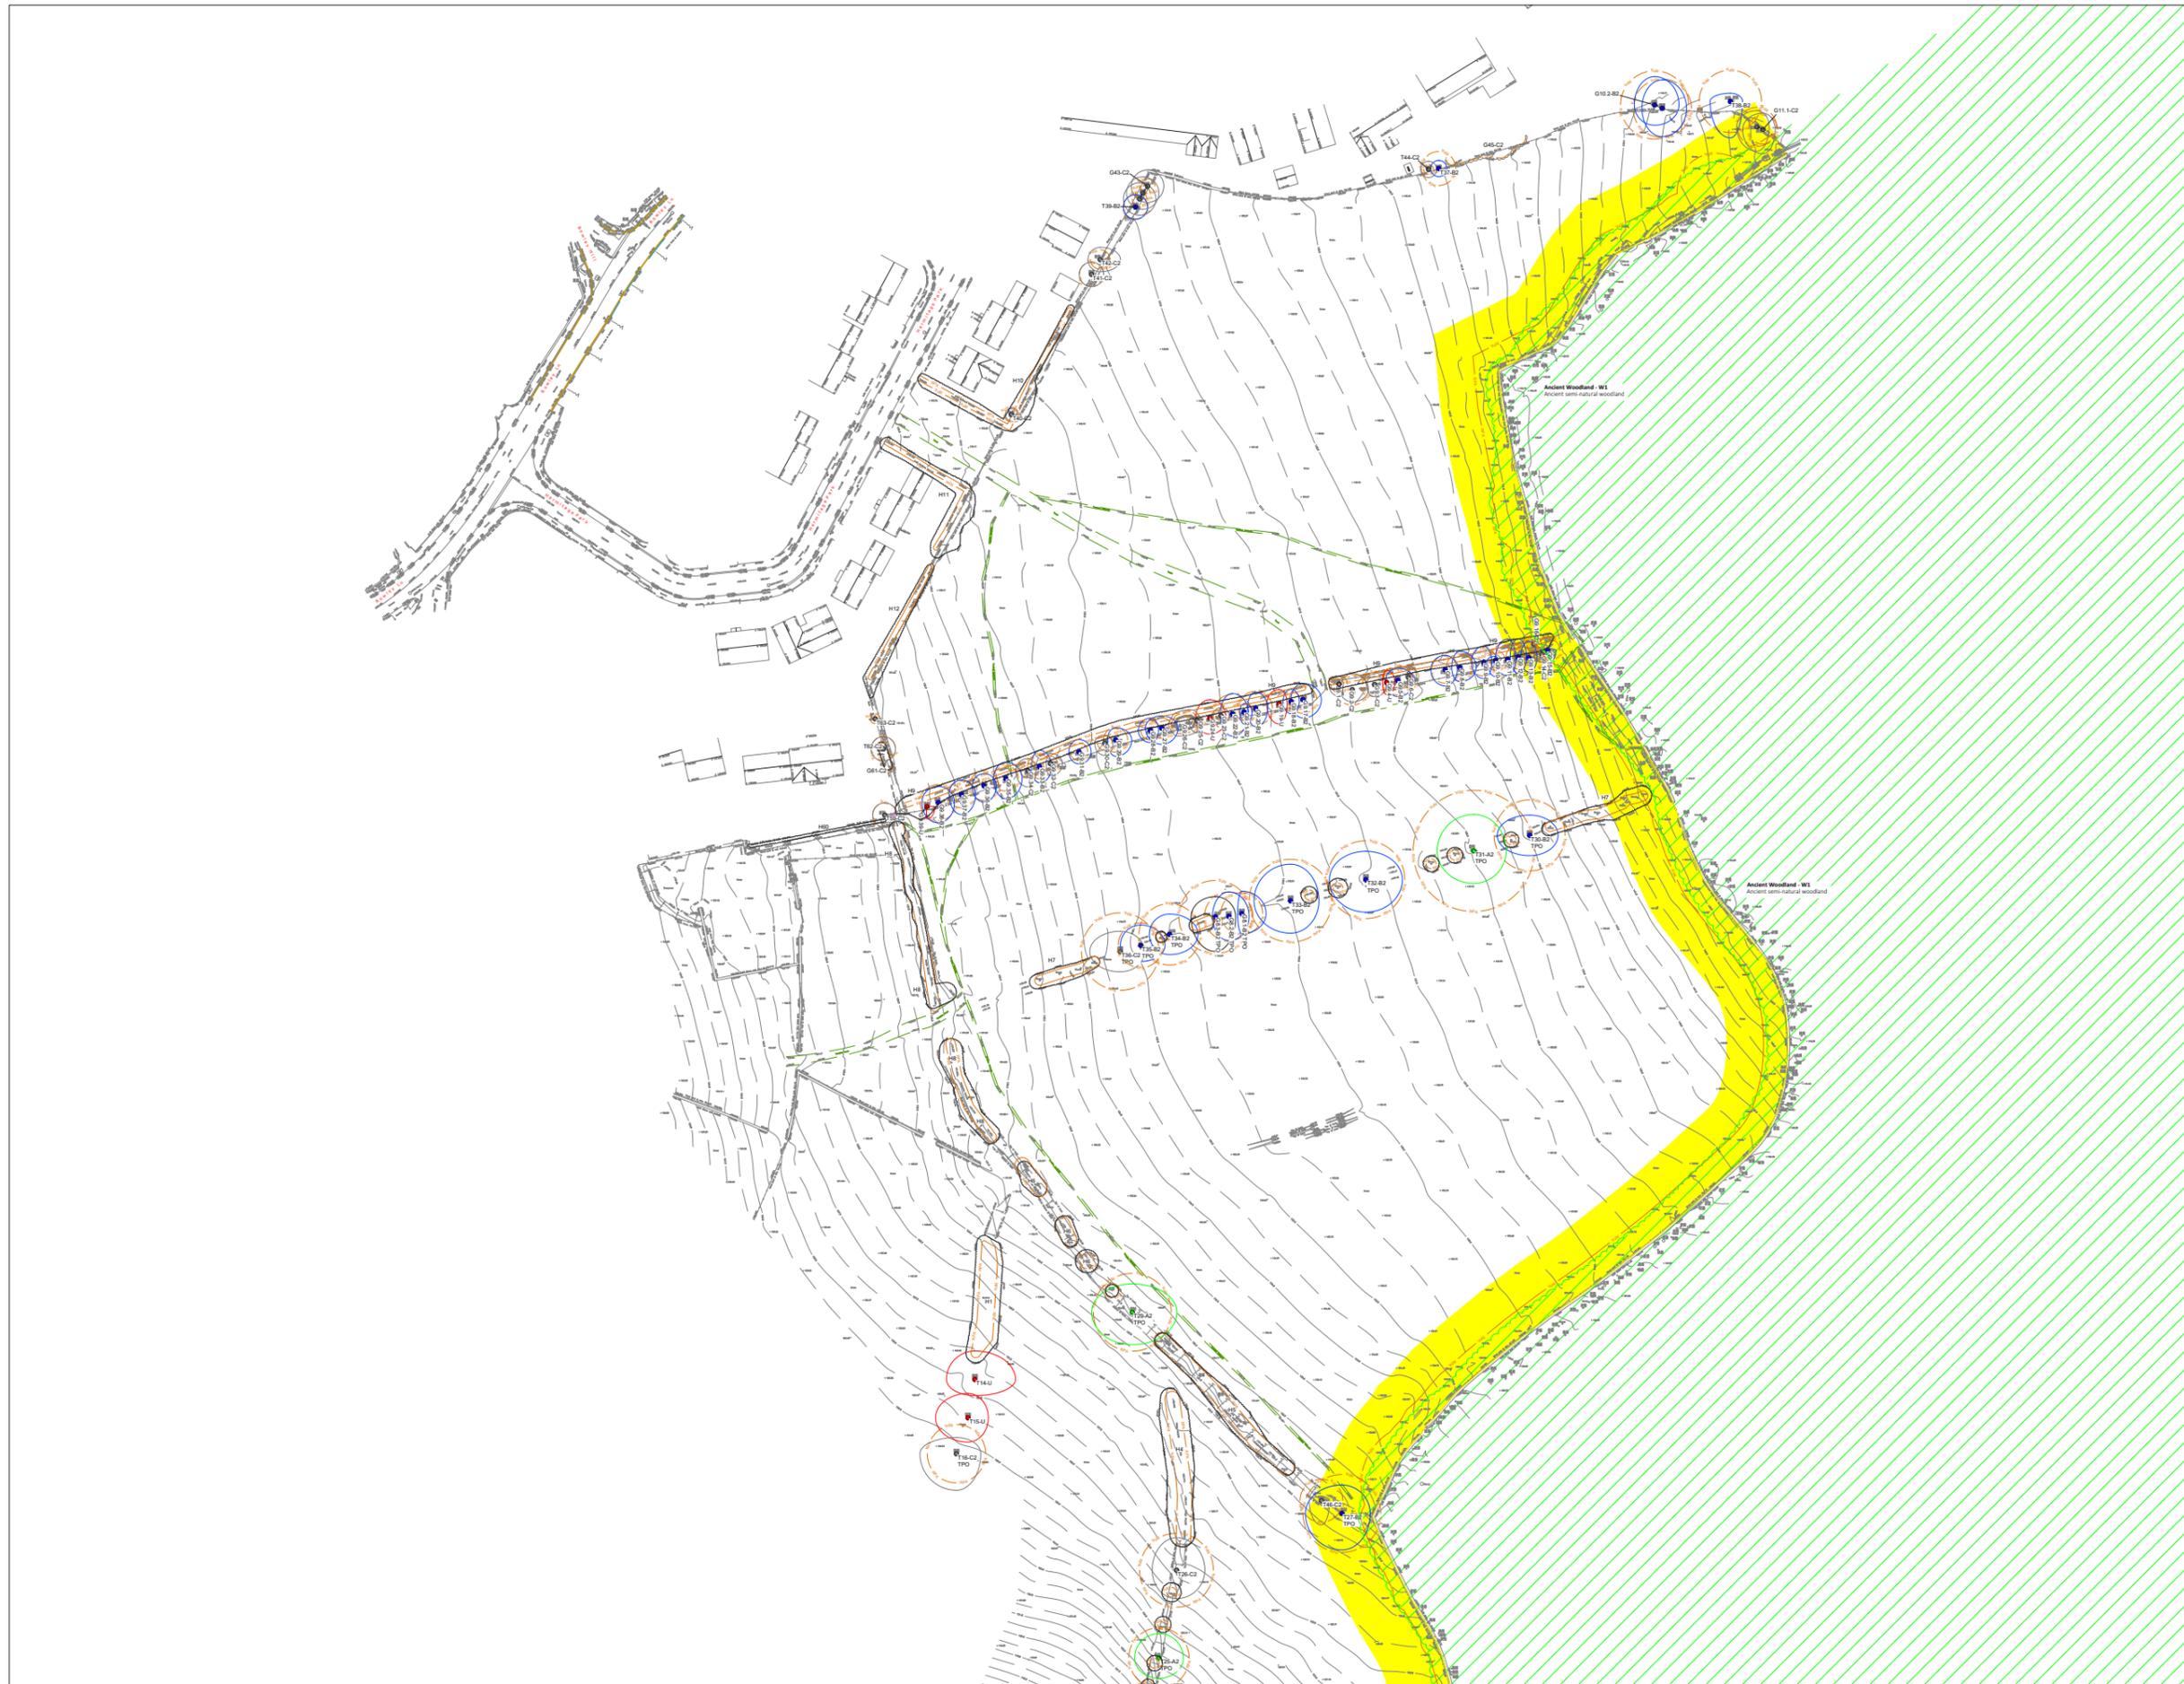
TREE CONSTRAINTS PLAN

Trees have been surveyed and categorized as per the recommendations and guidance in BS 5837:2012 Trees in relation to design, demolition and construction.

4.1.1 The extent to which a tree may represent a constraint to development will depend both upon the location of the trunk and size and nature of the canopy and also the extent of the roots below ground. The Tree Constraints Plan (SA 21376 TC01/2) plots the location, the true canopy spread and the Root Protection Area of the trees, through application of the calculation provided in section 4.6 of the BS5837:2012 Trees in relation to design demolition and construction – Recommendations.

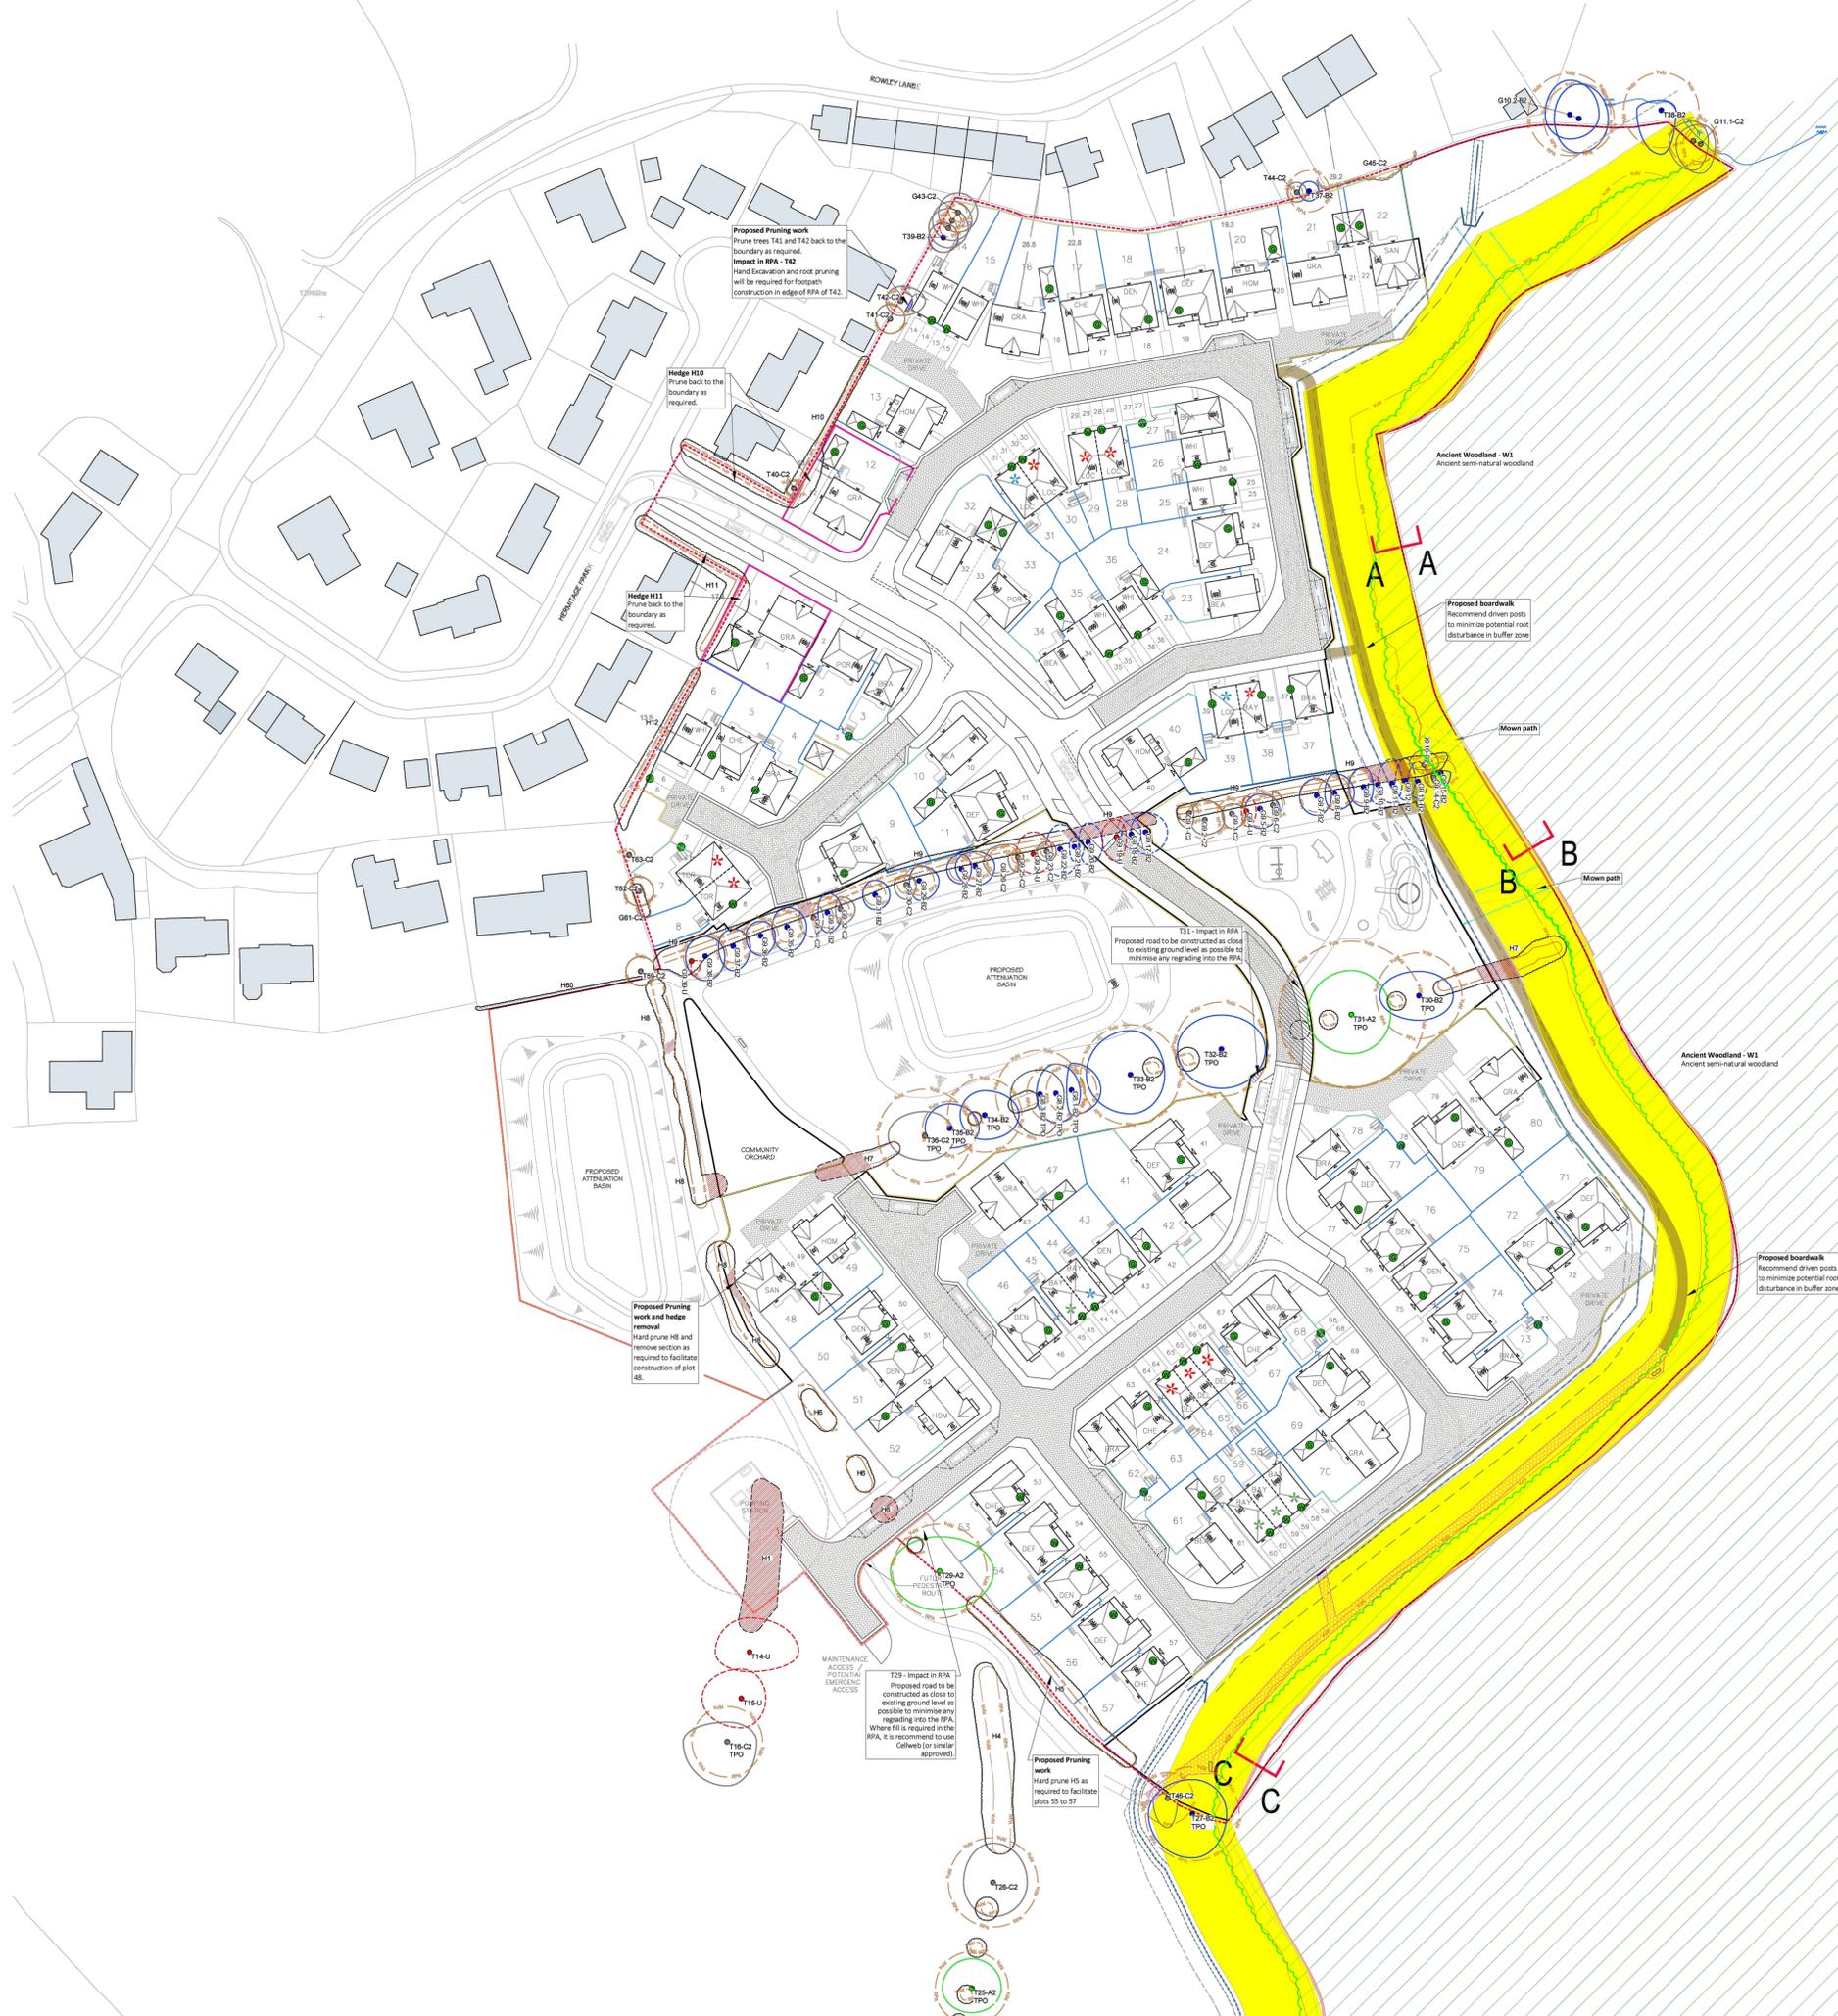
- Tree category U
- Poor condition with an estimated life expectancy of less than 10 years
- RPA
- minimum Root Protection Area
- Proposed tree removal
- To facilitate development

- Proposed tree removal
- Due to poor condition
- Impact in RPA
- Proposed road to be constructed as close to existing ground level as possible to minimise any regrading into the RPA.

- 5.8.1 The proposed road adjacent to tree T29 will be constructed as close to existing ground level as possible to minimise any regrading into the RPA. Where fill is required in the RPA, it is recommended to use Cellweb (or similar approved).

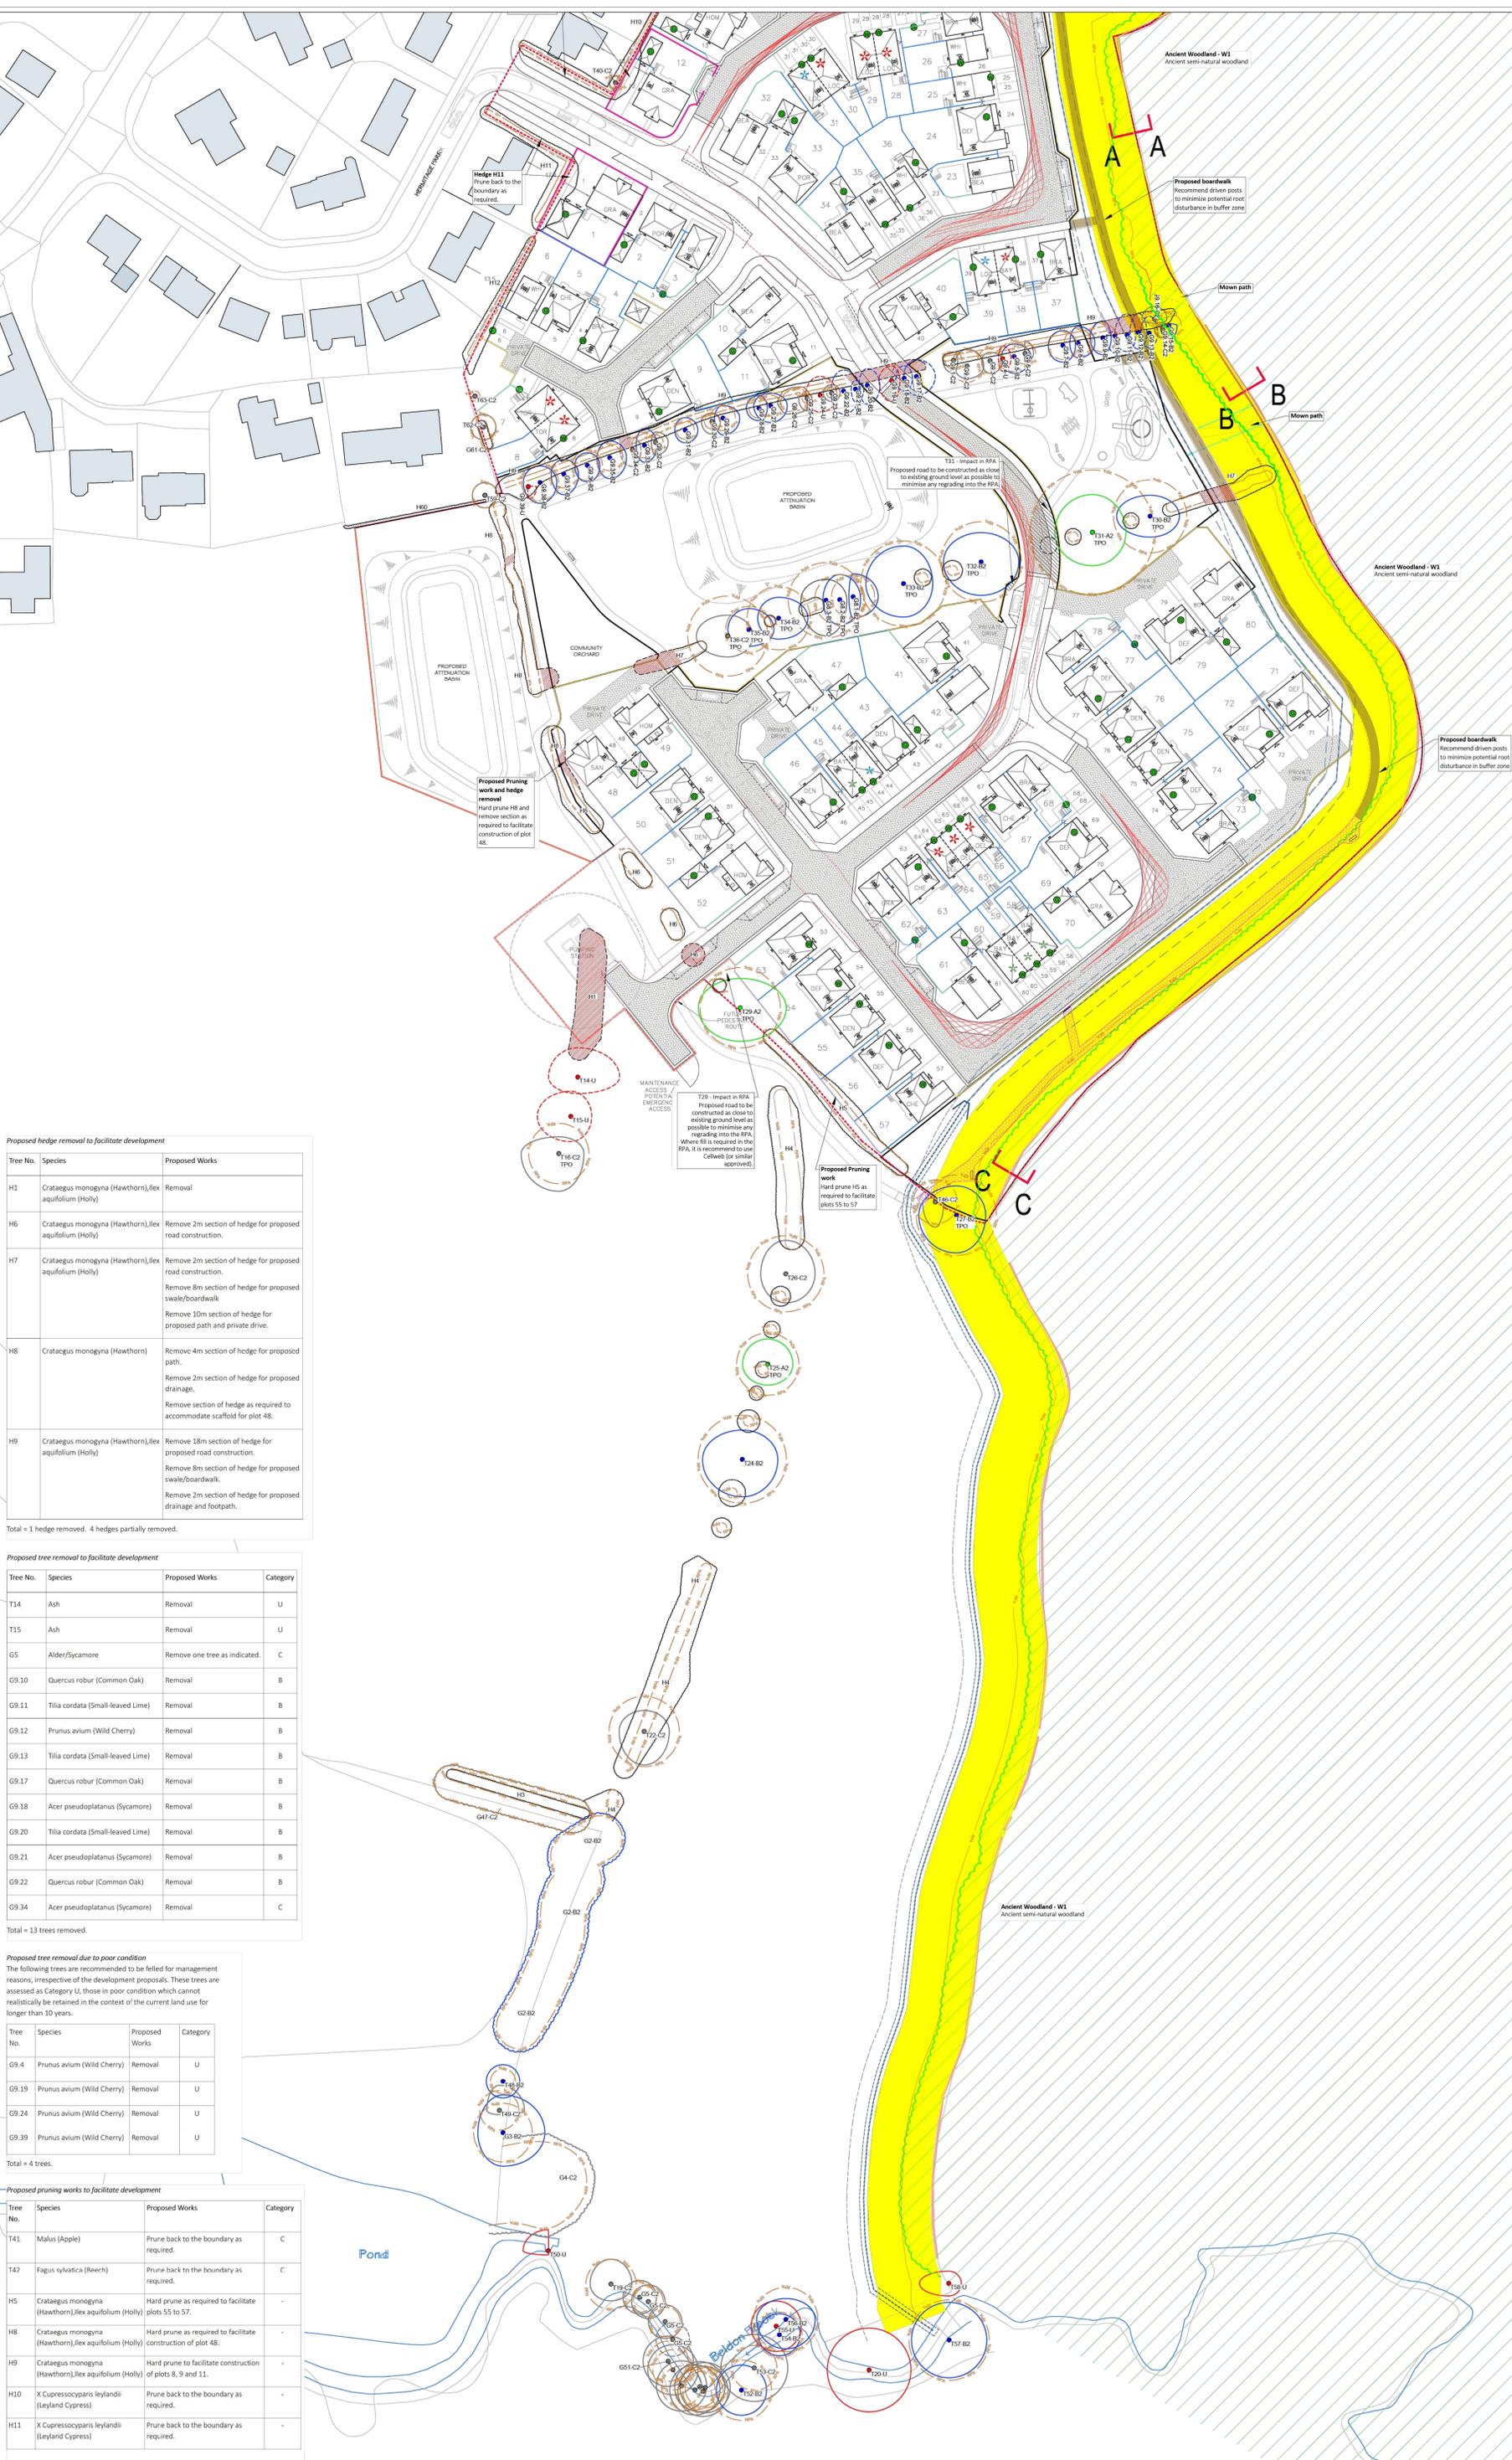
MIXING AND STORAGE OF MATERIALS
All mixing and storage of cement and concrete will take place in a designated area, which will be located well outside the vicinity of the RPA.
All mixing operations must take place with ground protection in place, which will comprise a tarpaulin and ground boards. A spill kit (which is adequately equipped to deal with the materials being held on site) must be kept on site at all times. A supply of water must also be available during mixing operations (to dilute any spillage).

HAND EXCAVATION AND ROOT PRUNING IN THE RPA
The impact in the RPA will be managed by hand digging and carrying out root pruning if required. The majority of the RPA of this tree will not be impacted by development (as it will be protected by fencing).
Excavations will be undertaken carefully within the RPA using either hand tools or an 'air spade' (a compressed air powered tool). Hand digging will commence using a fork to loosen the surrounding soil and expose any tree roots that may be present. The extent of excavation is to be the absolute minimum required to facilitate the construction.
The diameter of roots tends to taper rapidly at a distance of 2-3m from the tree, until they are only 2-5cm in diameter. Any roots smaller than 25mm diameter, may be pruned back if required. A clean cut must be made, preferably to a side branch, using a proprietary cutting tool such as bypass secateurs or hand saws. Roots larger than 25mm must only be severed following consultation with an arborist, as they may be essential to the tree's health and stability. Until such time that construction works in these areas are completed any severed roots, the ends of which may be exposed, are to be covered by dry, clean hessian sacking to prevent desiccation and to protect from rapid temperature changes. Prior to backfilling any hessian wrapping must be removed and retained roots will be surrounded with sharp sand (builder's sand must not be used due to its high salt content which is toxic to tree root), or other loose granular fill, before soil or other material is replaced.

- 6.3.5** **Tree Protection Fencing Type 2** must be installed in the position as shown on the Tree Protection Plan SA21376 TPP01/2 (APPENDIX D) before any other works on site can be undertaken.

- 6.5.4 The precise locations and distances of the boardwalk is indicated on the Tree Protection Plan SA21376 TPP01/2 (APPENDIX D).
- 6.5.5 The board walk must comprise a rot resistant composite material.

- 6.6.1 The precise locations of the swale is indicated on the Tree Protection Plan SA21376 TPP01/2 (APPENDIX D).
- 6.6.2 Any machinery used in the swale excavation should be operated from outside the buffer zone to avoid compaction damage to the soil and roots.
- 6.6.3 The extent of excavation is to be the absolute minimum required to facilitate the construction.
