Project  
Red House,  
281 Oxford Road, Gomersal,  
Cleckheaton, BD19 4JP

Drawing title  
Coach House  
Ground Floor & Roof Plan as Proposed

PLANNING APPLICATION

| 24.034/ (AL)20 | B |

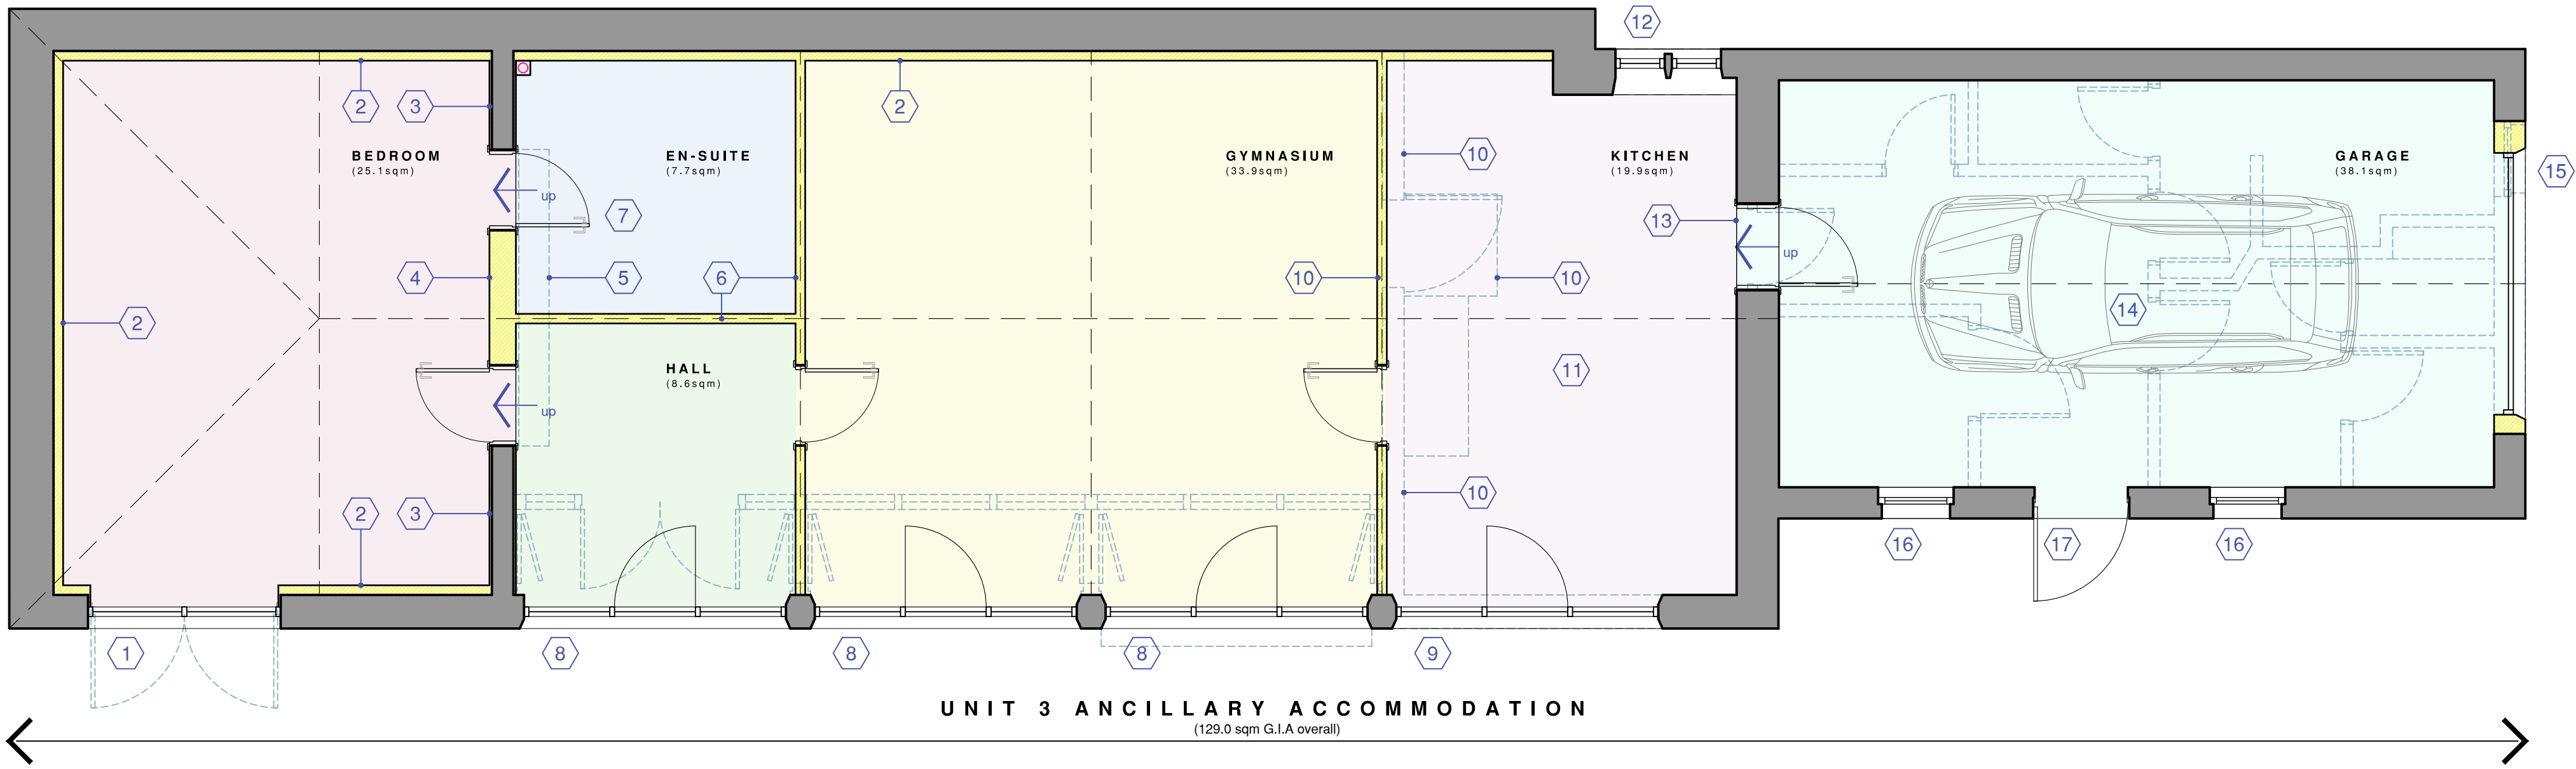
1 GROUND FLOOR PLAN AS PROPOSED  
SCALE 1:50

| 1 | Existing external timber doorset removed & new aluminium framed (colour: black) double glazed external doorset installed within existing opening. |
| 2 | External walls lined internally with new insulation/ plaster lining. New lining materials and insulation to be fully breathable & permeable. |
| 3 | Existing internal masonry wall to be finished with plasterboard & skim finish, on timber battens. |
| 4 | Existing opening within internal wall to be infilled with plasterboard & stud internal partition with new timber doorsets to separate bedroom from entrance hall & en-suite. |
| 5 | Existing stone step removed and existing floor finish to be made good. |
| 6 | New plasterboard & stud internal partitions with new timber doorset to form new entrance hall, en-suite & gymnasium. |
| 7 | Room to be fitted out with new sanitaryware, connected to new soil & vent pipe boxed out in plasterboard to corner of room. |
| 8 | Existing timber/ glazed doors & screen and timber shutters to be removed and new aluminium framed (colour: black) double glazed external doorsets/ screens installed within existing arched openings. |
| 9 | Existing opening to be carefully unblocked, and new aluminium framed (colour: black) double glazed external doorset/ screen installed within existing arched opening. |
| 10 | Existing internal masonry wall, door and stone steps to be removed. New plasterboard & stud internal partition with new timber doorset to separate kitchen from gymnasium. |
| 11 | Existing stone flag floor within new kitchen area to be carefully removed and new concrete floor finished with reclaimed stone flags to be constructed. New floor to have a finished level flush with the existing floor level within the gymnasium adjacent. |
| 12 | Existing window opening to be carefully unblocked, and new aluminium framed (colour: black) double glazed window units installed within existing opening. |
| 13 | Existing door removed & new/ adjusted stone steps constructed within opening between existing floor level to garage and new floor level to kitchen. New timber fire doorset to be installed within existing opening. |
| 14 | Existing partition walls & doors to be removed and ceiling/ floor finished made good, to form new garage. |
| 15 | New opening formed in external gable wall with ashlar stone head and jambs to match existing. New proprietary garage door to be installed within new opening. |
| 16 | Existing timber windows retained, refurbished and decorated (paint colour: black). |
| 17 | Existing timber door retained, refurbished and decorated (paint colour: black). |

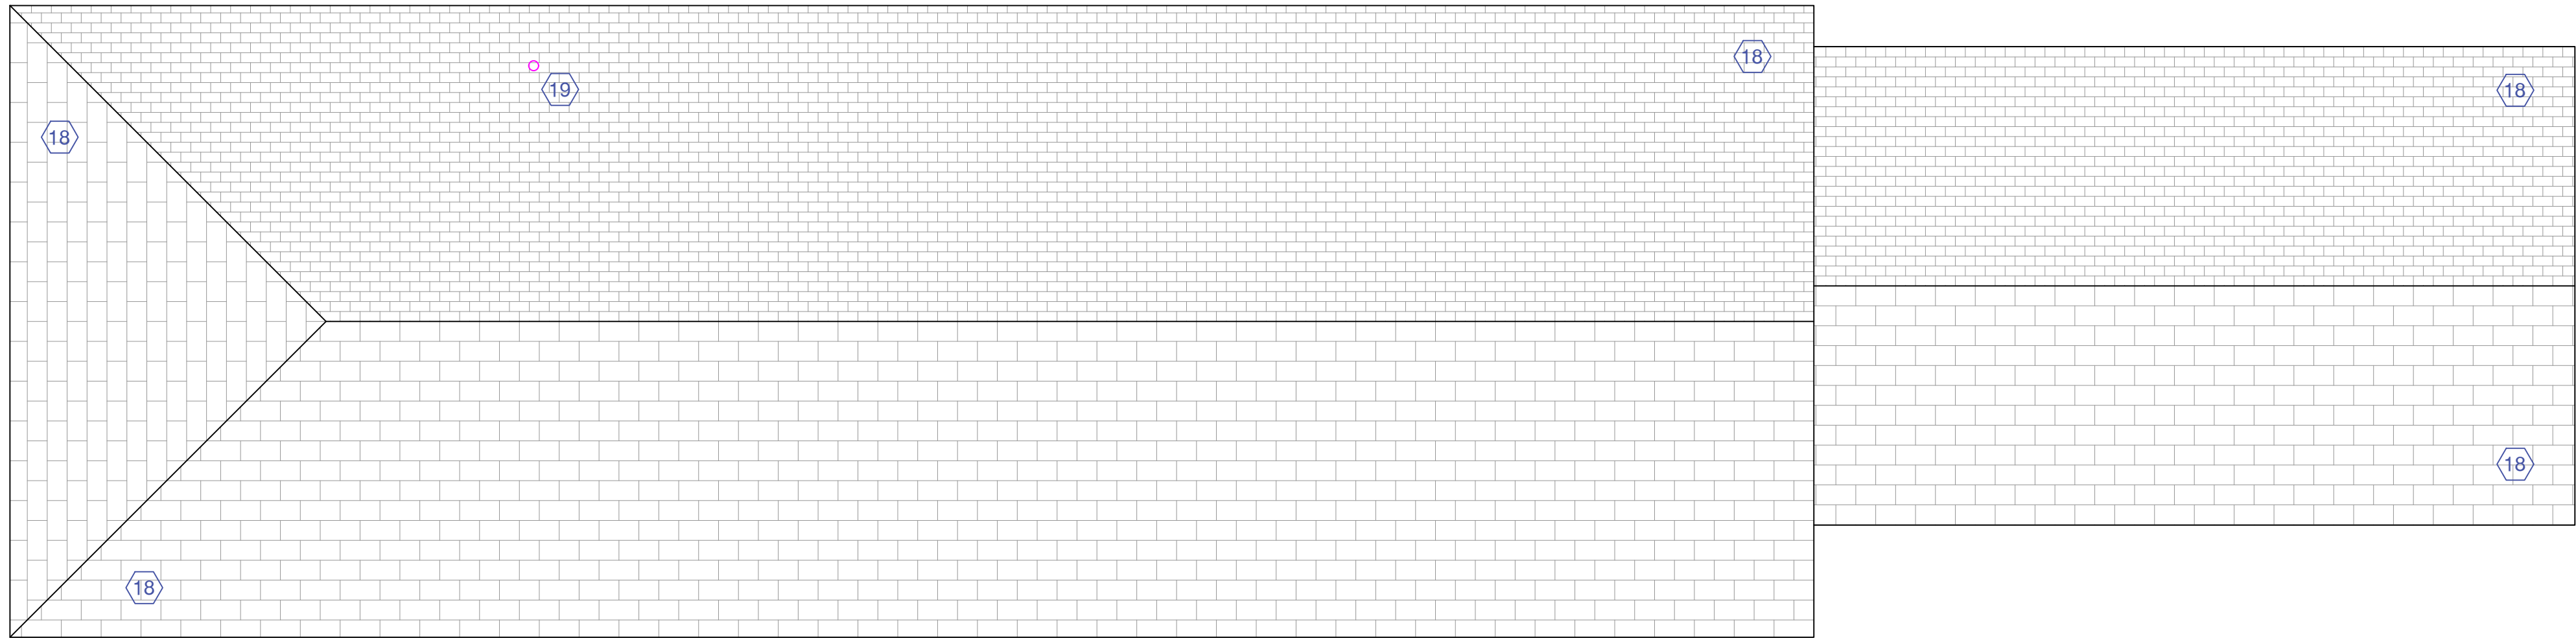
2 ROOF PLAN AS PROPOSED  
SCALE 1:50

| 18 | Existing stone flagged roof to be carefully stripped with re-usable stone flags retained for re-use. Voids between existing timber rafters to be insulated and new roof membrane and timber battens installed. South & west facing roof slopes to be finished in stone flags reclaimed from downmakings. Finish to north facing roof slopes to be confirmed following structural assessment of roof timbers to ascertain load bearing capacity. |
| 19 | New internal soil & vent pipes to terminate above existing roof. |
