Our Ref: E21/7893/MD/03A

**Re: Remediation Method Statement for Chairbarrows Farm, Whitechapel Road, Cleckheaton**

<b>Client</b>				
MICHAEL GRAVES				
<b>Project</b>				
294 - 298 WHITECHAPEL ROAD, CLECKHEATON				
<b>Detail</b>				
TRIAL PIT LOCATION PLAN				
<b>Scale</b>	<b>Dwn</b>	<b>Chkd</b>	<b>Date</b>	<b>Dwg No.</b>
1:500	IC	ML	18M-22	521/7203/003 01D

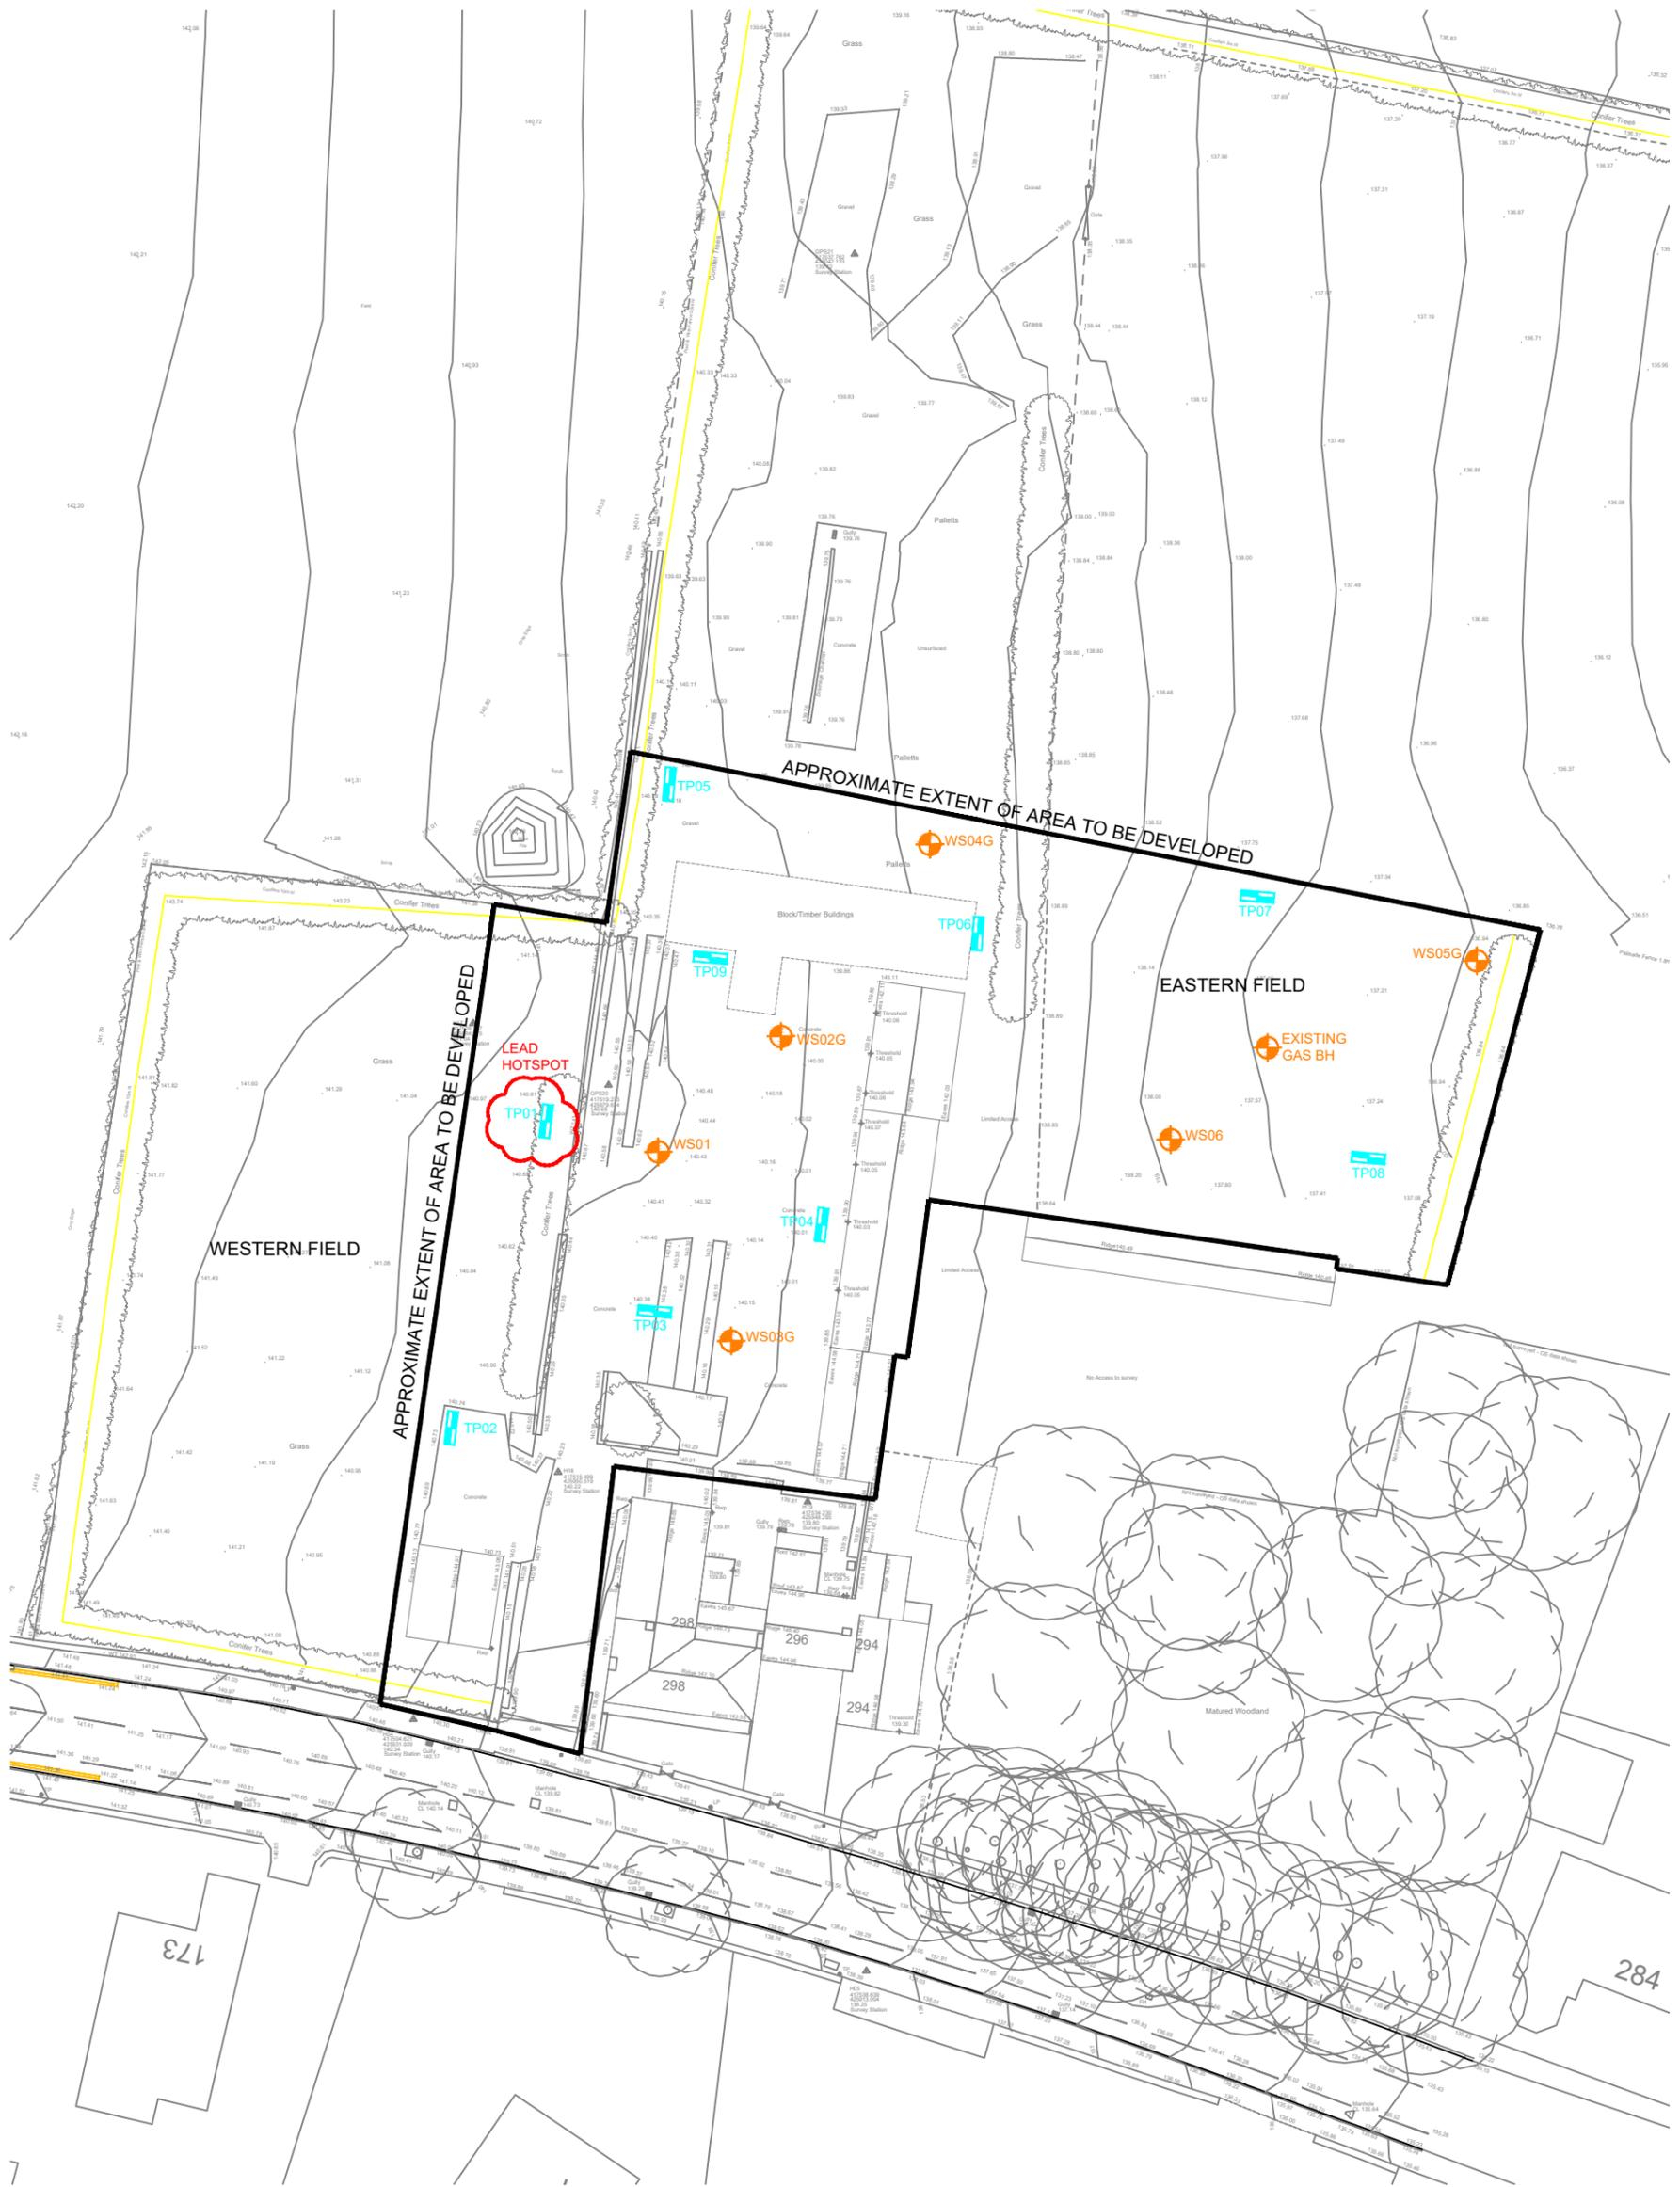
- 2.5 The Lead hotspot is shown on the plan attached to the rear of this report.

Rev B. Area to be developed highlighted  
 Rev A. Amended to suit Site Investigation Works.

- 2.6.4 The development of the site therefore exposes the developers and future residents to the following risks:
- i) Contamination hotspot identified at TP01  
The risk to the developers and future site residents is therefore considered to be low and remediation measures will be required to address there.

- 2.7.1 From the above, the remediation works required can be stated as follows:
- Removal of the material from the Lead contamination hotspot at TP01 to a licensed waste facility.

- 3.1.1 The Lead contaminated hotspot at TP01 recorded an elevated level of lead of 250 mg/kg compared to the tier 1 trigger level of 200 mg/kg, an exceedance of 25%.

- 3.1.2 The lead containing fill material should be excavated to expose the underlying clay strata and the contaminated material removed from site to a suitable licensed waste facility.
