Construction Environmental Management Plan

Wappy Springs

**ARBORICULTURAL METHOD STATEMENT
to BS 5837:2012
at
Wappy Spring Inn
Lindley Moor Road
Huddersfield
West Yorkshire
HD3 3TD**

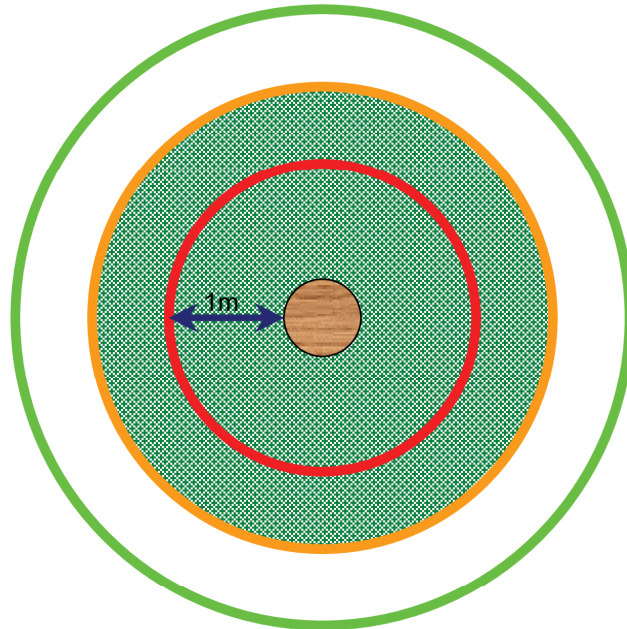
NJUG Guidelines for the Planning, Installation and Maintenance of Utility Apparatus in Proximity to Trees – Issue 2

PROHIBITED ZONE – 1m from trunk. Excavations of any kind must not be undertaken within this zone unless full consultation with Local Authority Tree Officer is undertaken. Materials, plant and spoil must not be stored within this zone.

PRECAUTIONARY ZONE – 4 x tree circumference. Where excavations must be undertaken within this zone the use of mechanical excavation plant should be prohibited. Precautions should be undertaken to protect any exposed roots. Materials, plant and spoil should not be stored within this zone. Consult with Local Authority Tree Officer if in any doubt.

PERMITTED ZONE – outside of precautionary zone. Excavation works may be undertaken within this zone however caution must be applied and the use of mechanical plant limited. Any exposed roots should be protected.

- A3.1 Over-ground services should be routed away from areas where they are likely to interfere with the crowns of trees. Similarly any landscaping should take account of over-ground services and mature tree size.
- A3.2 Underground services must be routed outside the RPA of retained trees, unless otherwise specified within this report. NJUG Volume 4 Issue 2 (on the next page) is a set of accepted guidelines for installing services in the proximity of trees. Please note that this is not a substitute for site-specific advice by an arboriculturalist and consultation should be made wherever incursions of RPAs are envisaged. The contents of this report, specifically **Section 4.5**, supersede the set of guidelines on the next page, which are only included for reference.

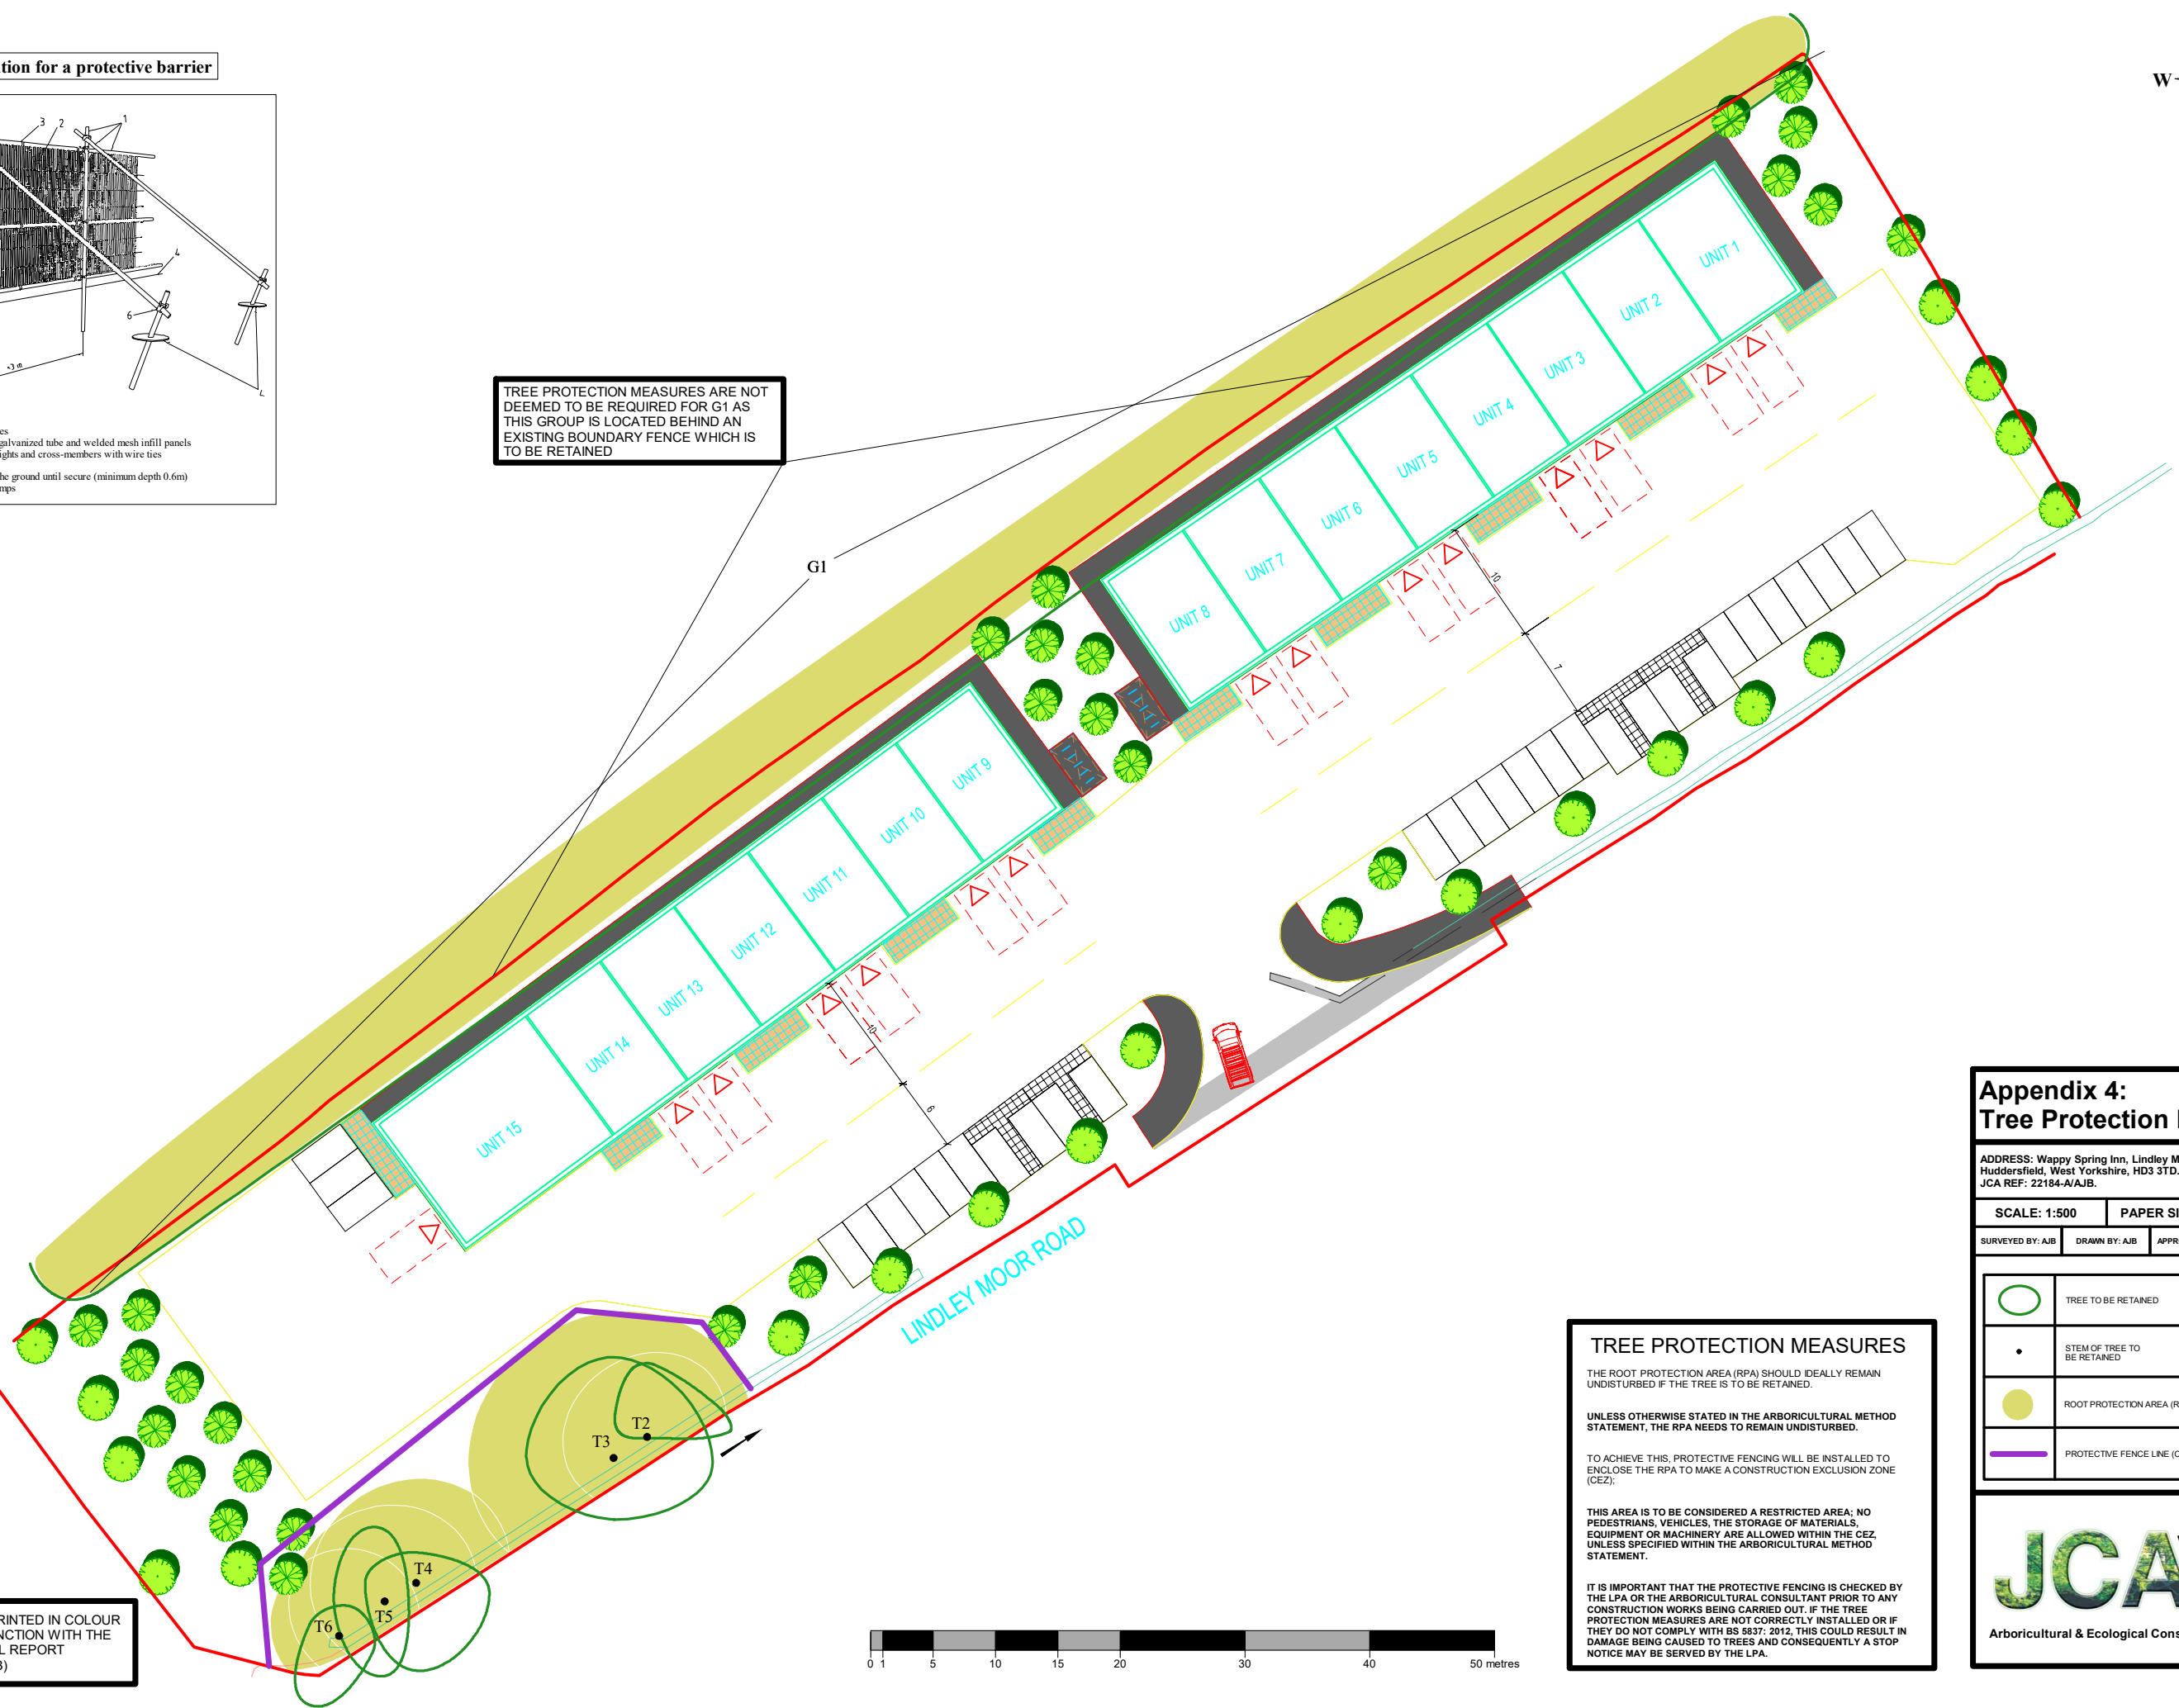
Appendix 4: Tree Protection Plan

TREE PROTECTION MEASURES ARE NOT DEEMED TO BE REQUIRED FOR G1 AS THIS GROUP IS LOCATED BEHIND AN EXISTING BOUNDARY FENCE WHICH IS TO BE RETAINED

THE ROOT PROTECTION AREA (RPA) SHOULD IDEALLY REMAIN UNDISTURBED IF THE TREE IS TO BE RETAINED.

UNLESS OTHERWISE STATED IN THE ARBORICULTURAL METHOD STATEMENT, THE RPA NEEDS TO REMAIN UNDISTURBED.

TO ACHIEVE THIS, PROTECTIVE FENCING WILL BE INSTALLED TO ENCLOSE THE RPA TO MAKE A CONSTRUCTION EXCLUSION ZONE (CEZ).

THIS AREA IS TO BE CONSIDERED A RESTRICTED AREA: NO PEDESTRIANS, VEHICLES, THE STORAGE OF MATERIALS, EQUIPMENT OR MACHINERY ARE ALLOWED WITHIN THE CEZ, UNLESS SPECIFIED WITHIN THE ARBORICULTURAL METHOD STATEMENT.

- 3.1.2 The protective fencing must be constructed in accordance with BS 5837: 2012 *Trees in relation to design, demolition and construction - Recommendations* and will be located as shown on the Tree Protection Plan at **Appendix 4**. The protective barrier will enclose the entire Root Protection Area (RPA) retained trees to create a Construction Exclusion Zone (CEZ); **this area is to be considered a restricted area; no pedestrians, vehicles, equipment or machinery are allowed within the CEZ and the storage of materials is not permitted, unless specified within this Method Statement.**
