client name	
Kirkless Council	
project	
Oakwell Hall - Fabric Repairs	
drawing	
Proposed Elevation - North East	
computer file	plot date
H:\BC\H\02024\2024.0049.010 - Kirkless Council - Oakwell Hall - Fabric Repairs\07_Design\Rev\2024.0049.010 - Oakwell Hall - LBC.dwg	Sept 25
project number	scale
2024.00049.010	As indicated@A1
drawing number	rev
AHR-OH-00-DR-A-21-012	A
	LBC

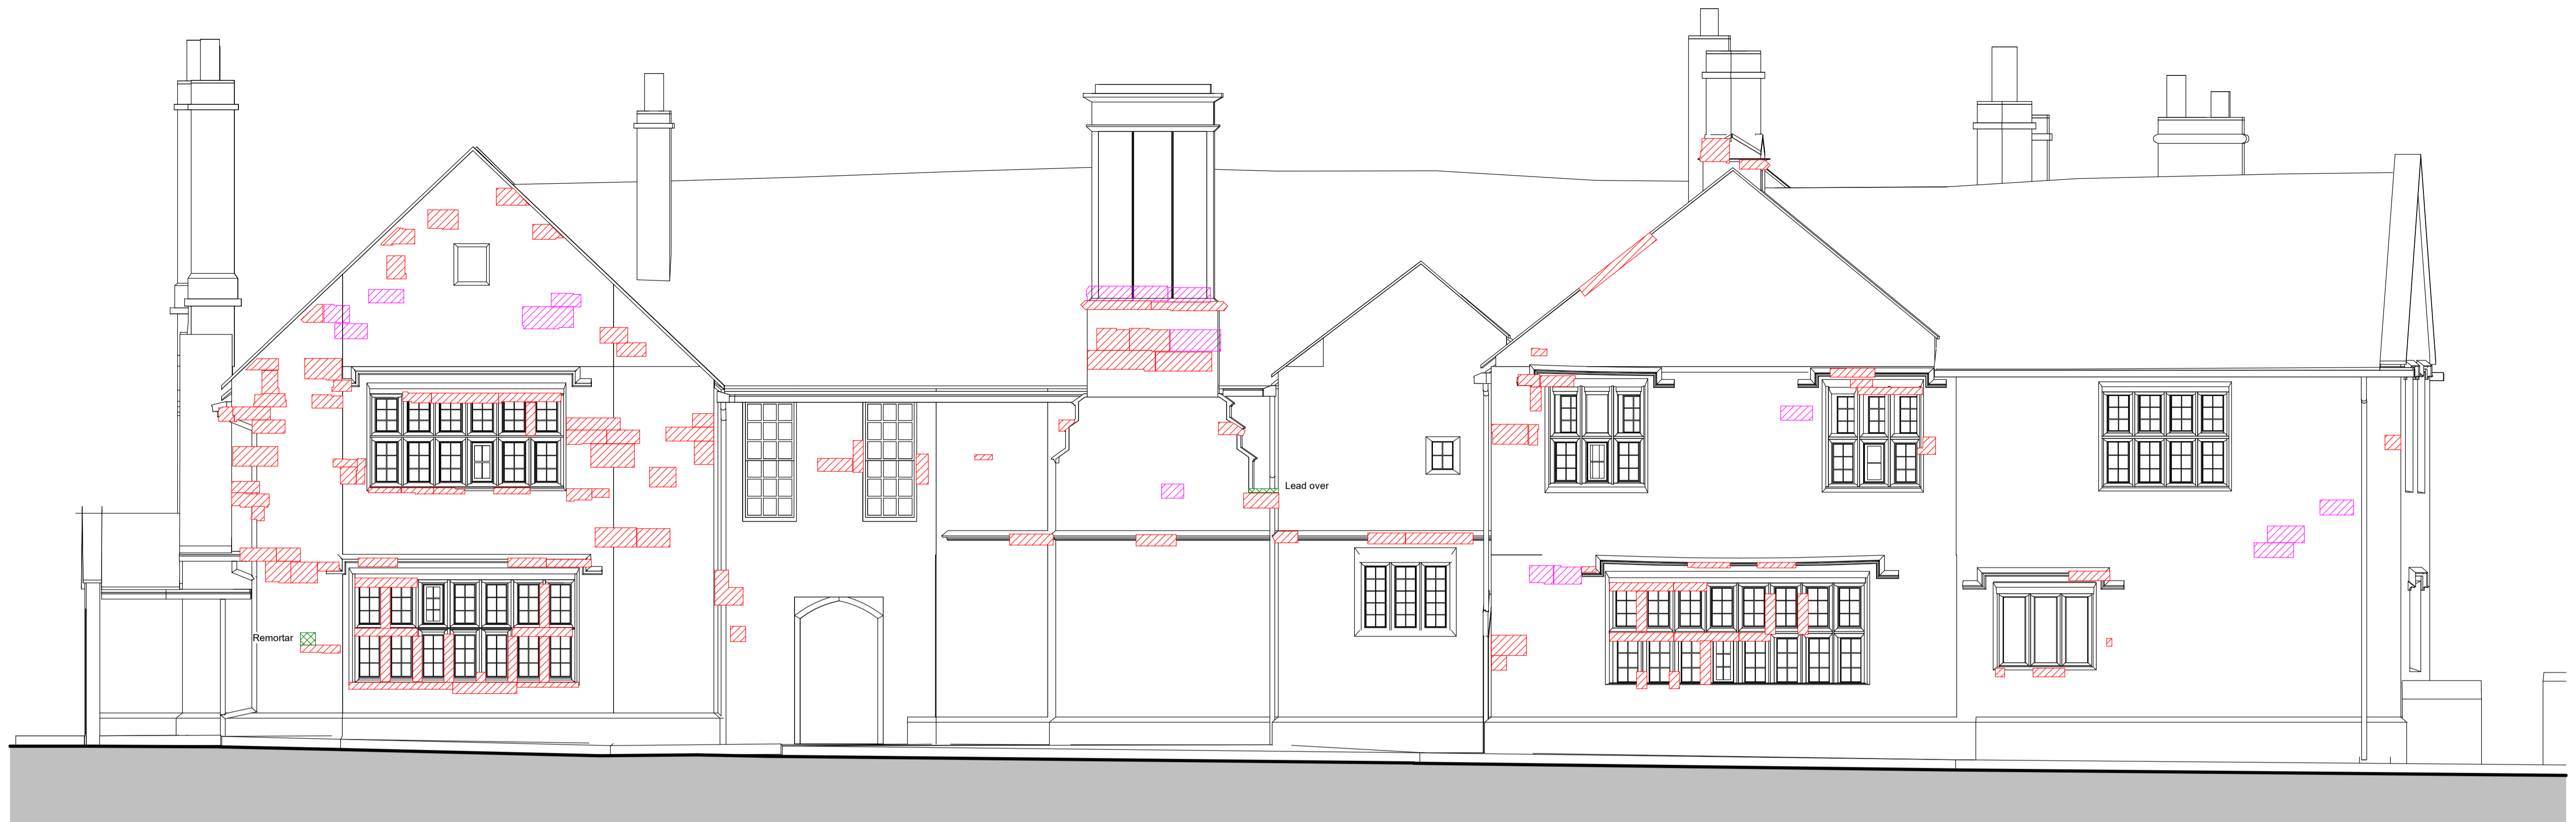
**1 Proposed - North East Elevation 1**  
1: 50

Refer to layout AHR-OH-DR-A-21-010 for Masonry repairs strategy and specification.
