**1 Proposed - North West Elevation 1**  
1 : 50

client name	Kirkless Council		
project	Oakwell Hall - Fabric Repairs		
drawing	Proposed Elevation - North West		
computer file	H:\BC\H\0224\2024\0049.010 - Kirkless Council - Oakwell Hall - Fabric Repairs\07_Design\Rev\2024\0049.010 - Oakwell Hall - LBC.rvt	plot date	Sept 25
project number	2024.00049.010	scale	As indicated@A1
drawing number	AHR-OH-00-DR-A-21-011	rev	A
		issue status	LBC

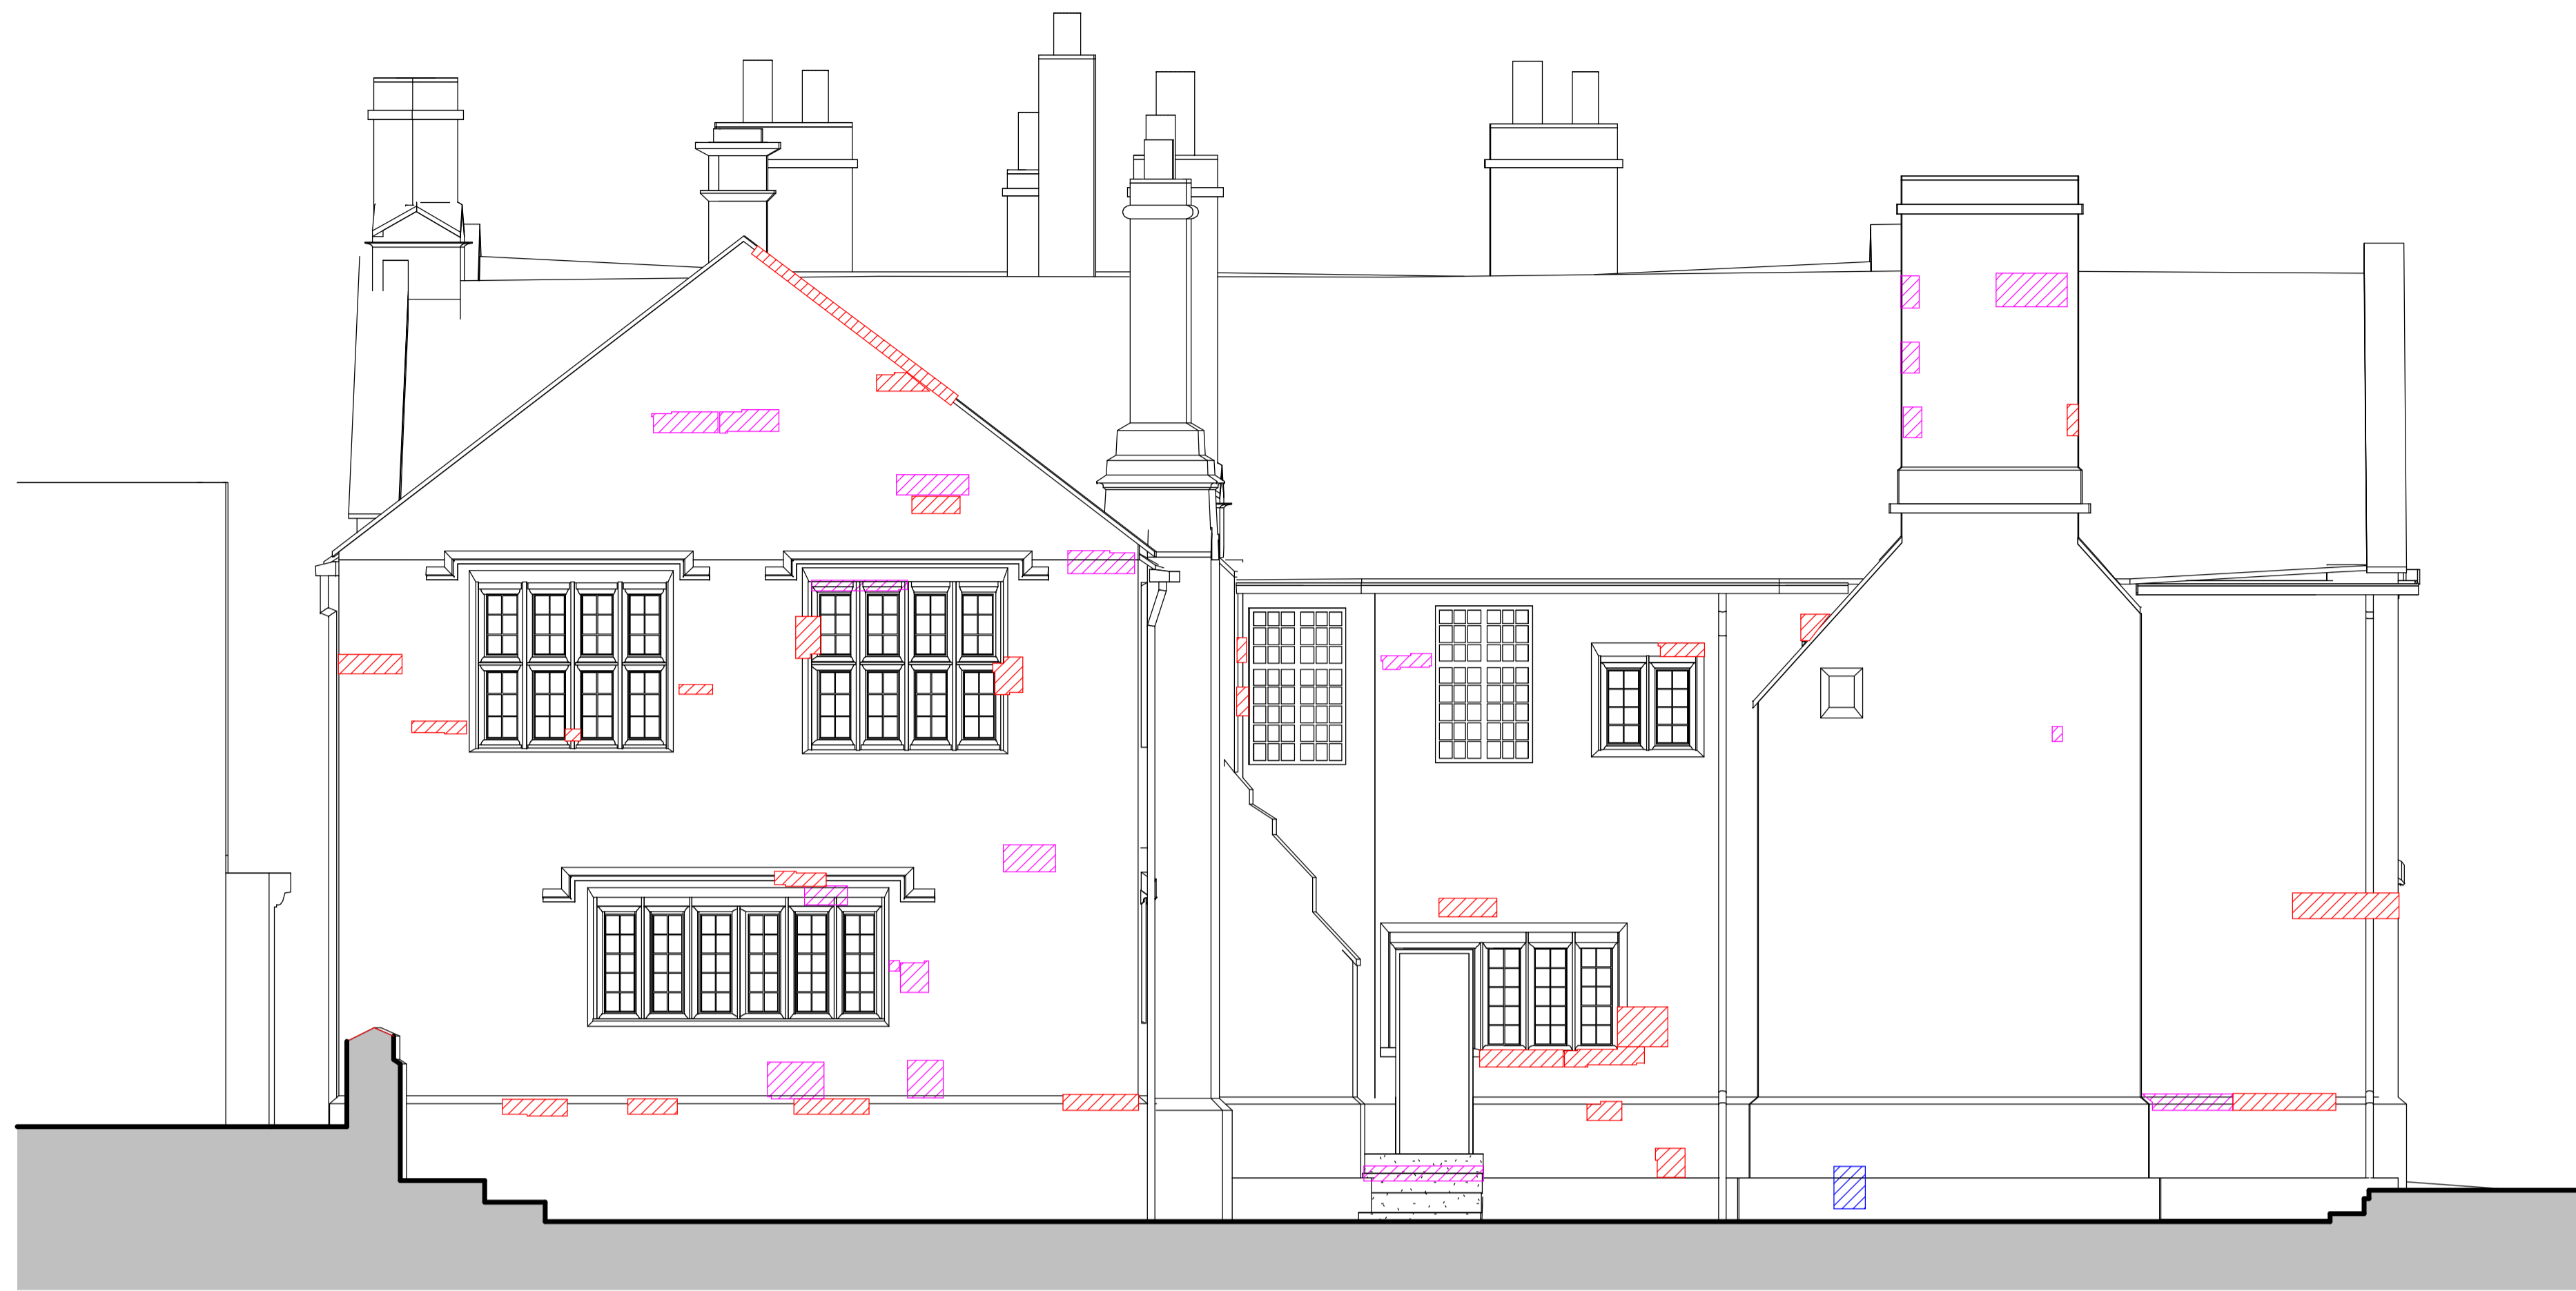
- Repairs Key:**
- Indent Required
  - Surface Descale / Defrass Required
  - Replace with New Stone Flag Vent

Refer to layout AHR-OH-DR-A-21-010 for Masonry repairs strategy and specification.
