**ARBORICULTURAL REPORT
AND
ARBORICULTURAL IMPACT ASSESSMENT
to BS 5837:2012
at
19 Old Mill View
Dewsbury
West Yorkshire
WF12 9QJ**

JCA Ref:
23334-Rev1/LW

**Appendix 5:
Tree Constraints Plan**

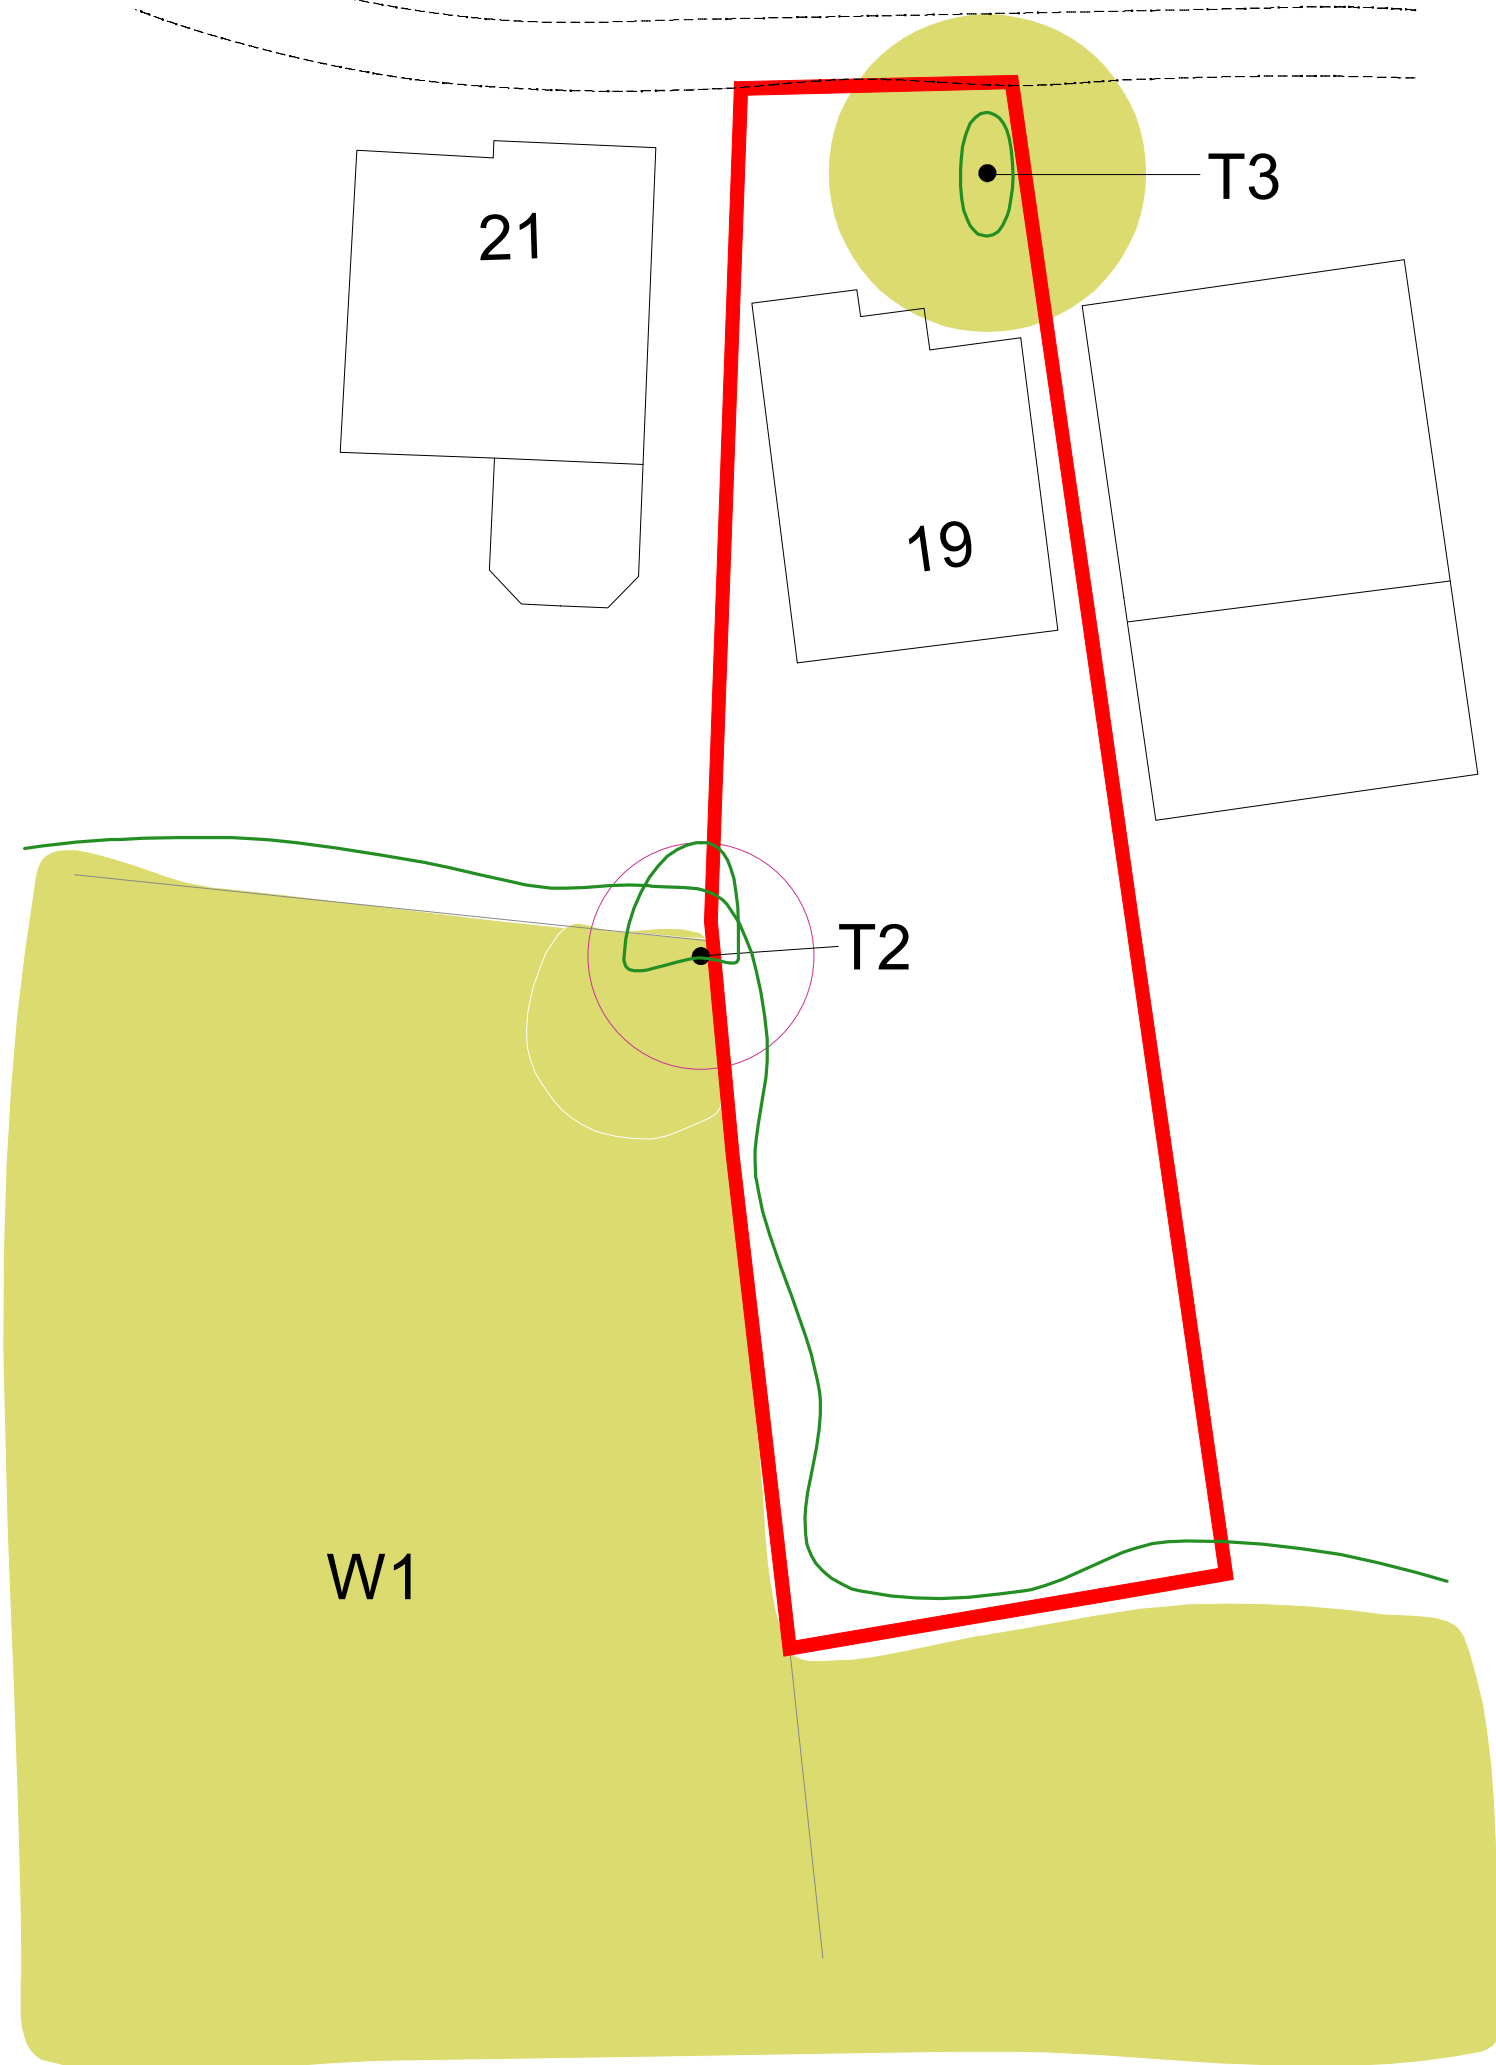
Root Protection Area: RPA
THE ROOT PROTECTION AREA SHOULD IDEALLY REMAIN UNDISTURBED IF THE TREE IS TO BE RETAINED.
THE DEVELOPMENT PROPOSALS SHOULD THEREFORE BE DESIGNED TO AVOID THE RPA OF ANY TREE WHICH IS TO BE RETAINED.
IF IT IS NECESSARY FOR THE DEVELOPMENT TO ENCRUCH INTO THE RPA OF A TREE WHICH IS TO BE RETAINED THEN SPECIALIST CONSTRUCTION TECHNIQUES AND MATERIALS MUST BE CONSIDERED.

T3

T2

W1

- 4.5.4.1 The footprint of proposed structures incurs the RPA of **T3**, a retained tree. Due to this, a specialist foundation design, such as pad and beam/raft foundations must be implemented to reduce excavation and the detrimental impact this can have on tree roots.

- 4.5.4.2 This method will minimise foreseeable damage and will allow the retention of this tree, whilst accommodating the proposed development. Full details of these works should be included in an associated Arboricultural Method Statement, along with any phasing of protection methods and arboricultural supervision which may be necessary.
