Haki Stair Demolition Notes

client name	GMI Construction Group		
project	George Hotel Refurbishment		
drawing	Haki Stair - Demolition Plans		
computer file	110.32.1.110EM_Profile_Folder_redirection\albor\Documents\Revit		plot date
project number	2024.00373.000	scale	1 : 100 @A1
drawing number	L054-AHR-ZZ-BA-ZZ-D-A-20710	rev	P1
		issue status	S2

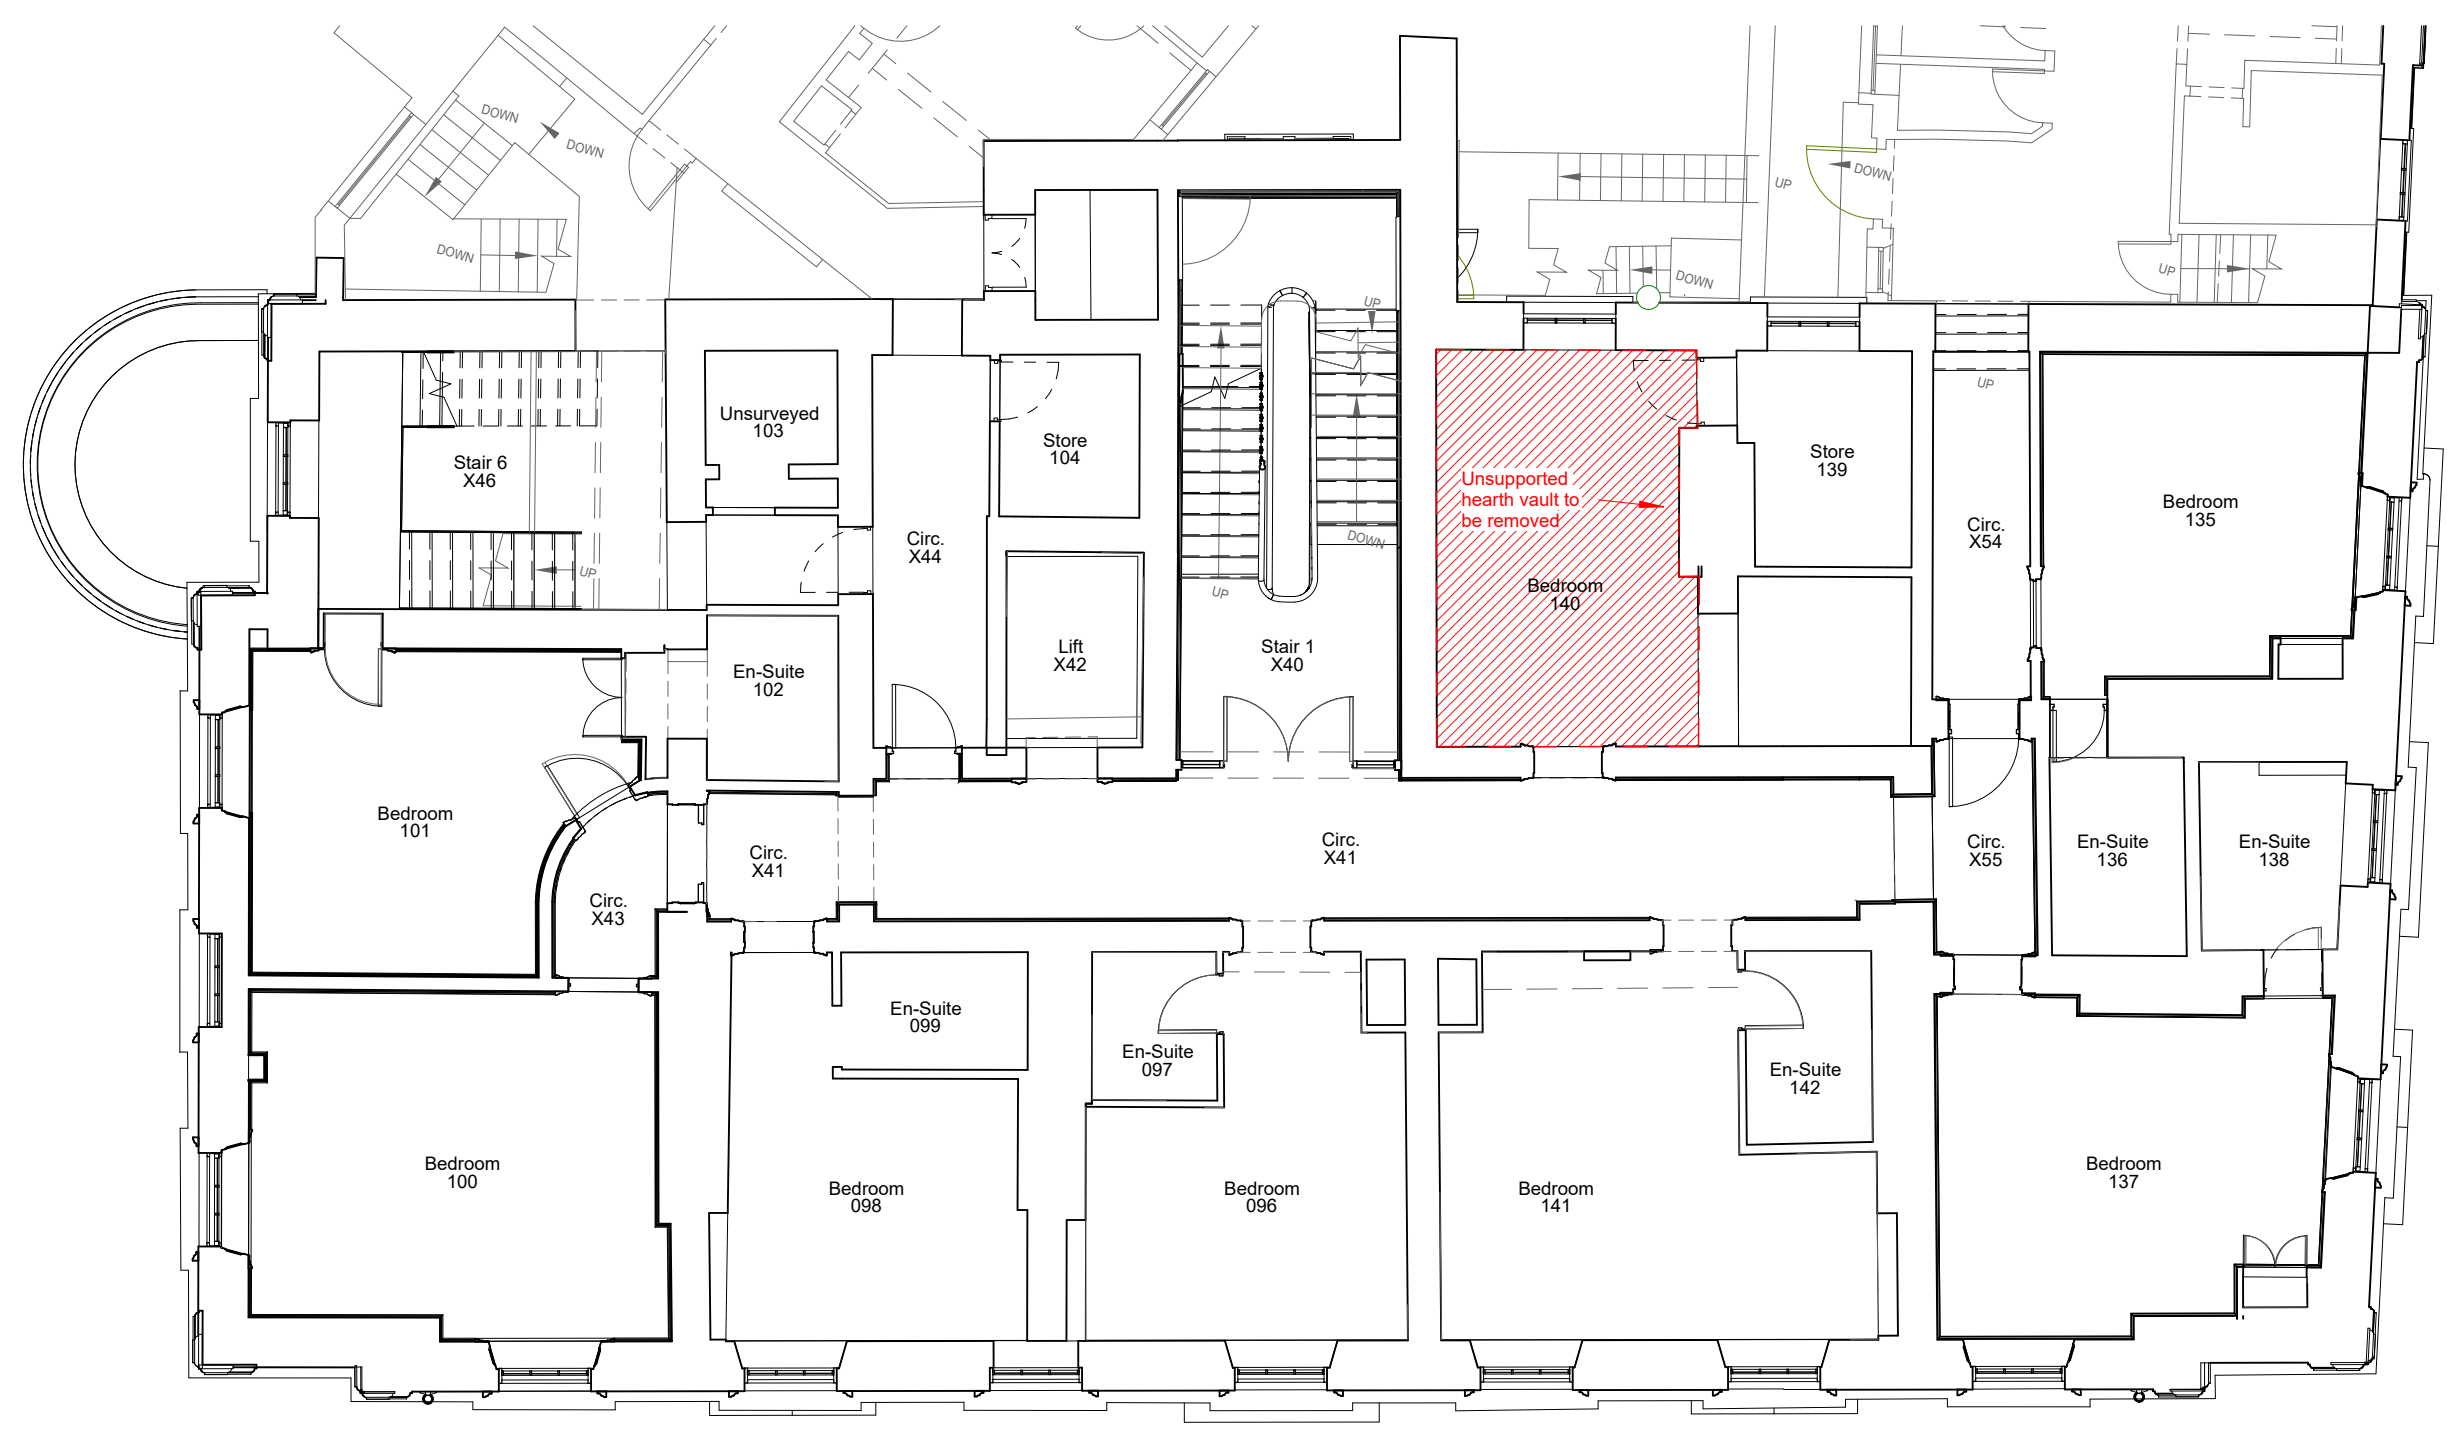
2 Level 02 - Haki Stair Demolition Plan
1 : 100

Hatch indicates demolition of the following items within the highlighted rooms:

- Existing hardboard
- Existing pugging
- Existing timber floorboards
- Existing joists
- Existing ceilings & all related decorative plaster (including cornice) are not included as part of this application. These are to be removed and reinstated in accordance with approved conditions consents:
