**AN APPLICATION FOR LISTED BUILDING CONSENT WITH REGARD TO THE
DEMOLITION OF A REDUNDANT AND STRUCTURALLY UNSOUND BUILDING KNOWN
AS THE “BIKE SHED” IN THE SCHOOL PLAYGROUND, AND THE REINSTATEMENT
OF THE GROUND TO FORM PART OF THE PLAYGROUND. AT SHEPLEY FIRST
SCHOOL, FIRTH STREET, SHEPLEY, HUDDERSFIELD HD8 8DD**

SUPPORTING HERITAGE STATEMENT

MAY 2026

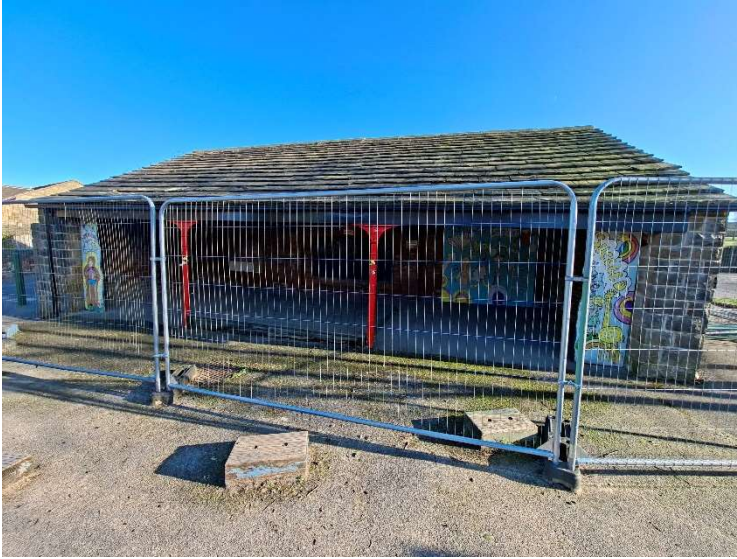
Southwest Elevation

- 1.9 Figure 1 presents photographs of the “Bike Shed” as it appears now, with Heras fencing around it to prevent children accessing the building. A photograph also shows the visual relationship between the main School building and the “Bike Shed”.

- 1.11 Due to the possibility of tiles falling off the roof onto the playground, Heras fencing has been placed around the bike shed to prevent access to the immediate area around the structure. The fencing can be seen in the photographs set out within Figure 1 following.

Figure 1 Photographs of the Bike Shed (March 2026)

- 1.10 A number of years ago, part of the stone tile roof was stolen and replaced, which meant that the wooden pegs fixing the tiles to the roof structure were replaced. However, in early 2025, one of the tiles slipped. The roof was inspected by Kirklees Building Services, which advised that the wooden pegs which had not been earlier replaced needed all of the remaining pegs replacing. The slipped tile slipped as its peg fixing had failed, and it was likely that other tiles would start to slip in the future.

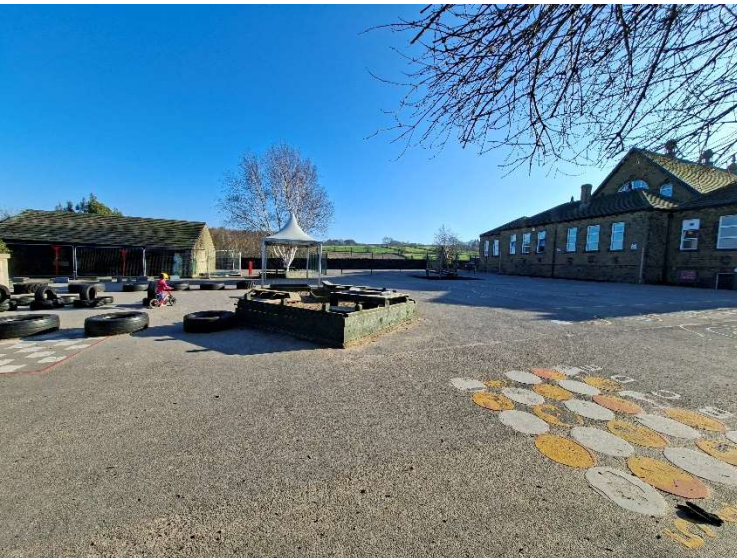
Photograph looking eastward with Bike Shed to the left and the main School building to the right.
