## Upper Road, Dewsbury

### Arboricultural Impact Assessment

May 2026

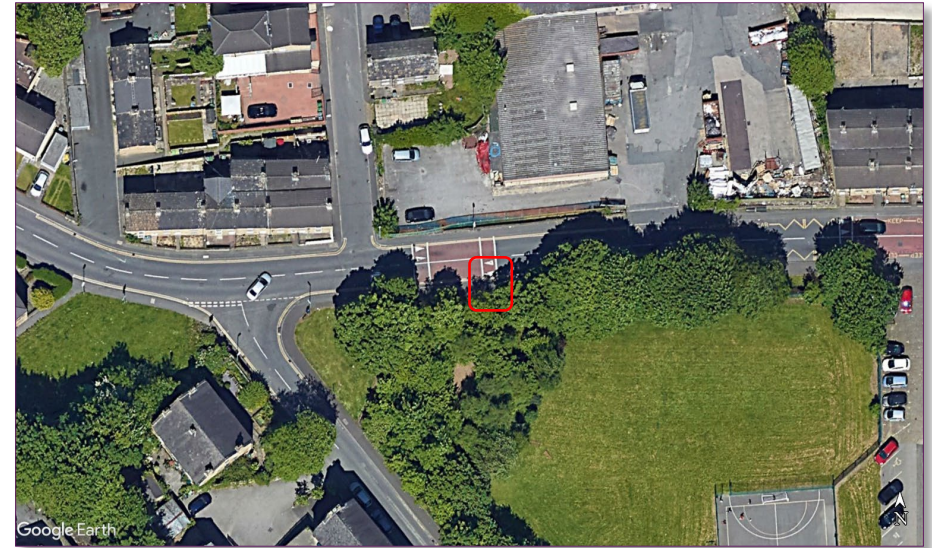
**Figure 1** Google Earth Image of the Site.

The site comprises a grassed strip in the highway estate on Upper Road, Dewsbury. The area is a mixed residential and light commercial district to the north of Dewsbury town centre (Figure 1).

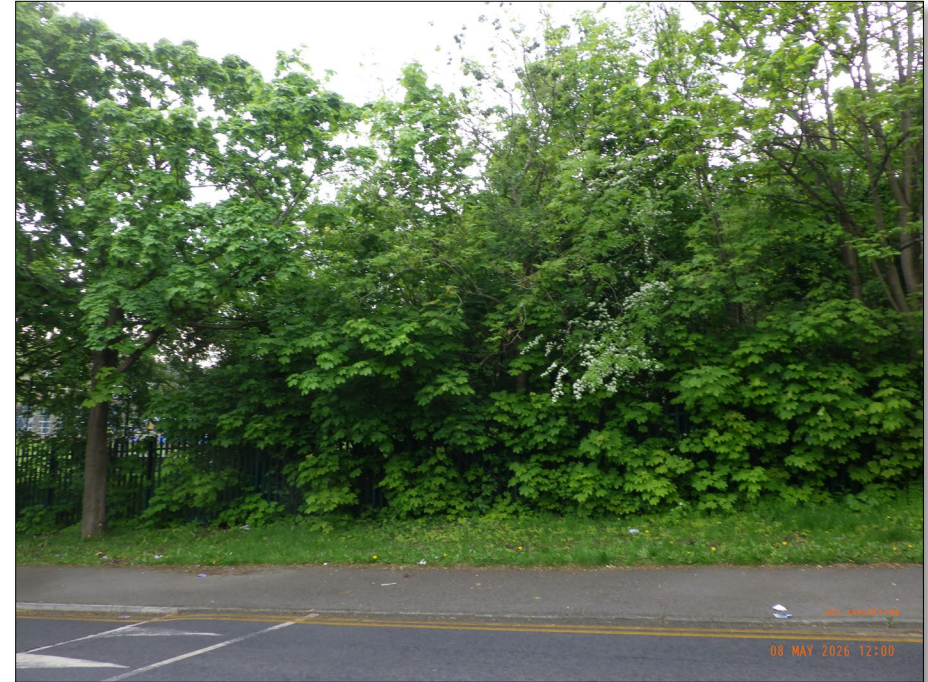
The tree data can be found at Appendix A. There is no requirement in BS 5837 to repeat the details of the constraints information save for confirming that the trees were surveyed for species type, age, height, crown spread, diameter-at-breast-height, condition, and their suitability for retention from ground level. Each tree or group was assigned to one of the four retention categories [A,B,C,U] specified by BS5837.

The individual descriptions and other relevant information are contained in the attached schedule and they are shown on the attached plans, based on the original topographical survey. Only trees with a stem diameter of 75 millimetres measured at 1.5 metres above the ground are required to be recorded.

The heights were measured with a digital Hypsometer and the diameters were taken with a diameter tape to give an average stem measurement. Canopy spreads have been measured at the cardinal points or where they significantly extend in other directions.

**Figure 2** Survey Trees

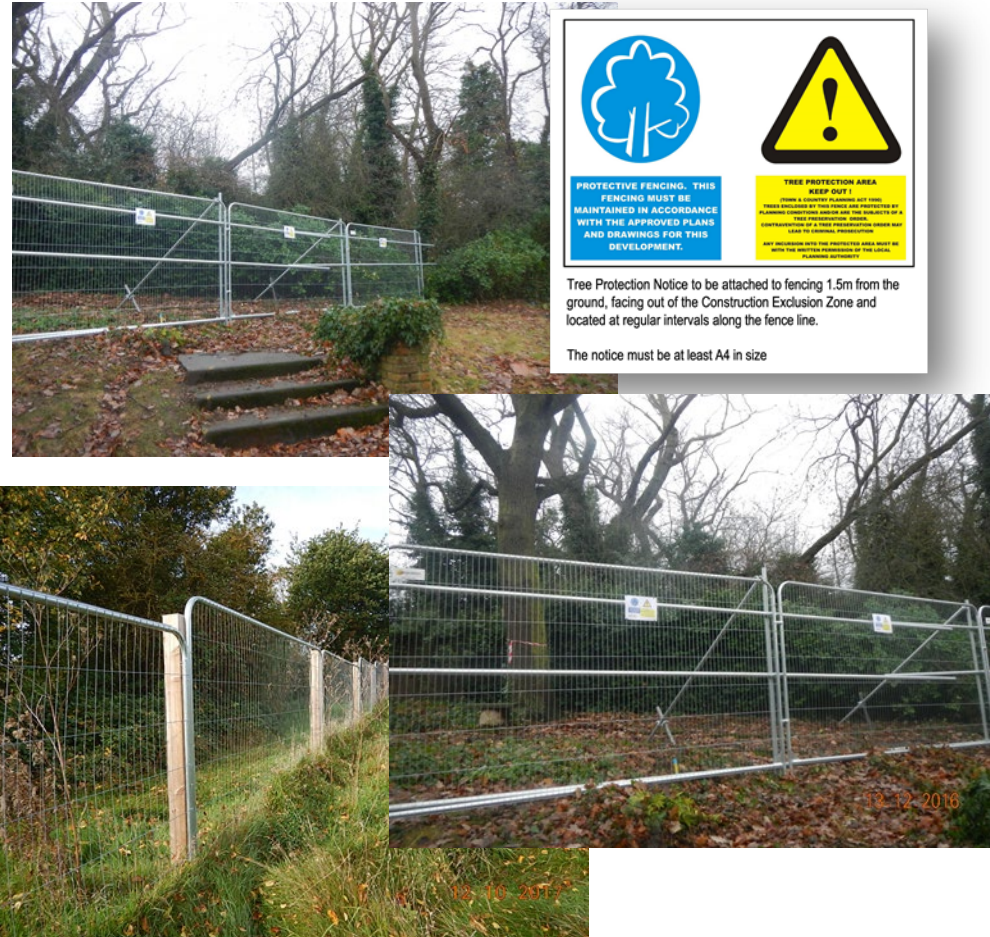
**Drawing No. – ARB/5524/Y/200.**

Due to the nature of the works, standard BS 5837 fencing will be used. The Construction Exclusion Zone fence will be heras fence panels fixed to a scaffold framework. Alternatively, heras panels fixed to timber posts. The location will be marked on site by the Arboricultural Consultant and are also shown on the Drawing No. – ARB/5524/Y/200. The requirement will be assessed on a weekly basis by the ACoW.

- Heras fencing fixed to a scaffold framework or timber posts as illustrated.
- Fencing installed at locations shown on the plan (**ARB/5524/Y/200**) and marked on site.
- Location and adequacy signed off by Arboricultural Consultant and LPA advised.
- Tool Box Talk – make construction staff aware of the importance of areas by site manager.
- Signs to be erected advising of the area's importance.
- Fence to be adjusted as noted in the Construction Timetable.

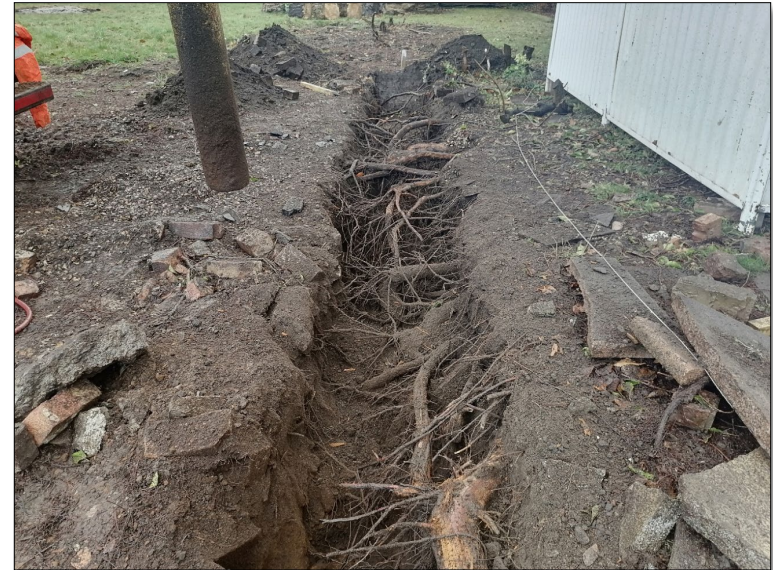
Drawing No. – ARB/5524/Y/200

- The works area is to be marked out.
- Soil tested to determine excavation method. Using either hand digging, Hydro Vacuum & Suction Excavation, Pneumatic Vacuum & Suction Excavation or Clay-Spade Assisted Suction Excavation, the foundation will be excavated.

- The foundation pit to be excavated to a maximum of 110% of the cabinet root fabricated metal base that sits securely underground. In all cases of excavation: Roots <25mm Ø are to be cut at the excavation face with secateurs. Roots >25mm Ø are to be assessed by the Arboricultural Consultant. Findings and decision on root retention/severance to be reported to the LPA.

- Exposed roots to be kept moist with hessian sacking.
- Following excavation of the foundations the sides are to be immediately lined with plastic/DPC barrier to prevent the pouring concrete leaching into the surrounding soil affecting its PH value and contact with any exposed roots.
