## S278 AGREEMENT WORKS

### MERAKI ALLIANCE: STAGE I ROAD SAFETY AUDIT.

RESPONSE DATE: 08.06.26

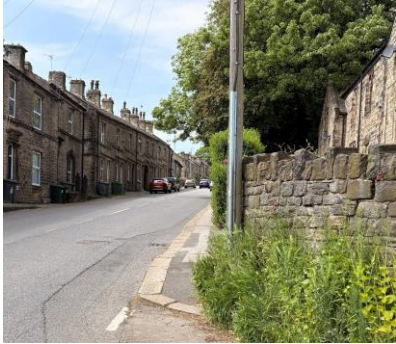
| Ref | Repeat Stage 1 Road Safety Audit | | Design Organisation response | Overseeing Organisation response | Agreed RSA action |
|---|---|---|---|---|---|
| 2.1 | <p><b>Location:</b> Proposed development access<br/><b>Summary:</b><br/>Increase in cross path collisions or pedestrian collisions, due to obstructed visibility.</p> | Ensure that the visibility splay is achieved and is kept free of obstructions, in perpetuity by undertaking site clearance. | Dwg. 8392_040A shows 2.4m x 40m Visibility Splay achieved, with no obstructions. | The area within visibility splay indicates vegetation on the background topo survey information on Dwg. 8392_040A, please add a note on this drawing indicating that all obstructions including vegetation will be removed. | Amend dwg. 8392_040A as per the Overseeing Organisation Response. |
