**Land Adjacent to Halifax Old Road, Birkby**

**Partially collapsed burr wall & adjacent tree**

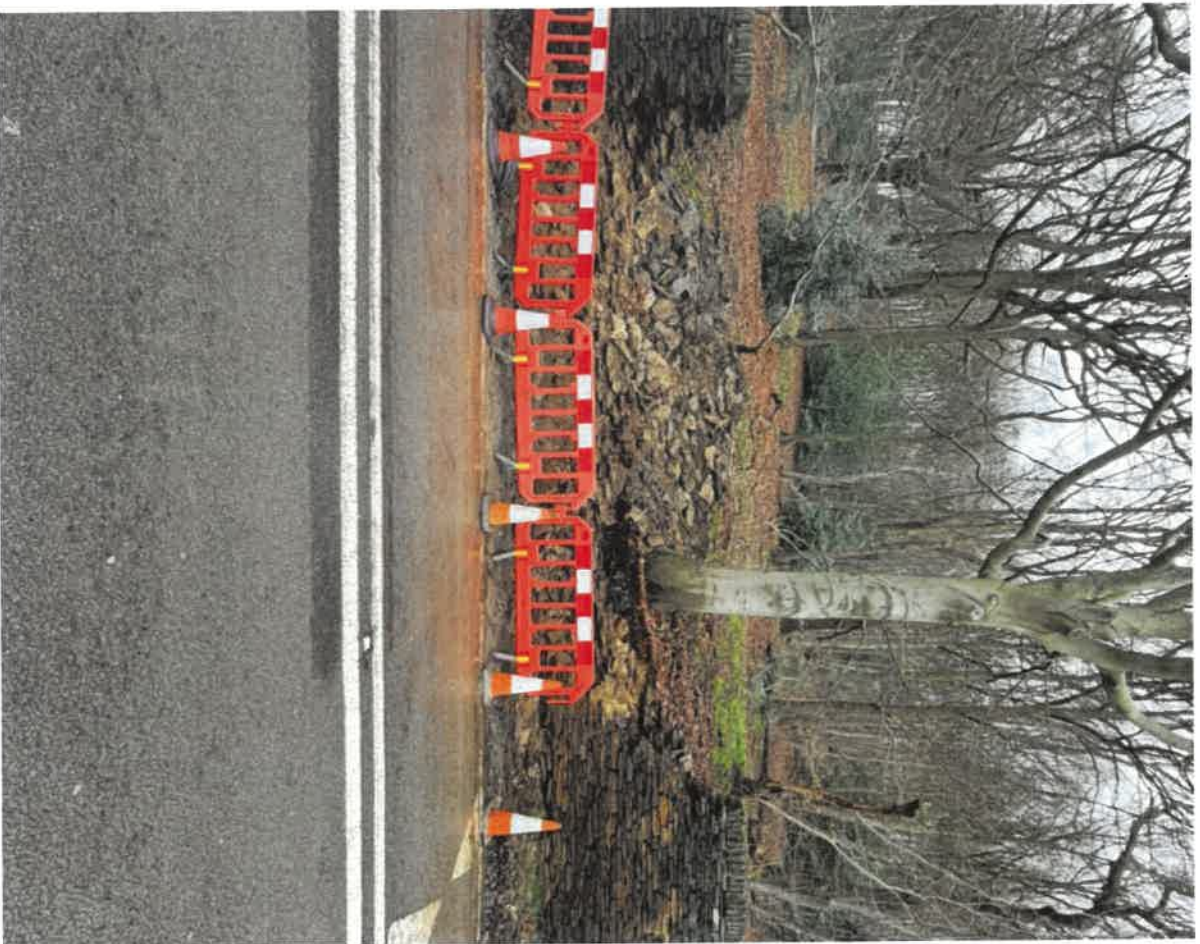
Following a recent inspection of a reported collapse of a highway retaining wall which retains private woodland it was noted that a large tree which is located directly behind it has contributed to a section of the wall partially collapsing onto the adjacent highway verge.

Photo 1 – Showing collapsed section of wall and tree

A recent land ownership search undertaken by the Council has identified you as the registered owner of the land where the tree is located. I am therefore writing to ask you to arrange for the removal of the offending tree in order to facilitate the necessary remediation of the wall.

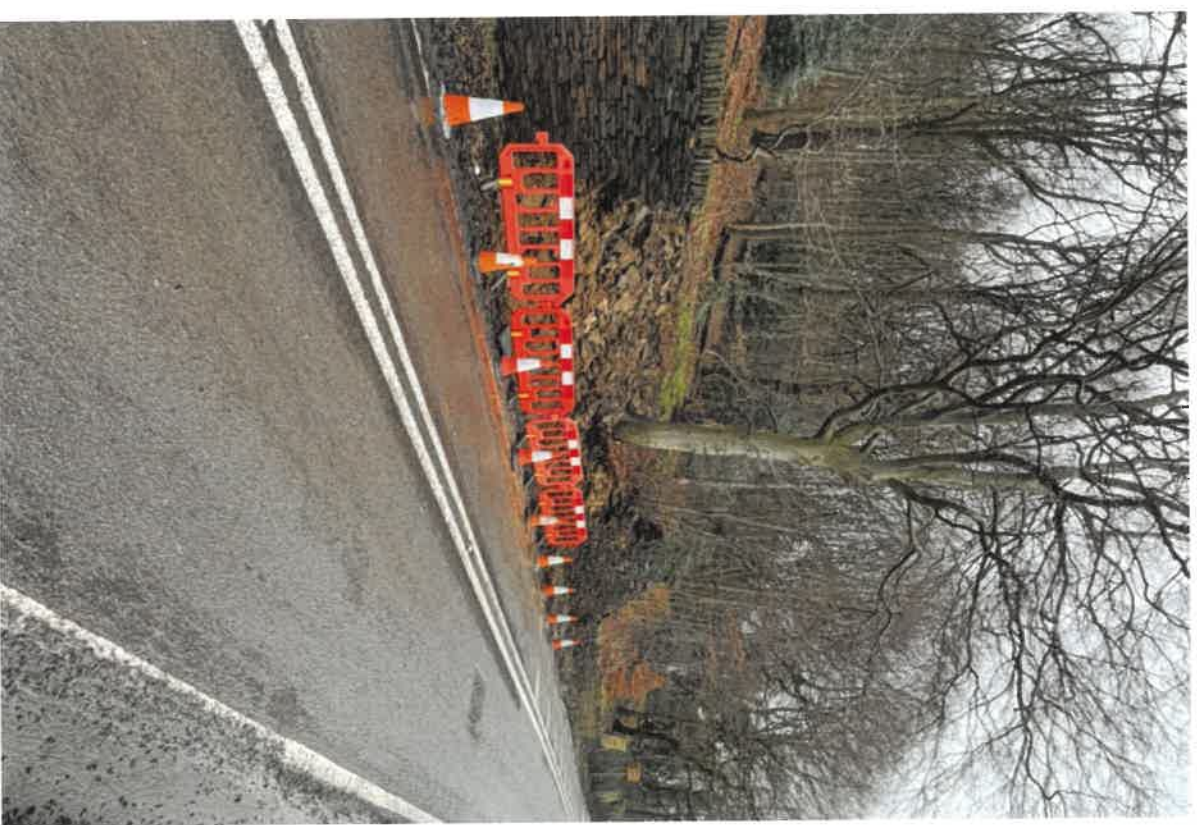
Photo 2 – Showing collapsed wall and relative proximity to dragons teeth markings and 30mph limit sign
