## **REMEDIATION METHOD STATEMENT**

**Northorpe Lane, Mirfield, West Yorkshire**

**Report: 26058-RMS**

**Date: July 2026**

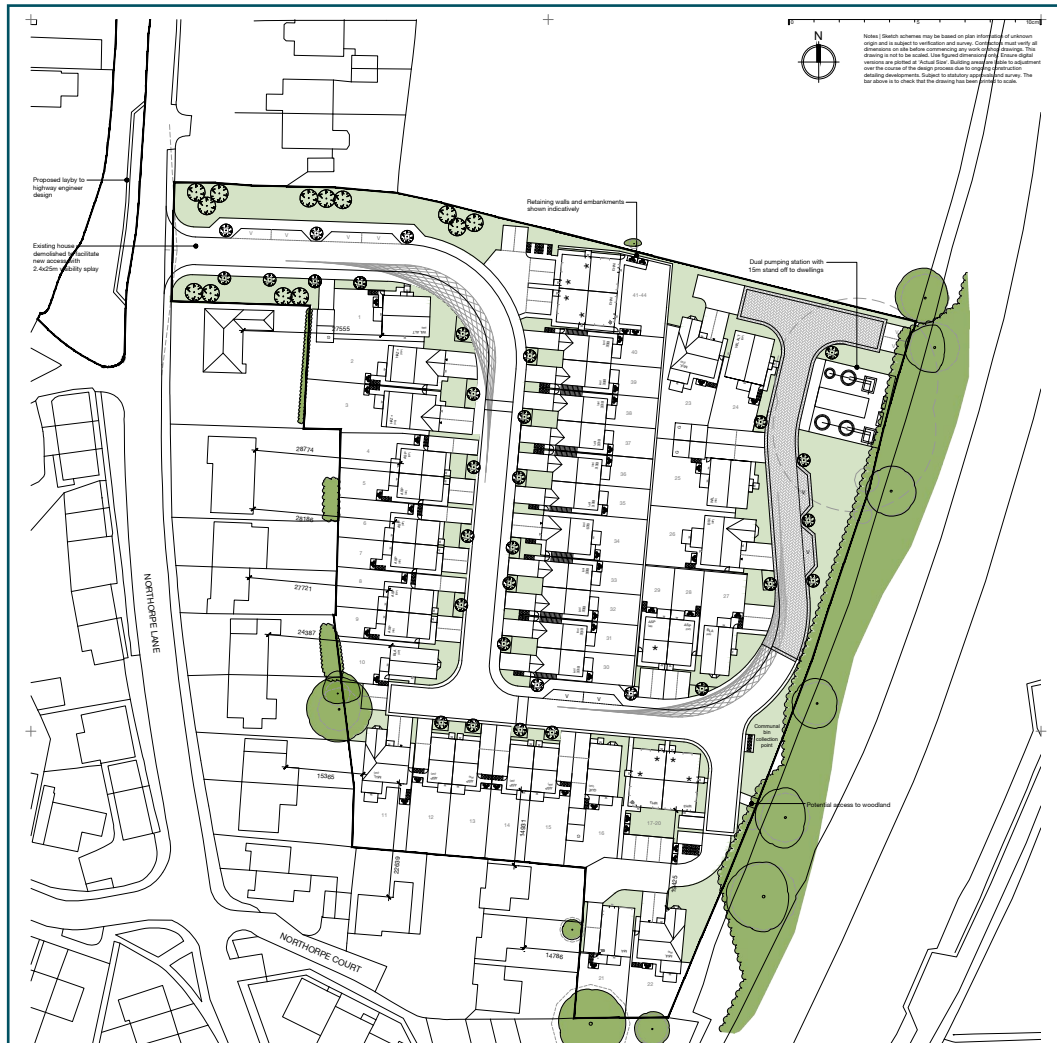
**FIGURE 2 - PROPOSED LAYOUT PLAN**

The proposed site layout is shown on Figure 2.

If there are changes to the nature, scale or layout of the proposed development then some modification to the comments and recommendations given may be required. The proposed site layout is shown on the site plan in Appendix A.

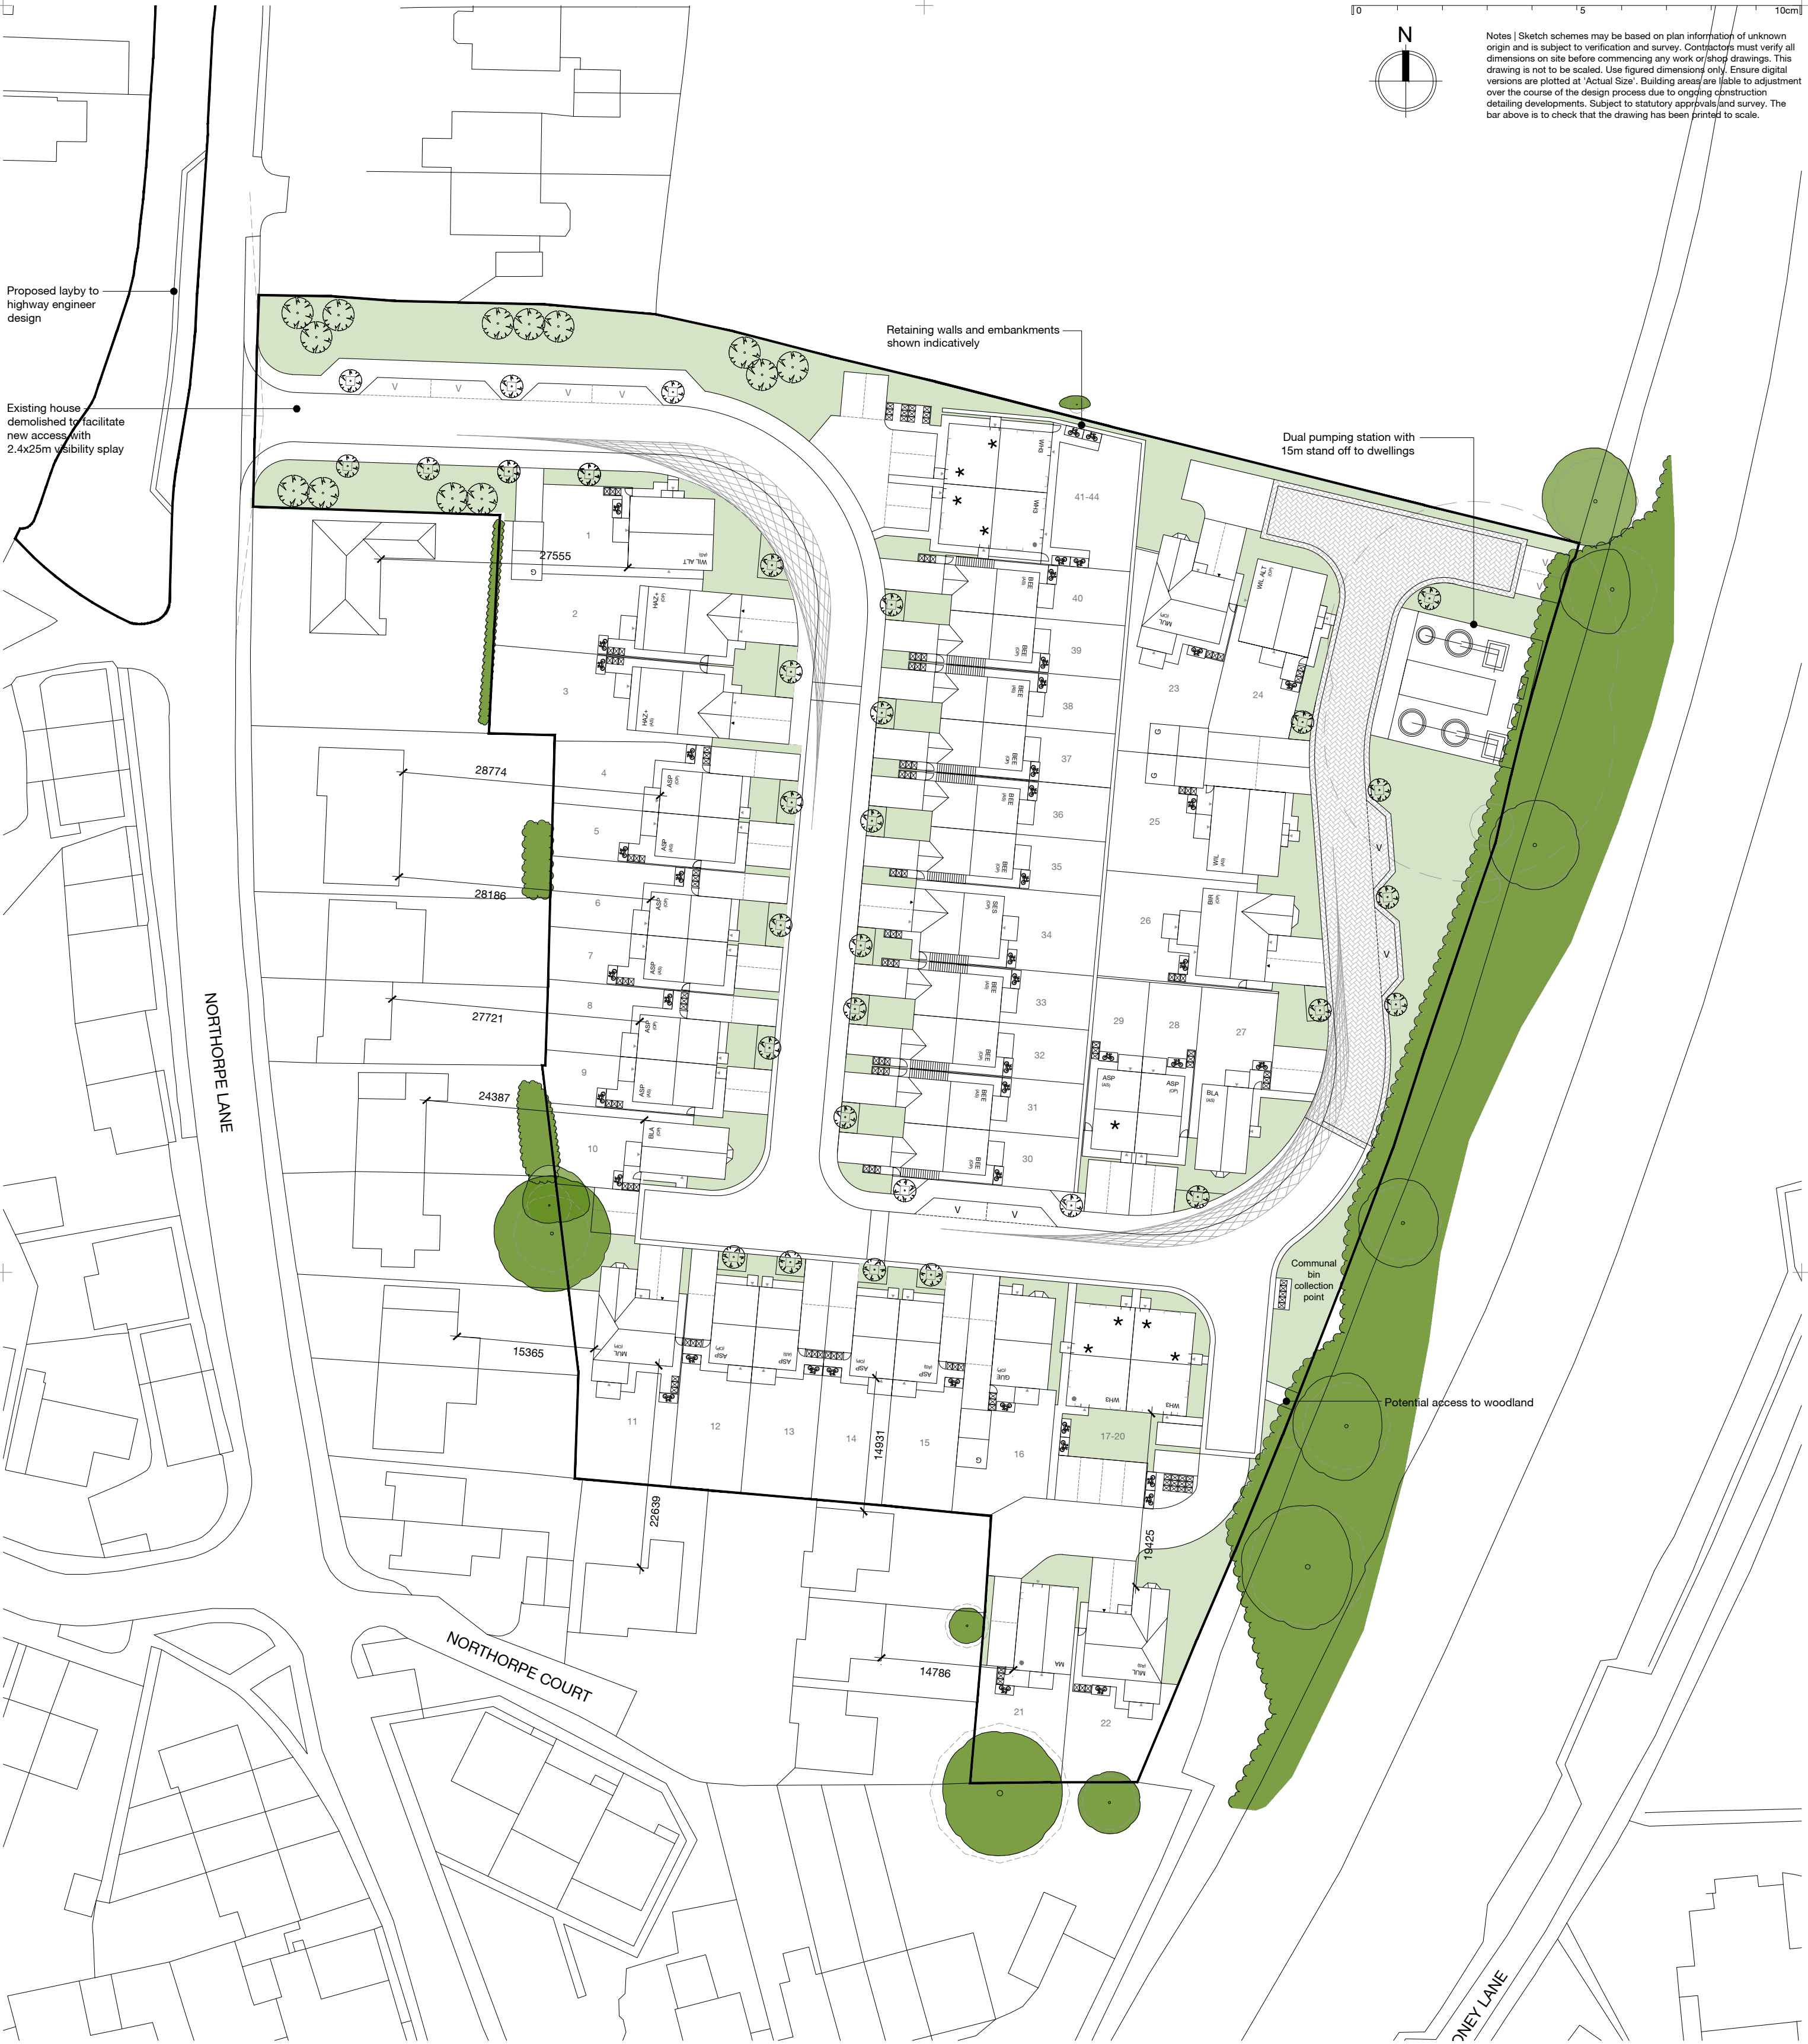
## **APPENDIX A - PROPOSED LAYOUT DRAWING**

Proposed Site Layout
