**ARBORICULTURAL IMPACT ASSESSMENT  
to BS 5837:2012  
at  
Land at Primrose Lane  
Liversedge  
West Yorkshire**

**Client:**  
Jones Homes  
(Yorkshire) Limited

**JCA Ref:**  
21600-F/AJB

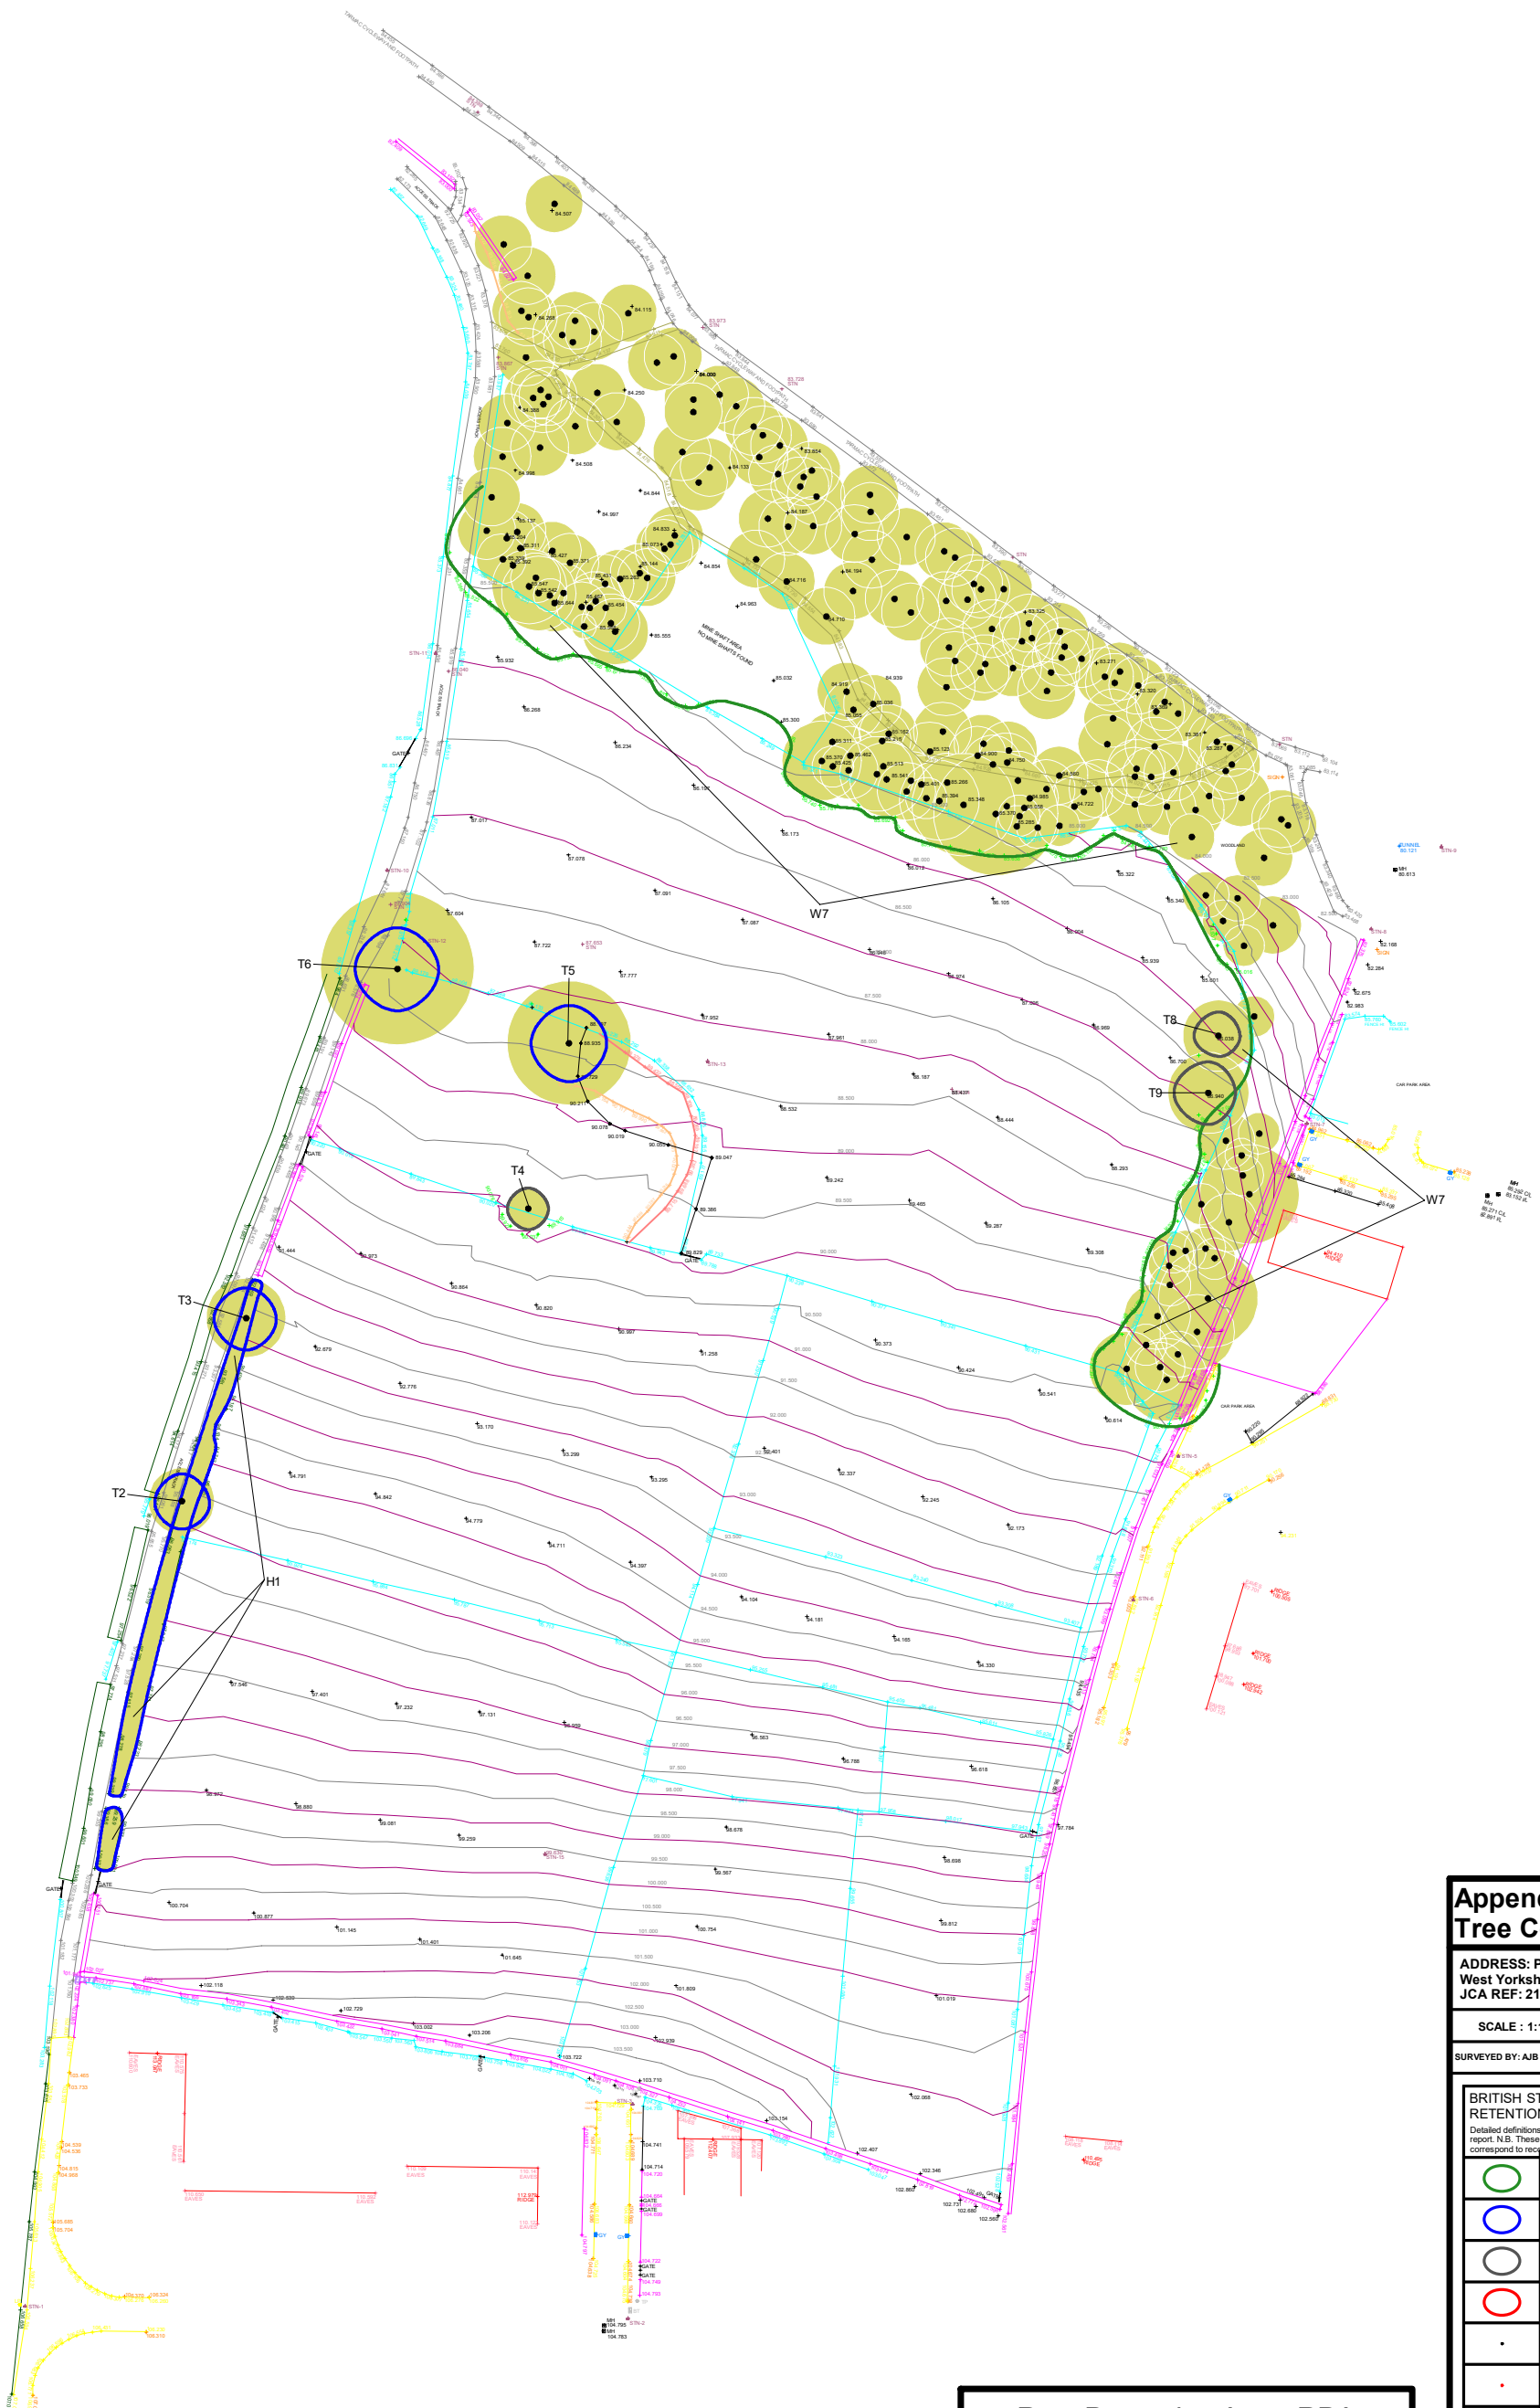
### Appendix 6: Tree Constraints Plan

**Root Protection Area: RPA**

THE ROOT PROTECTION AREA SHOULD IDEALLY REMAIN UNDISTURBED IF THE TREE IS TO BE RETAINED.

THE DEVELOPMENT PROPOSALS SHOULD THEREFORE BE DESIGNED TO AVOID THE RPA OF ANY TREE WHICH IS TO BE RETAINED.

IF IT IS NECESSARY FOR THE DEVELOPMENT TO ENCROACH INTO THE RPA OF A TREE WHICH IS TO BE RETAINED THEN SPECIALIST CONSTRUCTION TECHNIQUES AND MATERIALS MUST BE CONSIDERED.

- 2.1 The tree information recorded during the original survey is detailed in the tables at **Appendix 1**. A full explanation of the tables can be found at **Appendix 2**. Please refer also to the Tree Constraints Plan at **Appendix 5** for tree locations.

- 4.6 The protection of retained trees can be achieved by the creation of a Construction Exclusion Zone based on the Root Protection Area of a tree. The Root Protection Area of each tree or group is marked on the Tree Constraints Plan at **Appendix 5**.

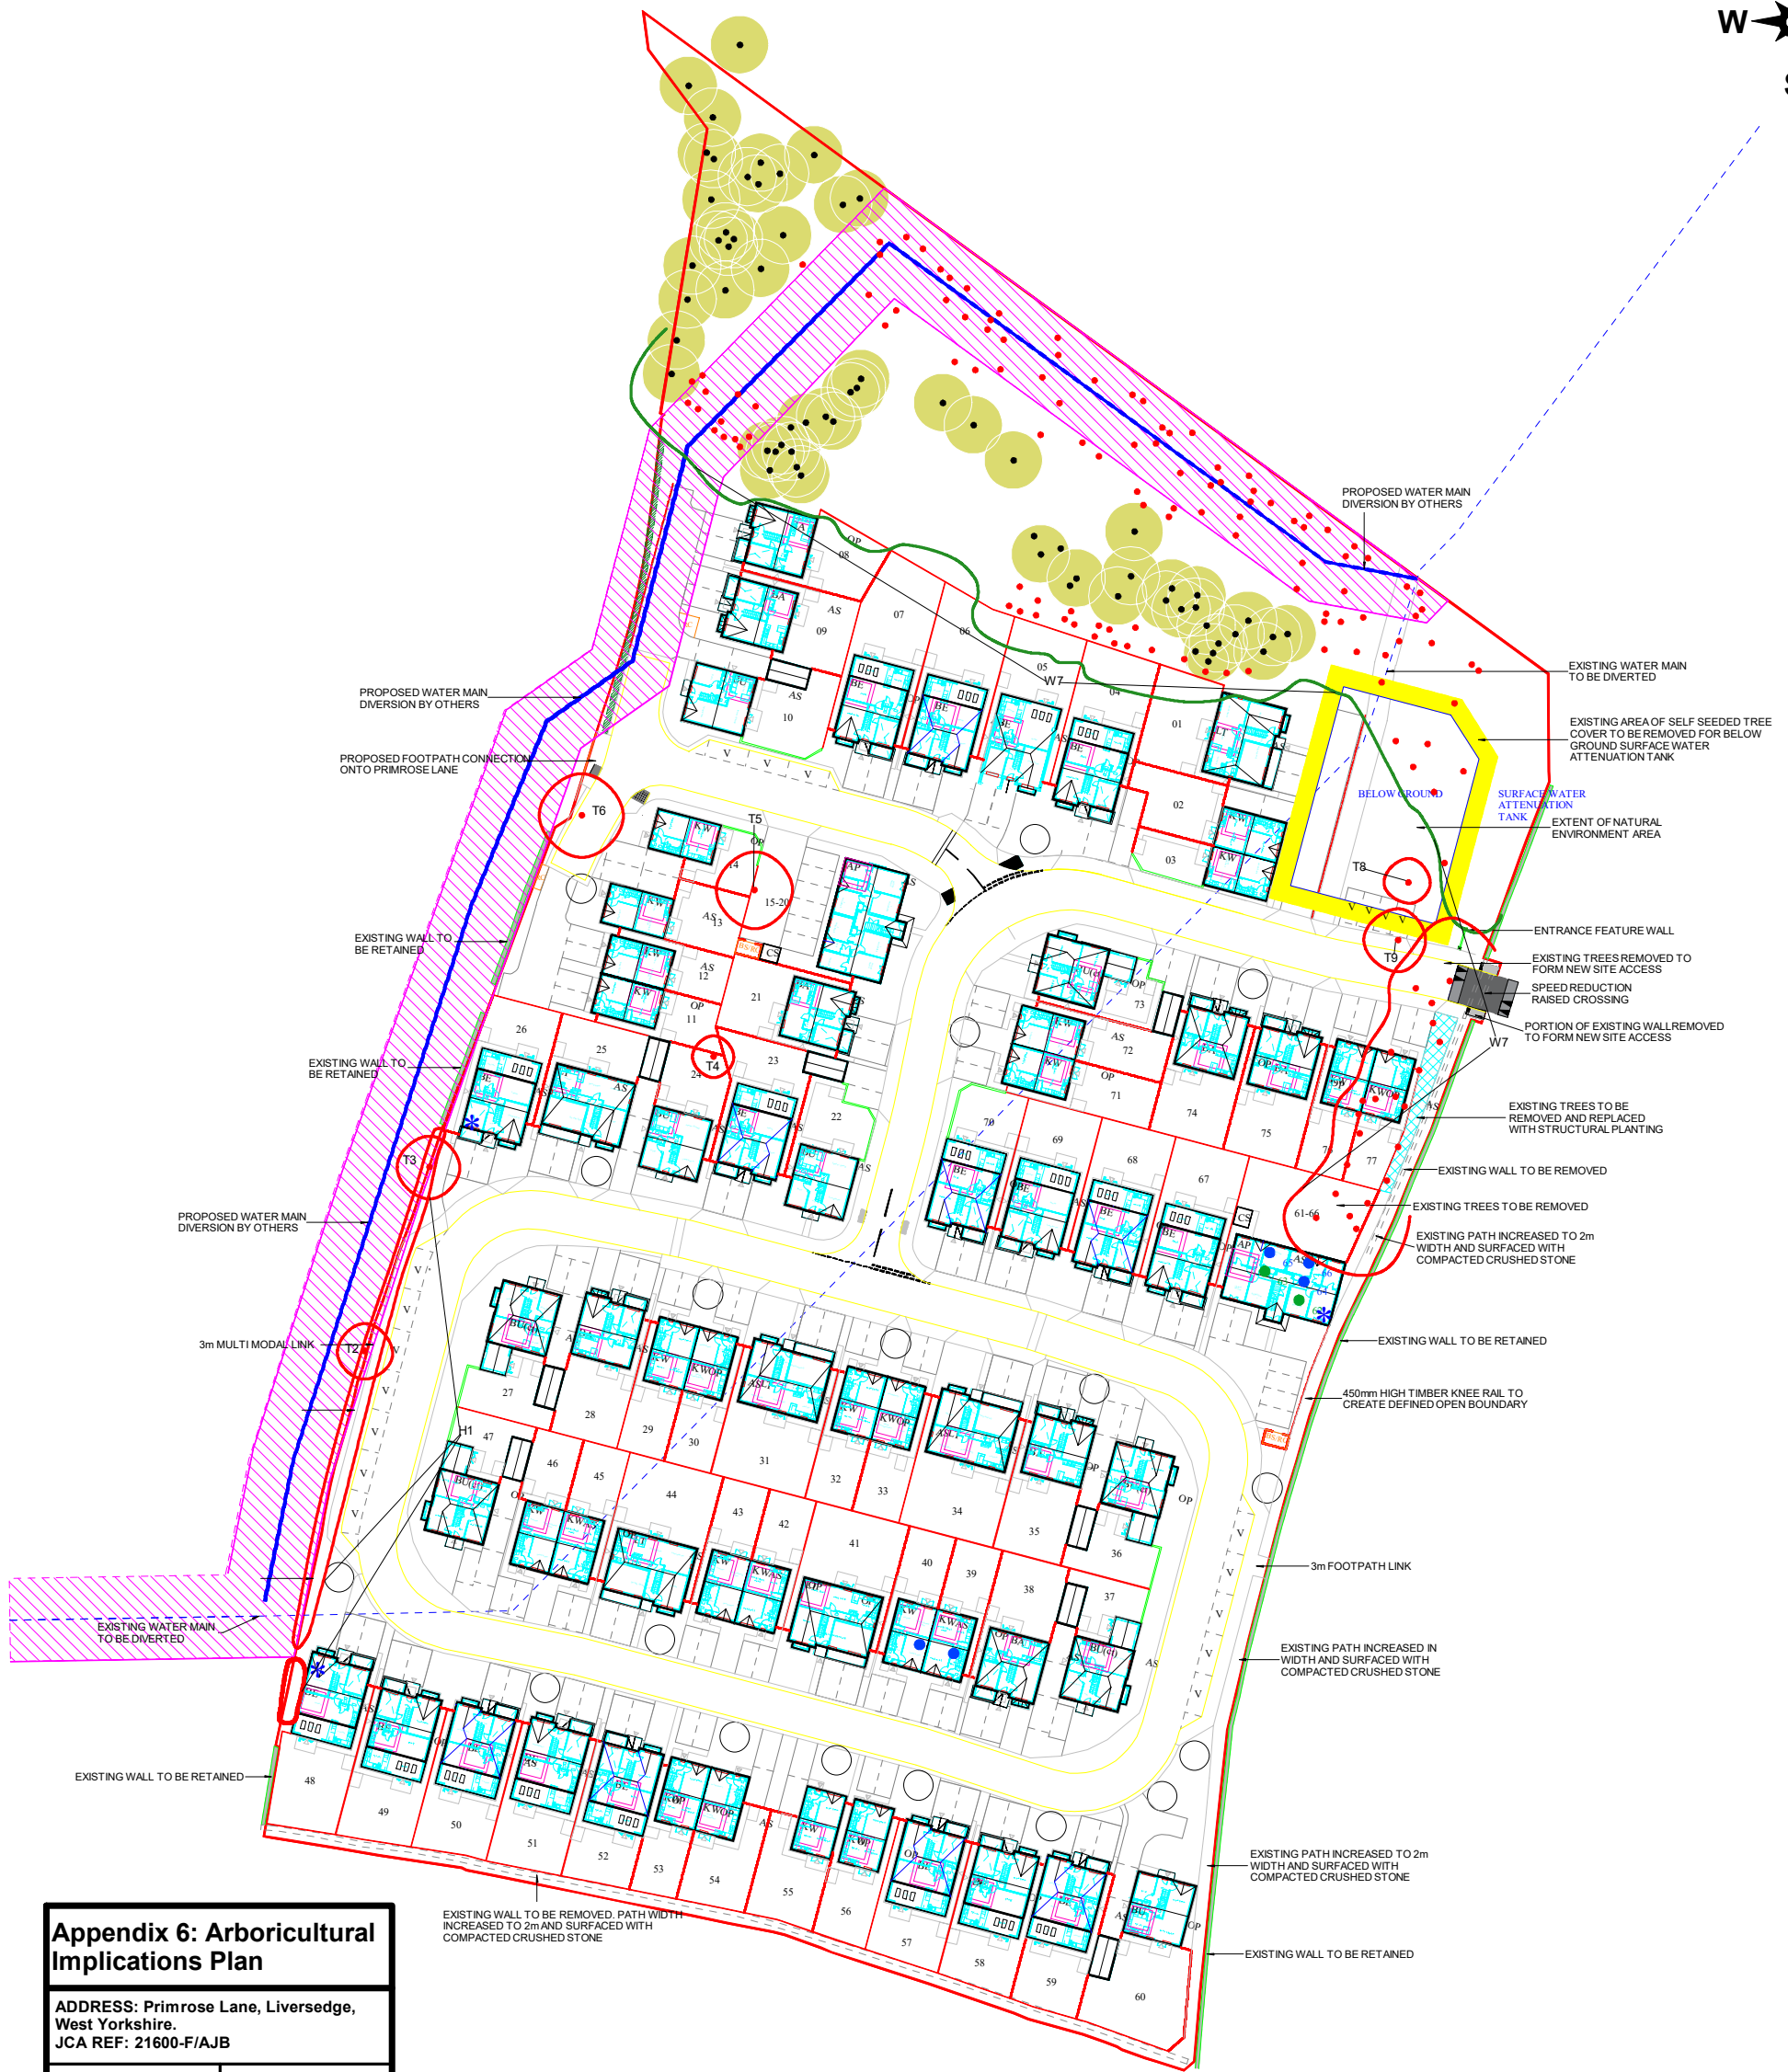
**Appendix 6: Arboricultural Implications Plan**

- 3.2.1 To facilitate the proposed development, it will be necessary to remove **H1, T2, T3, T4, T5, T6**, approximately **136** trees within **W7, T8** and **T9**. Of these, **W7** falls into retention category 'A', **H1, T2, T3, T5** and **T6** fall into retention category 'B' and **T4** and **T9** fall into retention category 'C'.
- 3.2.2 Whilst the development will require the removal of many trees within the site, it should be noted that a planting scheme is included within the proposals. This will act to mitigate tree losses, improve the visual benefits of the site and will improve the localised tree stock.

- 1.3.1 This report is compiled in accordance with *BS 5837:2012 'Trees in relation to design, demolition and construction – Recommendations'* and is based on an objective assessment of the existing vegetation.
- 1.3.2 The specific design of the proposed development has been considered within the Arboricultural Implication Assessment in **Section 3** and is detailed on the Arboricultural Implications Plan at **Appendix 6**.

- 4.3 The arboricultural implications of the development have been considered and are discussed in **Section 3**.
- 4.4 A number of trees require removal in order to facilitate the proposed development. Tree works required to accommodate the proposals are detailed in *italics* in the tables at **Appendix 1**. Those trees requiring removal are shown in **red** on the Arboricultural Implications Plan at **Appendix 6**, where the proposals can also be viewed.
