| Site Air Test Certificate Ref: | ST/26/7/1/MH1 | Date of Issue: | 01/07/2026 | Page 1 of 5 |

### Air Testing

| | <b>Description of reason for test (including the nature and extent of ACMs removed):</b> | Reassurance Air Test following removal of Bitumen Adhesive to Floor and Textured Coating from Ceilings (Concrete) and Textured Coating to Concrete Walls and Ceiling to Corridors |

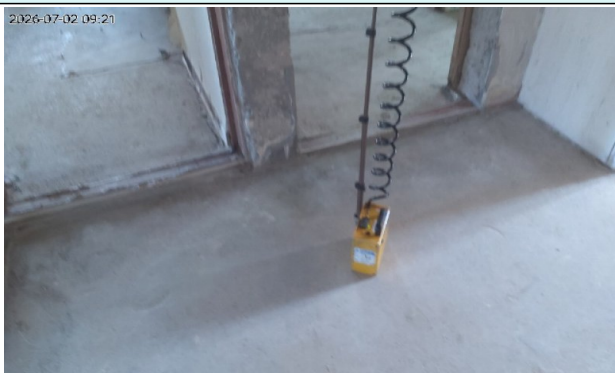
#### Sampling pump (sample ref: 26/7/A/1/MH1)

| 26/7/A/1/MH1 | HFNE 10 | 6A | N/A | N/A | 8.5 | 09:15 | - | --:-- | 8.5 | 10:16 |

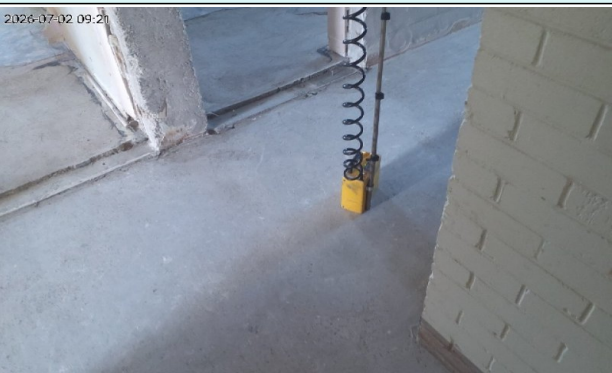
#### Sampling pump (sample ref: 26/7/A/1/MH2)

| 26/7/A/1/MH2 | HFNE 21 | 6B | N/A | N/A | 8.5 | 09:16 | - | --:-- | 8.5 | 10:17 |

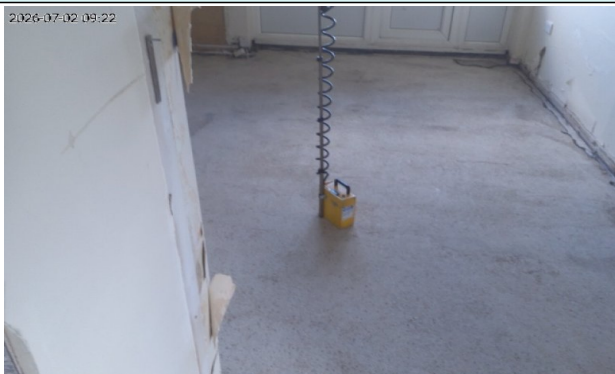
#### Sampling pump (sample ref: 26/7/A/1/MH3)

| 26/7/A/1/MH3 | HFNE 22 | 6C | N/A | N/A | 8.5 | 09:17 | - | --:-- | 8.5 | 10:18 |

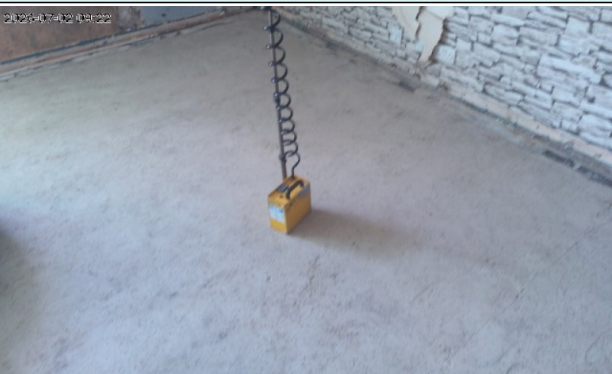
#### Sampling pump (sample ref: 26/7/A/1/MH4)

| 26/7/A/1/MH4 | HFNE 23 | 6D | N/A | N/A | 8.5 | 09:18 | - | --:-- | 8.5 | 10:19 |

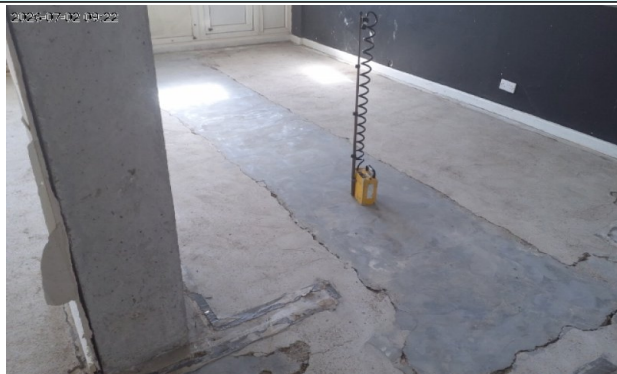
Sampling pump (sample ref: 26/7/A/1/MH5)

| 26/7/A/1/MH5 | HFNE 25 | 6E | N/A | N/A | 8.5 | 09:19 | - | --:-- | 8.5 | 10:20 |

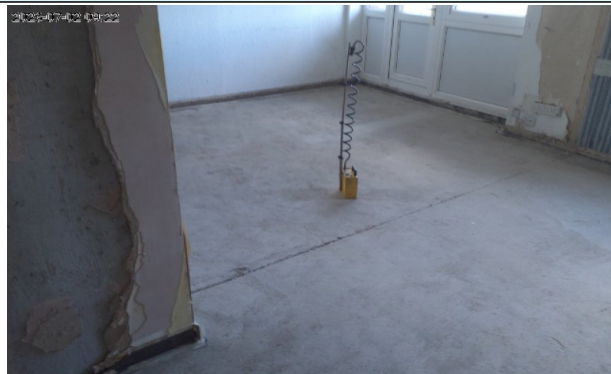
Sampling pump (sample ref: 26/7/A/1/MH6)

| 26/7/A/1/MH6 | HFNE 26 | 6F | N/A | N/A | 8.5 | 09:21 | - | --:-- | 8.5 | 10:22 |
