| Site Air Test Certificate Ref: | ST/26/6/26/MH2 | Date of Issue: | 26/06/2026 | Page 1 of 5 |

| <b>Area Assessed:</b> | Thirteenth Floor of Block of Flats |
| <b>Description of reason for test (including the nature and extent of ACMs removed):</b> | Reassurance Air Test following removal of Bitumen Adhesive to Floor and Textured Coating to Concrete Ceilings and Walls |

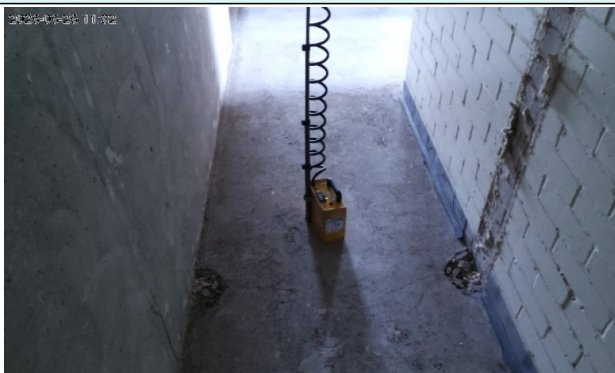
#### Sampling pump (sample ref: 26/6/A/26/MH8)

| 26/6/A/26/MH8 | HFNE 10 | 6A | N/A | N/A | 8.5 | 11:25 | - | --:-- | 8.5 | 12:26 |

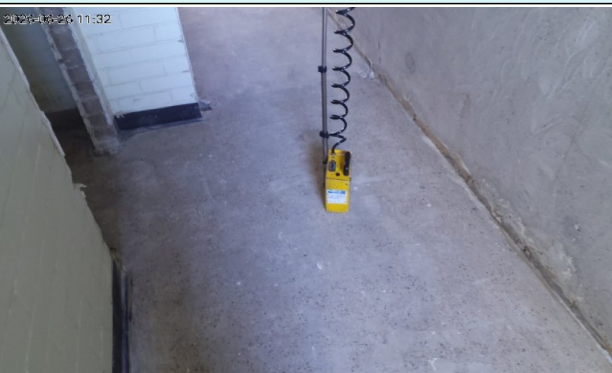
#### Sampling pump (sample ref: 26/6/A/26/MH9)

| 26/6/A/26/MH9 | HFNE 21 | 6B | N/A | N/A | 8.5 | 11:26 | - | --:-- | 8.5 | 12:27 |

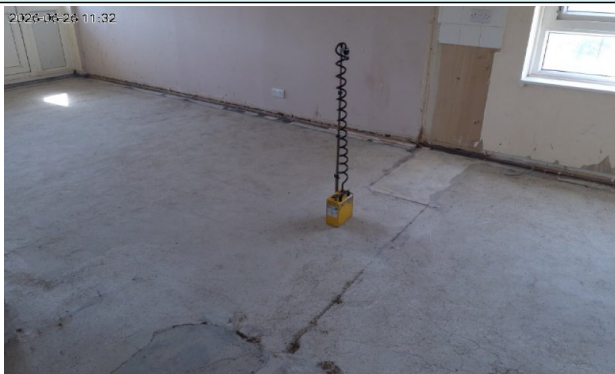
#### Sampling pump (sample ref: 26/6/A/26/MH10)

| 26/6/A/26/MH10 | HFNE 25 | 6C | N/A | N/A | 8.5 | 11:27 | - | --:-- | 8.5 | 12:28 |

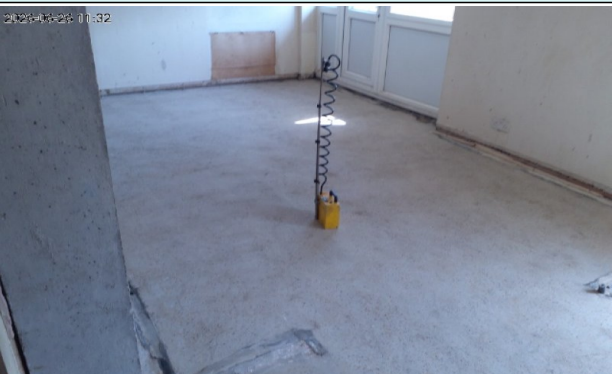
#### Sampling pump (sample ref: 26/6/A/26/MH11)

| 26/6/A/26/MH11 | HFNE 22 | 6D | N/A | N/A | 8.5 | 11:28 | - | --:-- | 8.5 | 12:29 |

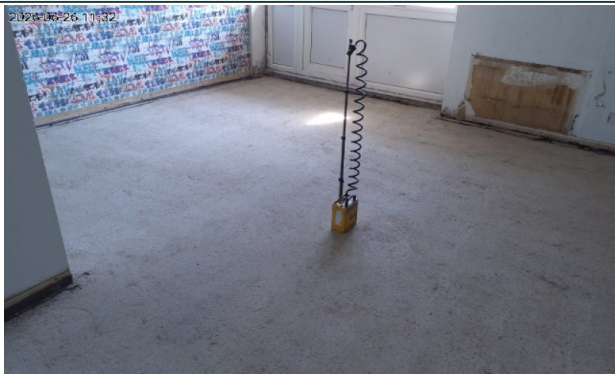
Sampling pump (sample ref: 26/6/A/26/MH12)

| 26/6/A/26/MH12 | HFNE 23 | 6E | N/A | N/A | 8.5 | 11:29 | - | --:-- | 8.5 | 12:30 |

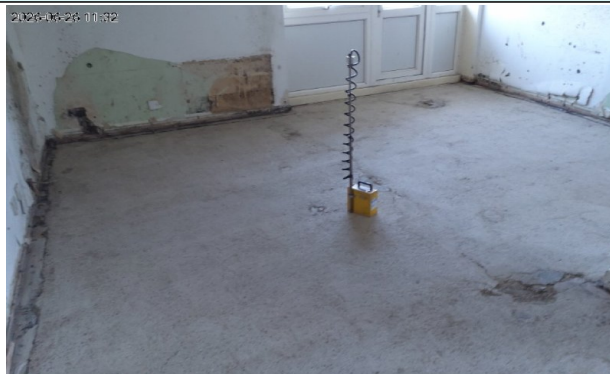
Sampling pump (sample ref: 26/6/A/26/MH13)

| 26/6/A/26/MH13 | HFNE 26 | 6F | N/A | N/A | 8.5 | 11:30 | - | --:-- | 8.5 | 12:31 |
