| Site Air Test Certificate Ref: | ST/26/6/26/MH1 | Date of Issue: | 26/06/2026 | Page 1 of 5 |

| <b>Area Assessed:</b> | Fourteenth Floor of Block of Flats |
| <b>Description of reason for test (including the nature and extent of ACMs removed):</b> | Reassurance Air Test following removal of Bitumen Adhesive to Floor and Textured Coating from Ceilings (Concrete) and Textured Coating to Concrete Walls and Ceiling to Corridors |

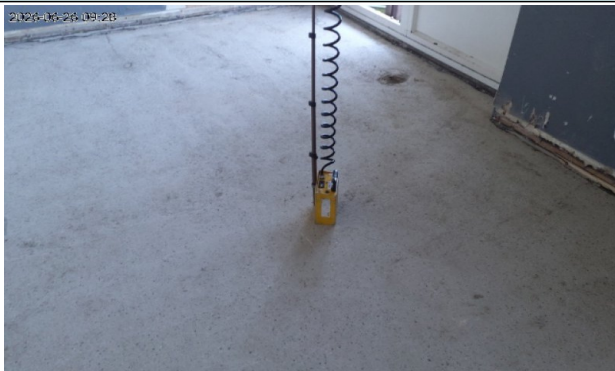
#### Sampling pump (sample ref: 26/6/A/26/MH1)

| 26/6/A/26/MH1 | HFNE 10 | 6A | N/A | N/A | 8.5 | 09:22 | - | --:-- | 8.5 | 10:23 |

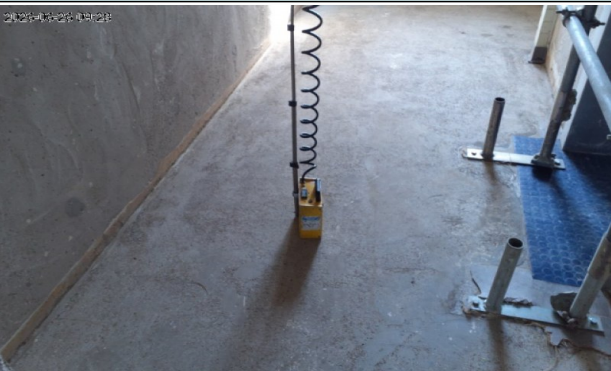
#### Sampling pump (sample ref: 26/6/A/26/MH2)

| 26/6/A/26/MH2 | HFNE 21 | 6B | N/A | N/A | 8.5 | 09:23 | - | --:-- | 8.5 | 10:24 |

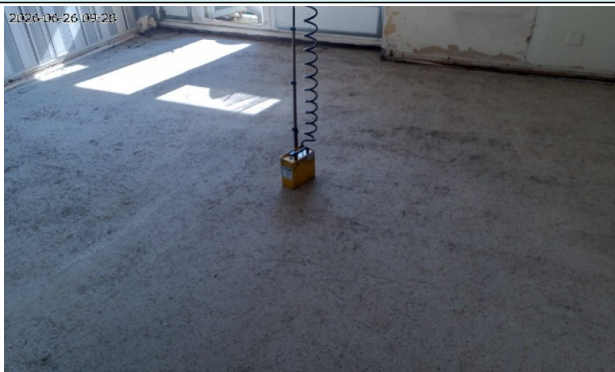
#### Sampling pump (sample ref: 26/6/A/26/MH3)

| 26/6/A/26/MH3 | HFNE 22 | 6C | N/A | N/A | 8.5 | 09:24 | - | --:-- | 8.5 | 10:25 |

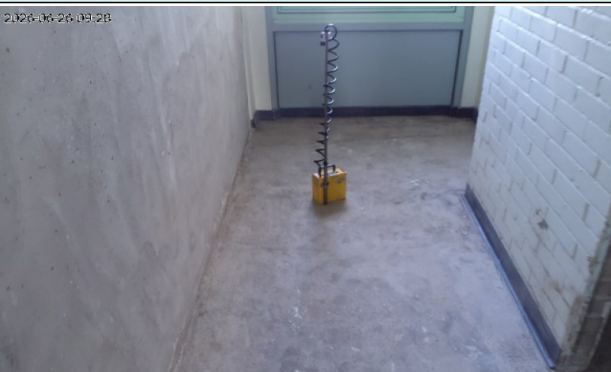
#### Sampling pump (sample ref: 26/6/A/26/MH4)

| 26/6/A/26/MH4 | HFNE 23 | 6D | N/A | N/A | 8.5 | 09:25 | - | --:-- | 8.5 | 10:26 |

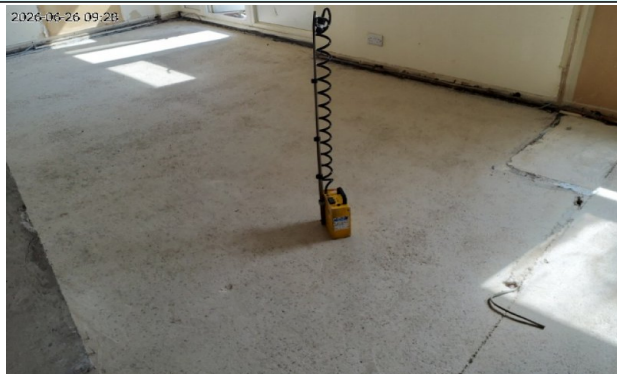
Sampling pump (sample ref: 26/6/A/26/MH5)

| 26/6/A/26/MH5 | HFNE 25 | 6E | N/A | N/A | 8.5 | 09:26 | - | --:-- | 8.5 | 10:27 |

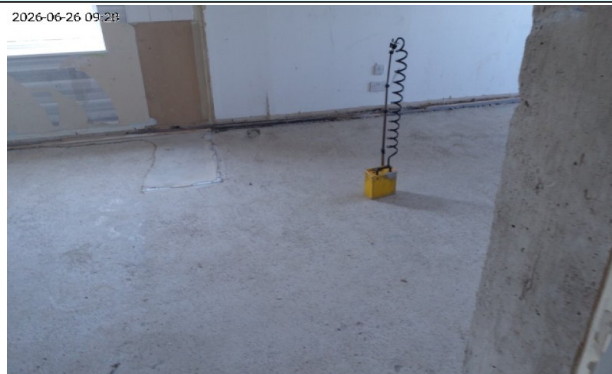
Sampling pump (sample ref: 26/6/A/26/MH6)

| 26/6/A/26/MH6 | HFNE 26 | 6F | N/A | N/A | 8.5 | 09:27 | - | --:-- | 8.5 | 10:28 |
