| Site Air Test Certificate Ref: | ST/26/6/12/MH1 | Date of Issue: | 12/06/2026 | Page 1 of 5 |

### Air Testing

| | <b>Area Assessed:</b> | Sixteenth Floor of Block of Flats |
| | <b>Description of reason for test (including the nature and extent of ACMs removed):</b> | Reassurance Air Test following removal of Bitumen Adhesive to Floor and Textured Coating from Ceilings (Concrete to Corridors and Plasterboard to Flats) and Textured Coating to Concrete Walls and Corridors |

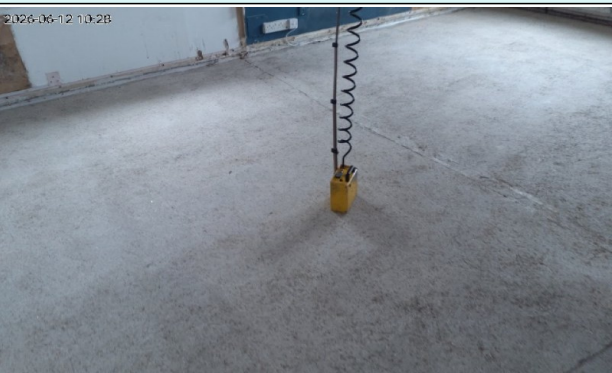
#### Sampling pump (sample ref: 26/6/A/12/MH2)

| 26/6/A/12/MH2 | HFNE 13 | 6B | N/A | N/A | 8.5 | 10:22 | - | --:-- | 8.5 | 11:23 |

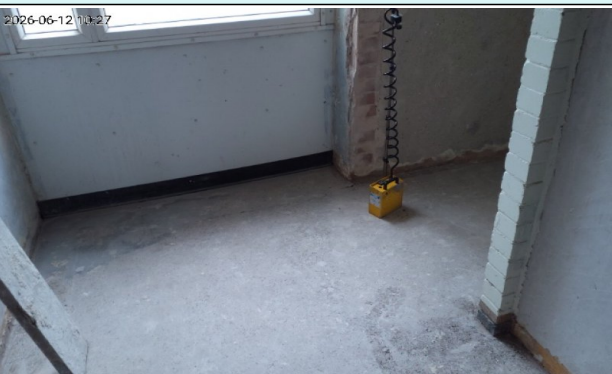
#### Sampling pump (sample ref: 26/6/A/12/MH4)

| 26/6/A/12/MH4 | HFNE 23 | 6D | N/A | N/A | 8.5 | 10:24 | - | --:-- | 8.5 | 11:25 |

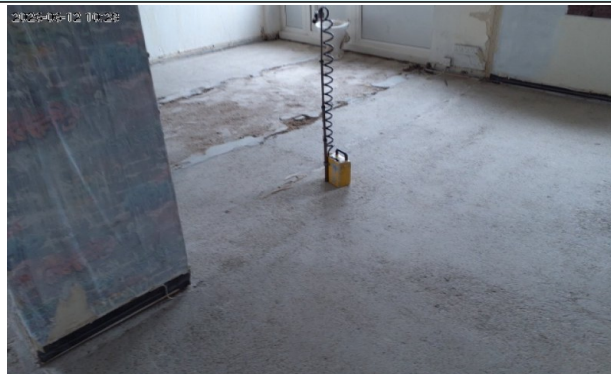
Sampling pump (sample ref: 26/6/A/12/MH6)

| 26/6/A/12/MH6 | HFNE 26 | 6F | N/A | N/A | 8.5 | 10:26 | - | --:-- | 8.5 | 11:27 |
