| Site Air Test Certificate Ref: | ST/26/9/28/GBR1 | Date of Issue: | 28/09/2026 | Page 1 of 6 |

| <b>Site:</b><br>Bishops Court<br>Floors 15 + 16<br>Huddersfield<br>HD4 7PL | <b>Client:</b><br>One Group Solutions Ltd<br>Newtown Road<br>Marlow<br>Buckinghamshire<br>SL7 1LQ | <b>Contractor:</b><br>One Group Solutions<br>Newtown Road<br>Marlow<br>Buckinghamshire<br>SL7 1LQ |

### Purpose of Test

| | <b>Description of reason for test (including the nature and extent of ACMs removed):</b> | Reassurance air monitoring following the removal of textured coating | | |

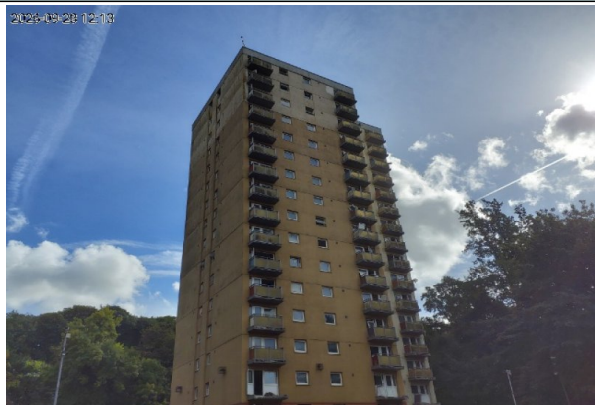
| | <b>Area Assessed:</b> | Floors 15 + 16 | | |

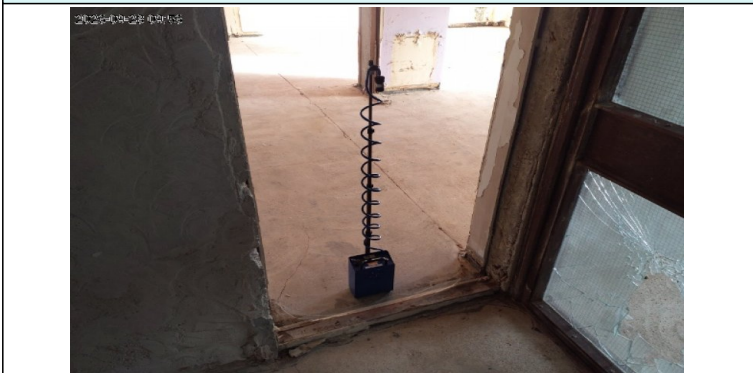
Sampling pump (sample ref: 26/9/A/28/CBR1)

| Sample Number | Pump No. | Head No. | Temp | Pressure | Start Flow | Start Time | Interim Flow | Interim Time | End Flow | End Time |
|---|---|---|---|---|---|---|---|---|---|---|
| 26/9/A/28/CBR1 | AHFSY16 | 9A | N/A | N/A | 8.4 | 09:18 | - | --:-- | 8.4 | 10:18 |

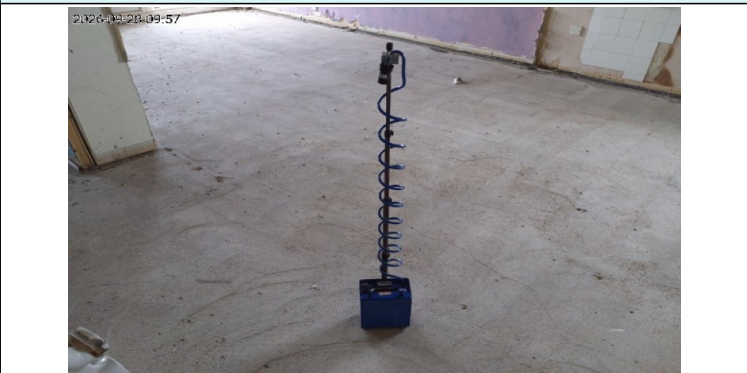
Sampling pump (sample ref: 26/9/A/28/CBR2)

| Sample Number | Pump No. | Head No. | Temp | Pressure | Start Flow | Start Time | Interim Flow | Interim Time | End Flow | End Time |
|---|---|---|---|---|---|---|---|---|---|---|
| 26/9/A/28/CBR2 | AHFSY17 | 9B | N/A | N/A | 8.4 | 09:19 | - | --:-- | 8.4 | 10:19 |

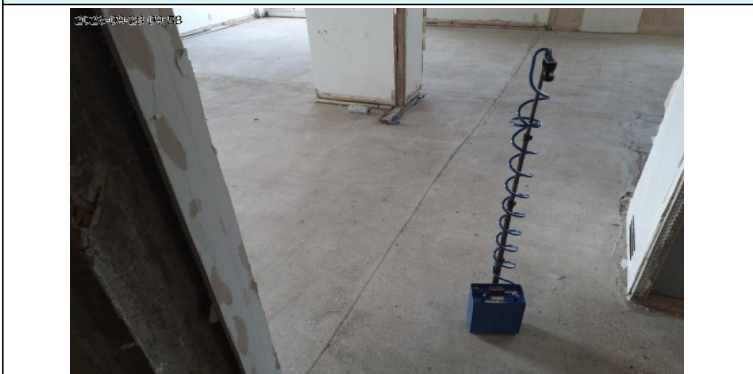
Sampling pump (sample ref: 26/9/A/28/CBR3)

| Sample Number | Pump No. | Head No. | Temp | Pressure | Start Flow | Start Time | Interim Flow | Interim Time | End Flow | End Time |
|---|---|---|---|---|---|---|---|---|---|---|
| 26/9/A/28/CBR3 | AHFSY18 | 9C | N/A | N/A | 8.4 | 09:20 | - | --:-- | 8.4 | 10:20 |

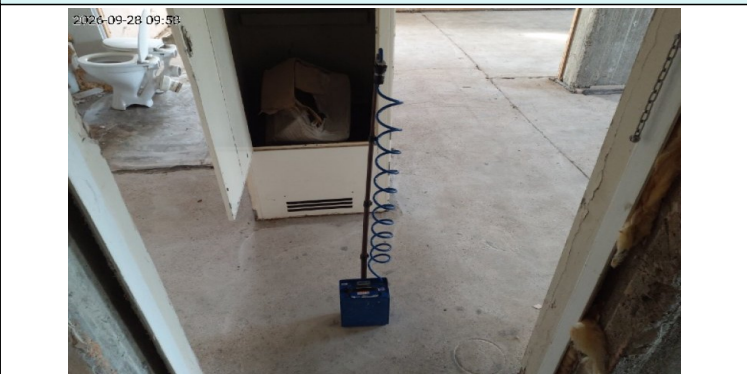
Sampling pump (sample ref: 26/9/A/28/CBR4)

| Sample Number | Pump No. | Head No. | Temp | Pressure | Start Flow | Start Time | Interim Flow | Interim Time | End Flow | End Time |
|---|---|---|---|---|---|---|---|---|---|---|
| 26/9/A/28/CBR4 | AHFSY19 | 9D | N/A | N/A | 8.4 | 09:21 | - | --:-- | 8.4 | 10:21 |

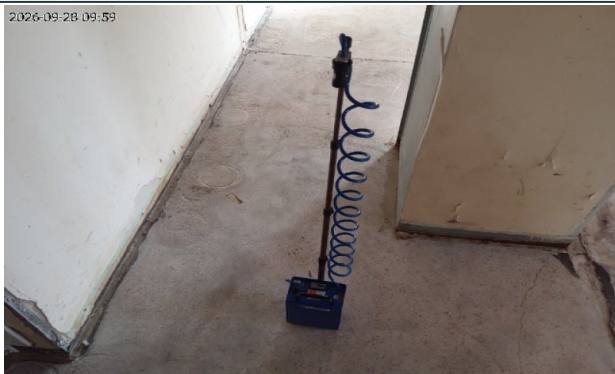
Sampling pump (sample ref: 26/9/A/28/CBR5)

| Sample Number | Pump No. | Head No. | Temp | Pressure | Start Flow | Start Time | Interim Flow | Interim Time | End Flow | End Time |
|---|---|---|---|---|---|---|---|---|---|---|
| 26/9/A/28/CBR5 | AHFSY20 | 9E | N/A | N/A | 8.4 | 09:22 | - | --:-- | 8.4 | 10:22 |

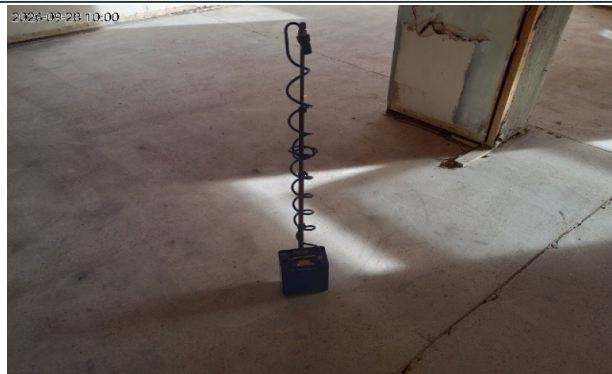
Sampling pump (sample ref: 26/9/A/28/CBR6)

| Sample Number | Pump No. | Head No. | Temp | Pressure | Start Flow | Start Time | Interim Flow | Interim Time | End Flow | End Time |
|---|---|---|---|---|---|---|---|---|---|---|
| 26/9/A/28/CBR6 | AHFSY21 | 9F | N/A | N/A | 8.4 | 09:23 | - | --:-- | 0.0 | 10:23 |

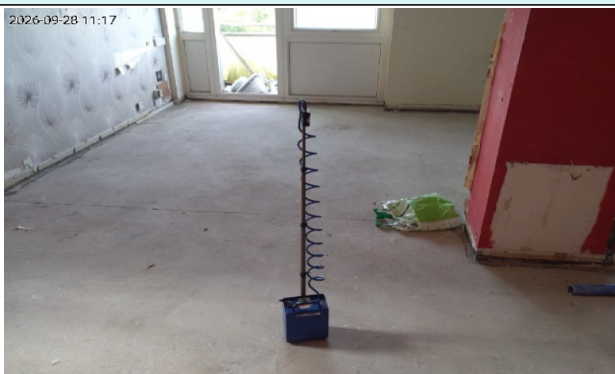
Sampling pump (sample ref: 26/9/A/28/CBR7)

| Sample Number | Pump No. | Head No. | Temp | Pressure | Start Flow | Start Time | Interim Flow | Interim Time | End Flow | End Time |
|---|---|---|---|---|---|---|---|---|---|---|
| 26/9/A/28/CBR7 | AHFSY16 | 9G | N/A | N/A | 8.4 | 11:06 | - | --:-- | 8.4 | 12:06 |

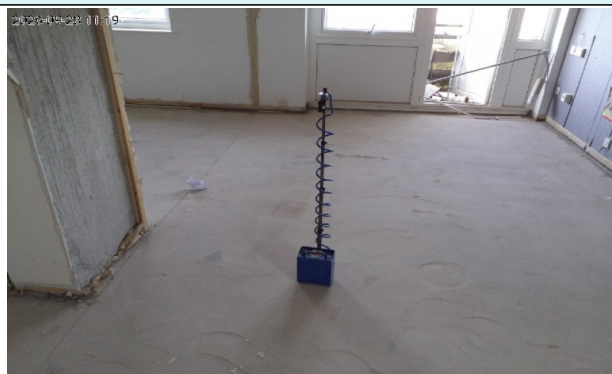
Sampling pump (sample ref: 26/9/A/28/CBR8)

| Sample Number | Pump No. | Head No. | Temp | Pressure | Start Flow | Start Time | Interim Flow | Interim Time | End Flow | End Time |
|---|---|---|---|---|---|---|---|---|---|---|
| 26/9/A/28/CBR8 | AHFSY17 | 9H | N/A | N/A | 8.4 | 11:07 | - | --:-- | 8.4 | 12:07 |

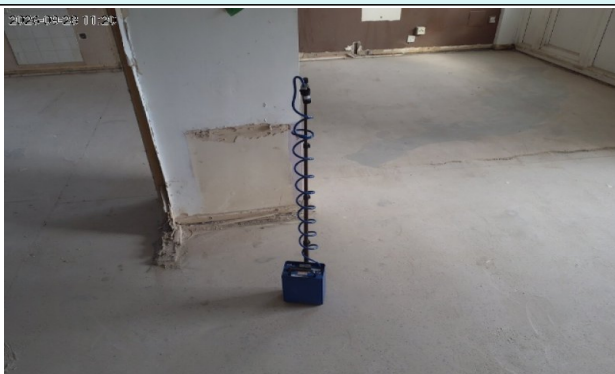
Sampling pump (sample ref: 26/9/A/28/CBR9)

| Sample Number | Pump No. | Head No. | Temp | Pressure | Start Flow | Start Time | Interim Flow | Interim Time | End Flow | End Time |
|---|---|---|---|---|---|---|---|---|---|---|
| 26/9/A/28/CBR9 | AHFSY18 | 9I | N/A | N/A | 8.4 | 11:08 | - | --:-- | 8.4 | 12:08 |

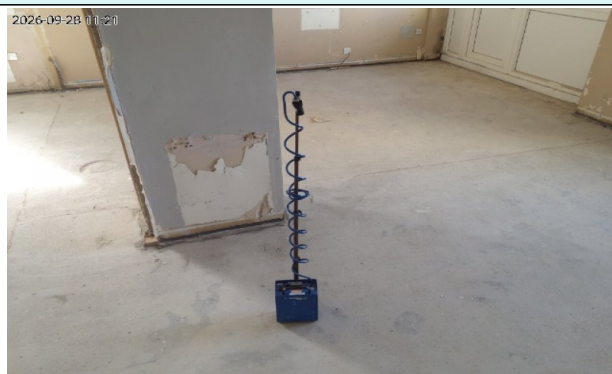
Sampling pump (sample ref: 26/9/A/28/CBR10)

| Sample Number | Pump No. | Head No. | Temp | Pressure | Start Flow | Start Time | Interim Flow | Interim Time | End Flow | End Time |
|---|---|---|---|---|---|---|---|---|---|---|
| 26/9/A/28/CBR10 | AHFSY19 | 9J | N/A | N/A | 8.4 | 11:09 | - | --:-- | 8.4 | 12:09 |

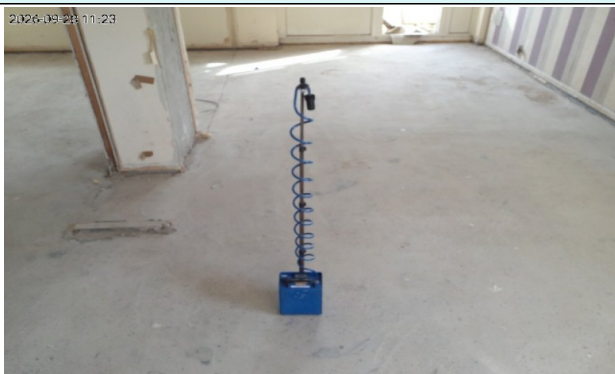
Sampling pump (sample ref: 26/9/A/28/CBR11)

| Sample Number | Pump No. | Head No. | Temp | Pressure | Start Flow | Start Time | Interim Flow | Interim Time | End Flow | End Time |
|---|---|---|---|---|---|---|---|---|---|---|
| 26/9/A/28/CBR11 | AHFSY20 | 9K | N/A | N/A | 8.4 | 11:09 | - | --:-- | 8.4 | 12:09 |

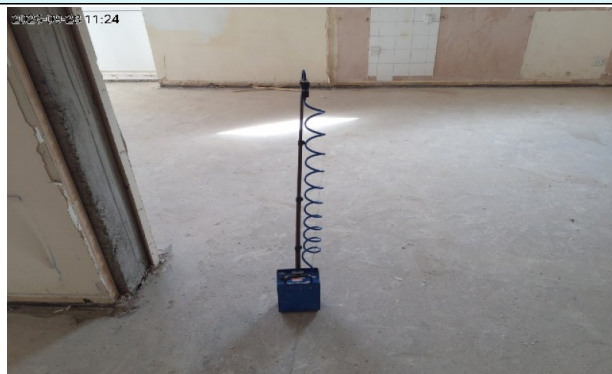
Sampling pump (sample ref: 26/9/A/28/CBR12)

| Sample Number | Pump No. | Head No. | Temp | Pressure | Start Flow | Start Time | Interim Flow | Interim Time | End Flow | End Time |
|---|---|---|---|---|---|---|---|---|---|---|
| 26/9/A/28/CBR12 | AHFSY21 | 9L | N/A | N/A | 8.4 | 11:10 | - | --:-- | 8.4 | 12:10 |
