| Site Air Test Certificate Ref: | ST/26/7/22/MH1 | Date of Issue: | 22/07/2026 | Page 1 of 5 |

| | <b>Area Assessed:</b> | Eighth Floor of Block of Flats |
| | <b>Description of reason for test (including the nature and extent of ACMs removed):</b> | Reassurance Air Test following removal of Bitumen Adhesive to Floor and Textured Coating from Ceilings (Concrete) and Textured Coating to Concrete Walls and Ceiling to Corridors |

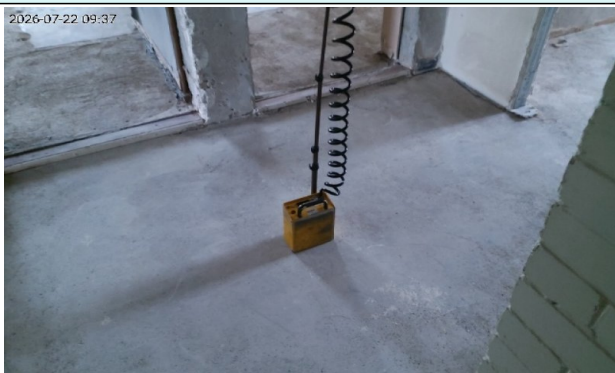
#### Sampling pump (sample ref: 26/7/A/22/MH1)

| 26/7/A/22/MH1 | HFNE 03 | 6A | N/A | N/A | 8.5 | 09:30 | - | --:-- | 8.5 | 10:31 |

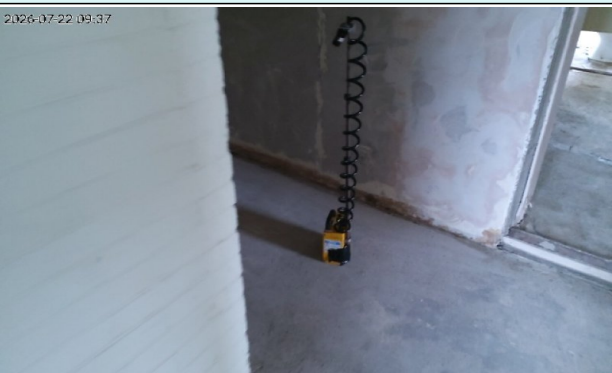
#### Sampling pump (sample ref: 26/7/A/22/MH2)

| 26/7/A/22/MH2 | HFNE 10 | 6B | N/A | N/A | 8.5 | 09:31 | - | --:-- | 8.5 | 10:32 |

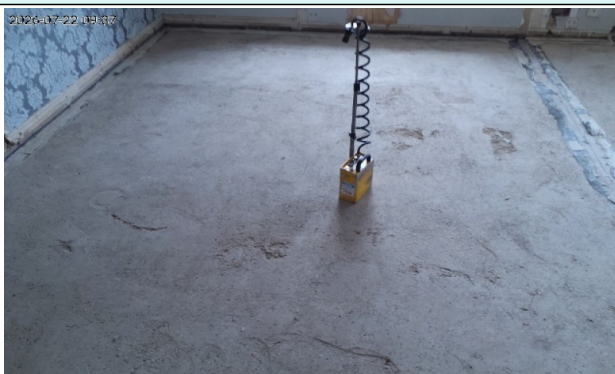
#### Sampling pump (sample ref: 26/7/A/22/MH3)

| 26/7/A/22/MH3 | HFNE 13 | 6C | N/A | N/A | 8.5 | 09:32 | - | --:-- | 8.5 | 10:33 |

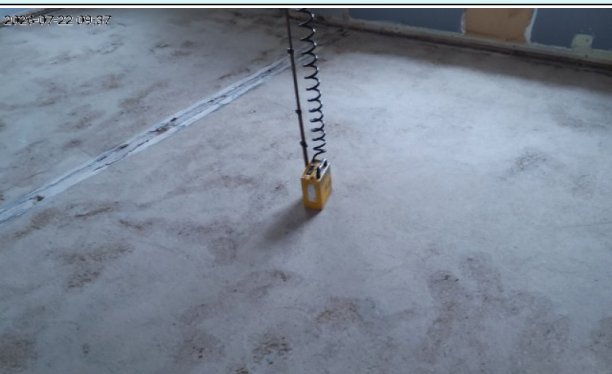
#### Sampling pump (sample ref: 26/7/A/22/MH4)

| 26/7/A/22/MH4 | HFNE 09 | 6D | N/A | N/A | 8.5 | 09:33 | - | --:-- | 8.5 | 10:34 |

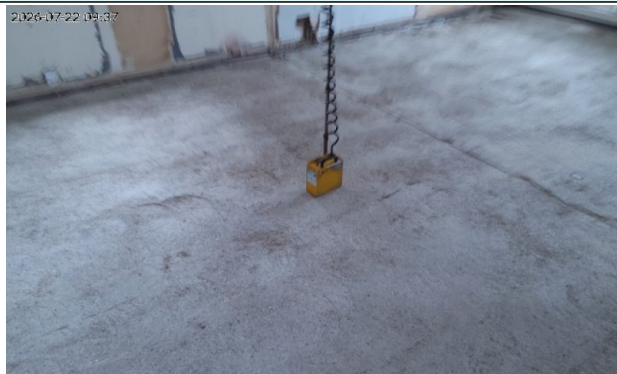
Sampling pump (sample ref: 26/7/A/22/MH5)

| 26/7/A/22/MH5 | HFNE 11 | 6E | N/A | N/A | 8.5 | 09:34 | - | --:-- | 8.5 | 10:35 |

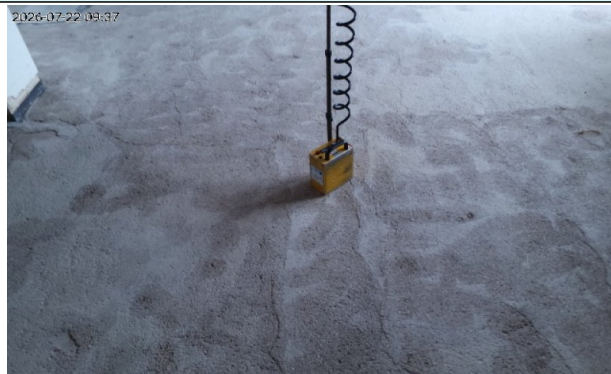
Sampling pump (sample ref: 26/7/A/22/MH6)

| 26/7/A/22/MH6 | HFNE 23 | 6F | N/A | N/A | 8.5 | 09:35 | - | --:-- | 8.5 | 10:36 |
