| Site Air Test Certificate Ref: | ST/26/6/12/MH2 | Date of Issue: | 12/06/2026 | Page 1 of 5 |

| | <b>Area Assessed:</b> | Fifteenth Floor of Block of Flats |
| | <b>Description of reason for test (including the nature and extent of ACMs removed):</b> | Reassurance Air Test following removal of Bitumen Adhesive to Floor and Textured Coating to Concrete Ceilings and Walls |

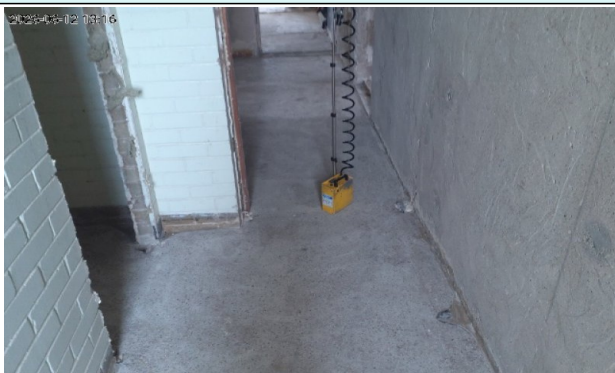
#### Sampling pump (sample ref: 26/6/A/12/MH8)

| 26/6/A/12/MH8 | HFNE 09 | 6A | N/A | N/A | 8.5 | 13:10 | - | --:-- | 8.5 | 14:11 |

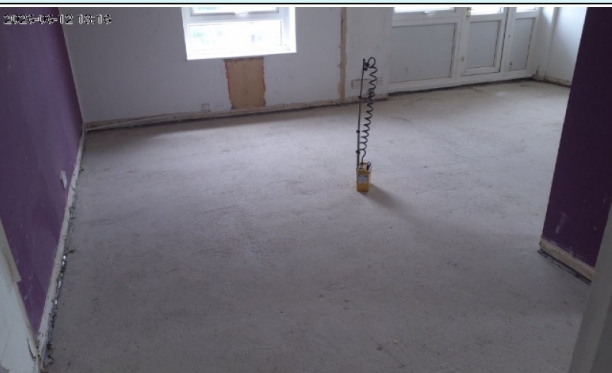
#### Sampling pump (sample ref: 26/6/A/12/MH9)

| 26/6/A/12/MH9 | HFNE 13 | 6B | N/A | N/A | 8.5 | 13:11 | - | --:-- | 8.5 | 14:12 |

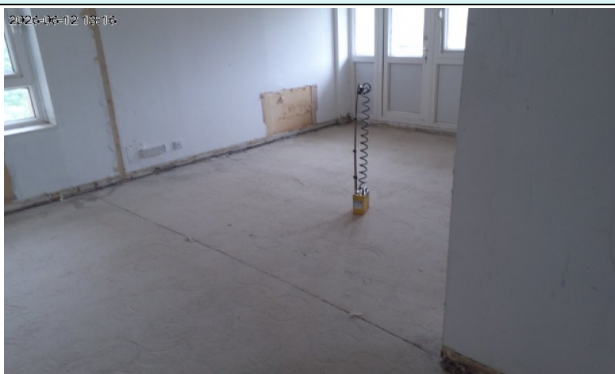
#### Sampling pump (sample ref: 26/6/A/12/MH10)

| 26/6/A/12/MH10 | HFNE 21 | 6C | N/A | N/A | 8.5 | 13:12 | - | --:-- | 8.5 | 14:13 |

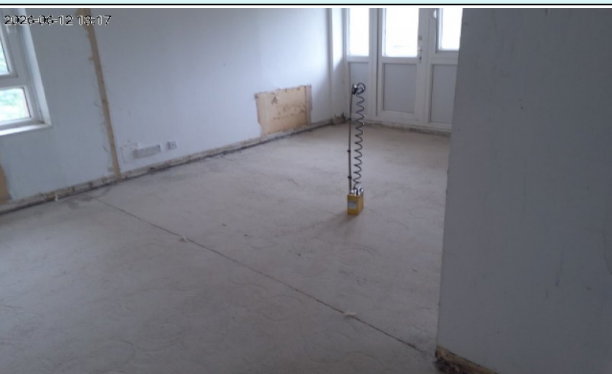
#### Sampling pump (sample ref: 26/6/A/12/MH11)

| 26/6/A/12/MH11 | HFNE 23 | 6D | N/A | N/A | 8.5 | 13:13 | - | --:-- | 8.5 | 14:14 |

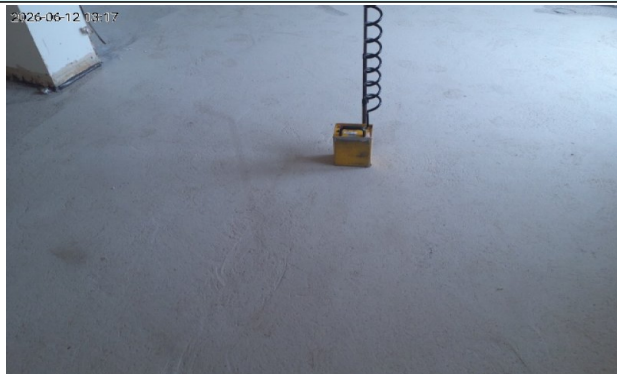
Sampling pump (sample ref: 26/6/A/12/MH12)

| 26/6/A/12/MH12 | HFNE 25 | 6E | N/A | N/A | 8.5 | 13:14 | - | --:-- | 8.5 | 14:15 |

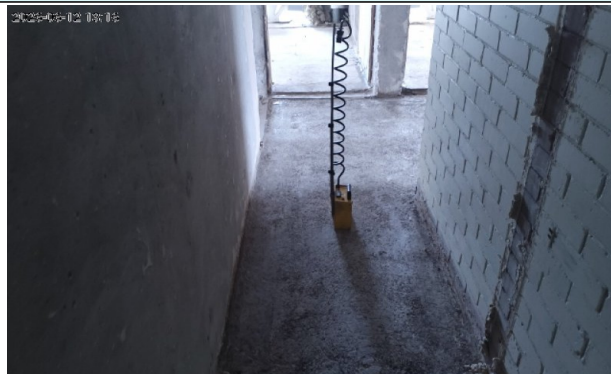
Sampling pump (sample ref: 26/6/A/12/MH13)

| 26/6/A/12/MH13 | HFNE 26 | 6F | N/A | N/A | 8.5 | 13:15 | - | --:-- | 8.5 | 14:16 |
