| Site Air Test Certificate Ref: | ST/26/7/24/MH2 | Date of Issue: | 24/07/2026 | Page 1 of 5 |

### Air Testing

| | <b>Area Assessed:</b> | First Floor of Block of Flats |
| | <b>Description of reason for test (including the nature and extent of ACMs removed):</b> | Reassurance Air Test following removal of Bitumen Adhesive to Floor and Textured Coating to Concrete Ceilings and Walls |

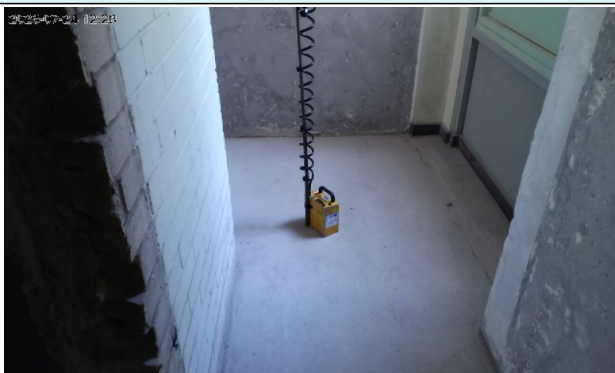
#### Sampling pump (sample ref: 26/7/A/24/MH8)

| 26/7/A/24/MH8 | HFNE 03 | 6A | N/A | N/A | 8.5 | 12:21 | - | --:-- | 8.5 | 13:22 |

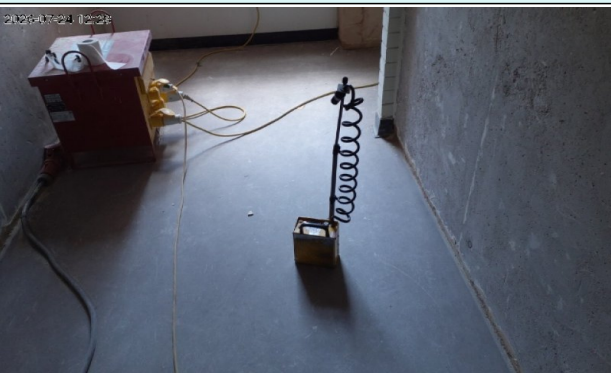
#### Sampling pump (sample ref: 26/7/A/24/MH9)

| 26/7/A/24/MH9 | HFNE 09 | 6B | N/A | N/A | 8.5 | 12:22 | - | --:-- | 8.5 | 13:23 |

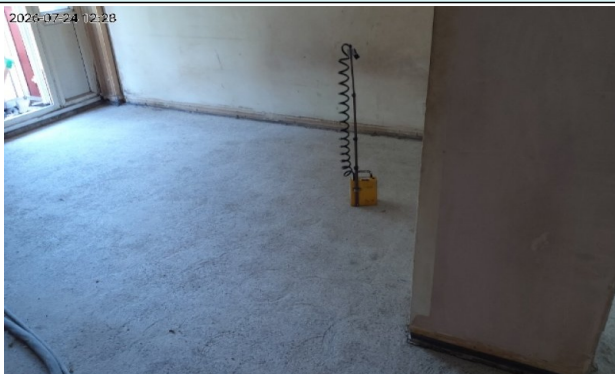
#### Sampling pump (sample ref: 26/7/A/24/MH10)

| 26/7/A/24/MH10 | HFNE 10 | 6C | N/A | N/A | 8.5 | 12:23 | - | --:-- | 8.5 | 13:24 |

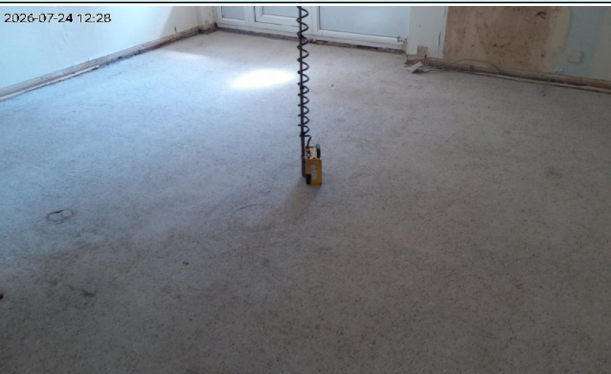
#### Sampling pump (sample ref: 26/7/A/24/MH11)

| 26/7/A/24/MH11 | HFNE 11 | 6D | N/A | N/A | 8.5 | 12:24 | - | --:-- | 8.5 | 13:25 |

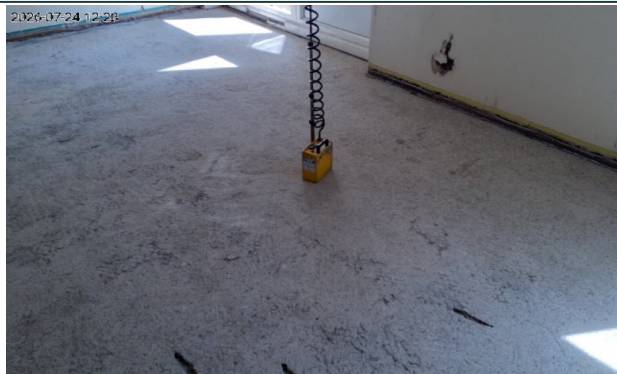
Sampling pump (sample ref: 26/7/A/24/MH12)

| 26/7/A/24/MH12 | HFNE 23 | 6E | N/A | N/A | 8.5 | 12:25 | - | --:-- | 8.5 | 13:26 |

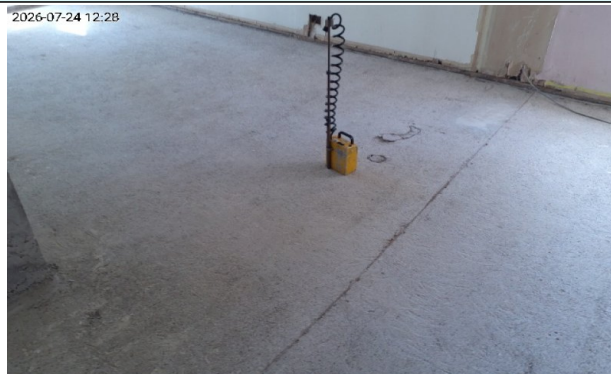
Sampling pump (sample ref: 26/7/A/24/MH13)

| 26/7/A/24/MH13 | HFNE 13 | 6F | N/A | N/A | 8.5 | 12:26 | - | --:-- | 8.5 | 13:27 |
