| Site Air Test Certificate Ref: | ST/26/6/26/MH1 | Date of Issue: | 26/06/2026 | Page 1 of 5 |

| <b>Area Assessed:</b> | Fourteenth Floor of Block of Flats |
| <b>Description of reason for test (including the nature and extent of ACMs removed):</b> | Reassurance Air Test following removal of Bitumen Adhesive to Floor and Textured Coating from Ceilings (Concrete) and Textured Coating to Concrete Walls and Ceiling to Corridors |

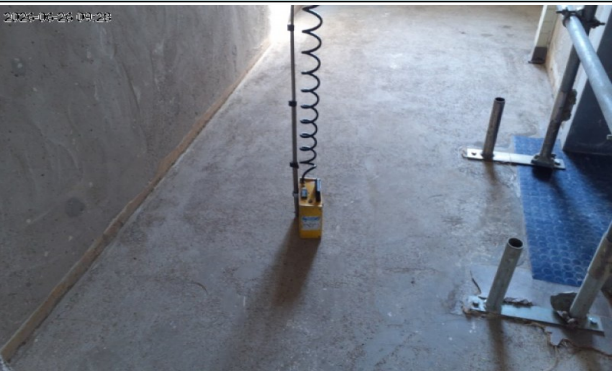
#### Sampling pump (sample ref: 26/6/A/26/MH2)

| Sample Number | Pump No. | Head No. | Temp | Pressure | Start Flow | Start Time | Interim Flow | Interim Time | End Flow | End Time |
|---|---|---|---|---|---|---|---|---|---|---|
| 26/6/A/26/MH2 | HFNE 21 | 6B | N/A | N/A | 8.5 | 09:23 | - | --:-- | 8.5 | 10:24 |

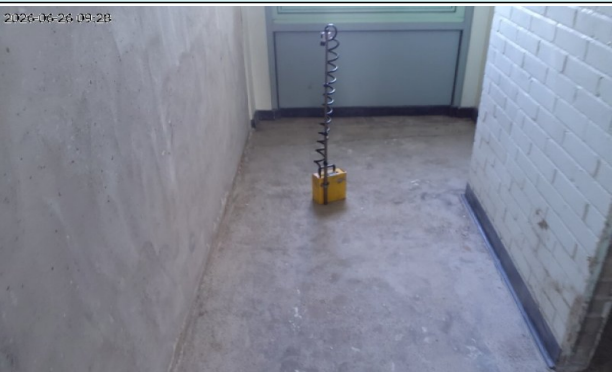
#### Sampling pump (sample ref: 26/6/A/26/MH4)

| Sample Number | Pump No. | Head No. | Temp | Pressure | Start Flow | Start Time | Interim Flow | Interim Time | End Flow | End Time |
|---|---|---|---|---|---|---|---|---|---|---|
| 26/6/A/26/MH4 | HFNE 23 | 6D | N/A | N/A | 8.5 | 09:25 | - | --:-- | 8.5 | 10:26 |
