| Site Air Test Certificate Ref: | ST/26/7/22/MH2 | Date of Issue: | 22/07/2026 | Page 1 of 5 |

**Note:** Inspection undertaken in accordance with APEC in-house Methods QCRF2, OH1 and OH2, based on the HSE publication HSG 248 'The Analysts Guide'

| | <b>Description of reason for test (including the nature and extent of ACMs removed):</b> | Reassurance Air Test following removal of Bitumen Adhesive to Floor and Textured Coating to Concrete Ceilings and Walls |

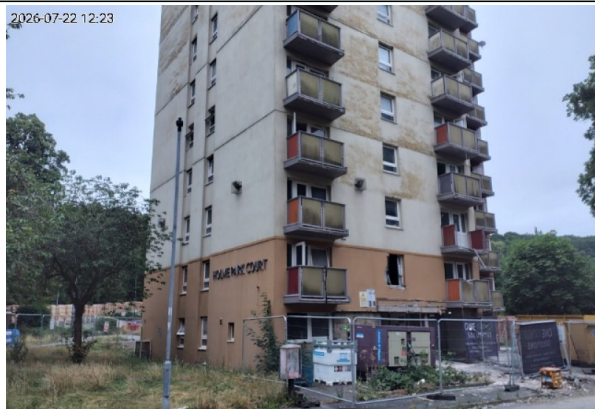
| | <b>Area Assessed:</b> | Seventh Floor of Block of Flats |

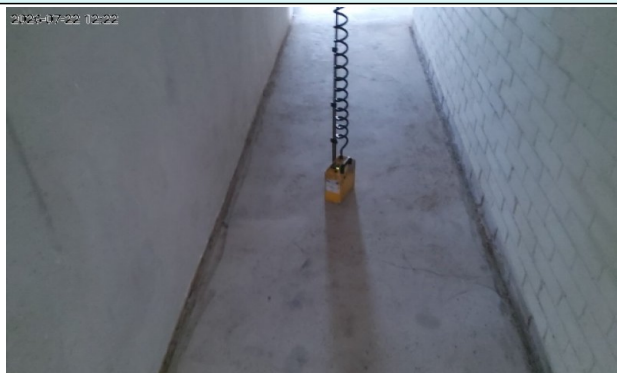
#### Sampling pump (sample ref: 26/7/A/22/MH8)

| 26/7/A/22/MH8 | HFNE 03 | 6A | N/A | N/A | 8.5 | 12:15 | - | --:-- | 8.5 | 13:16 |

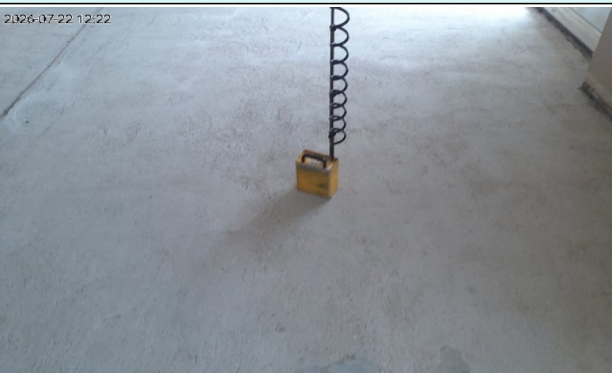
#### Sampling pump (sample ref: 26/7/A/22/MH9)

| 26/7/A/22/MH9 | HFNE 10 | 6B | N/A | N/A | 8.5 | 12:16 | - | --:-- | 8.5 | 13:17 |

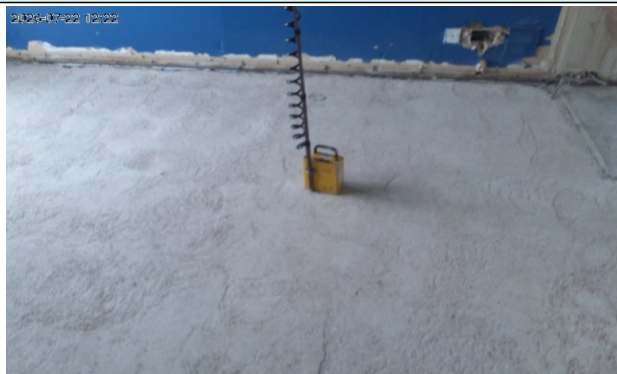
#### Sampling pump (sample ref: 26/7/A/22/MH10)

| 26/7/A/22/MH10 | HFNE 13 | 6C | N/A | N/A | 8.5 | 12:17 | - | --:-- | 8.5 | 13:18 |

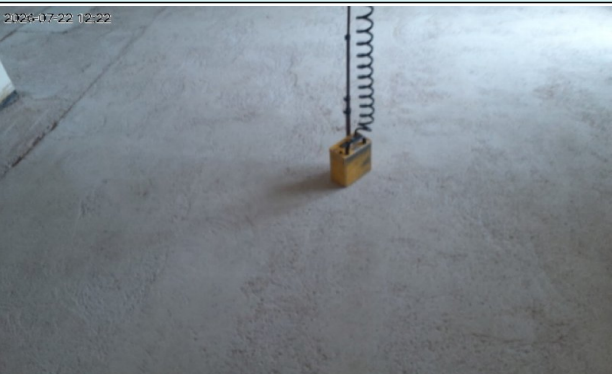
#### Sampling pump (sample ref: 26/7/A/22/MH11)

| 26/7/A/22/MH11 | HFNE 09 | 6D | N/A | N/A | 8.5 | 12:18 | - | --:-- | 8.5 | 13:19 |

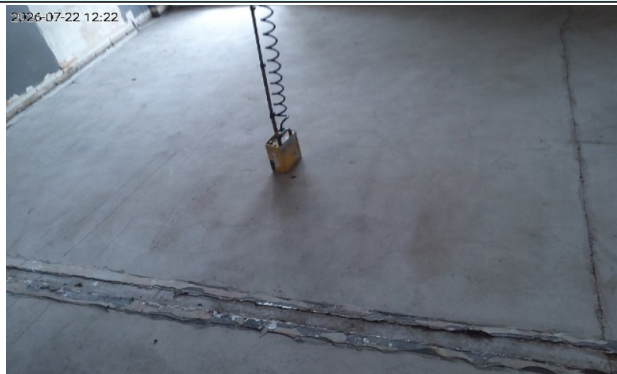
Sampling pump (sample ref: 26/7/A/22/MH12)

| 26/7/A/22/MH12 | HFNE 11 | 6E | N/A | N/A | 8.5 | 12:19 | - | --:-- | 8.5 | 13:20 |

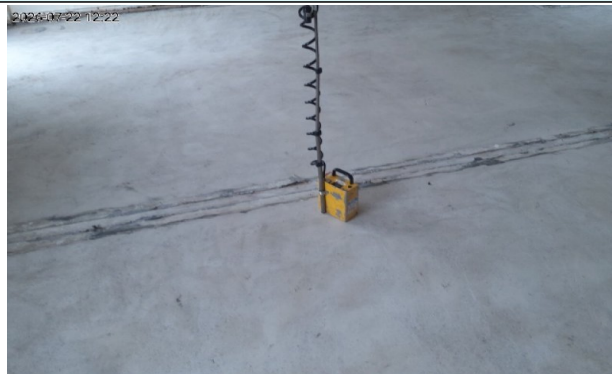
Sampling pump (sample ref: 26/7/A/22/MH13)

| 26/7/A/22/MH13 | HFNE 23 | 6F | N/A | N/A | 8.5 | 12:21 | - | --:-- | 8.5 | 13:22 |
