| Site Air Test Certificate Ref: | ST/26/6/12/MH1 | Date of Issue: | 12/06/2026 | Page 1 of 5 |

| | <b>Area Assessed:</b> | Sixteenth Floor of Block of Flats |
| | <b>Description of reason for test (including the nature and extent of ACMs removed):</b> | Reassurance Air Test following removal of Bitumen Adhesive to Floor and Textured Coating from Ceilings (Concrete to Corridors and Plasterboard to Flats) and Textured Coating to Concrete Walls and Corridors |

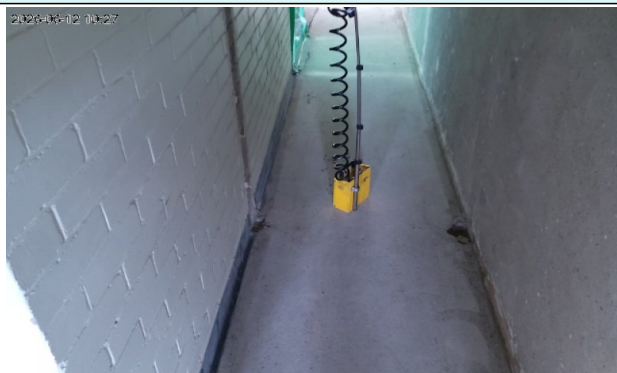
#### Sampling pump (sample ref: 26/6/A/12/MH1)

| 26/6/A/12/MH1 | HFNE 09 | 6A | N/A | N/A | 8.5 | 10:21 | - | --:-- | 8.5 | 11:22 |

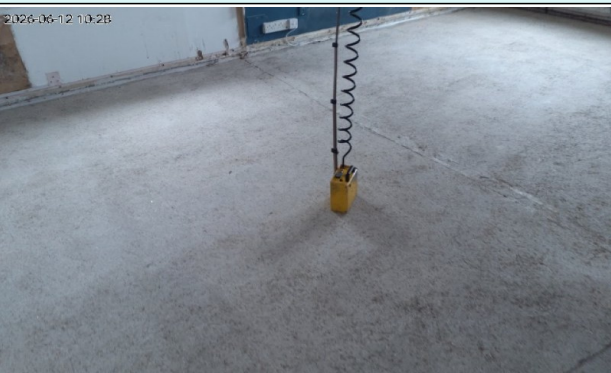
#### Sampling pump (sample ref: 26/6/A/12/MH2)

| 26/6/A/12/MH2 | HFNE 13 | 6B | N/A | N/A | 8.5 | 10:22 | - | --:-- | 8.5 | 11:23 |

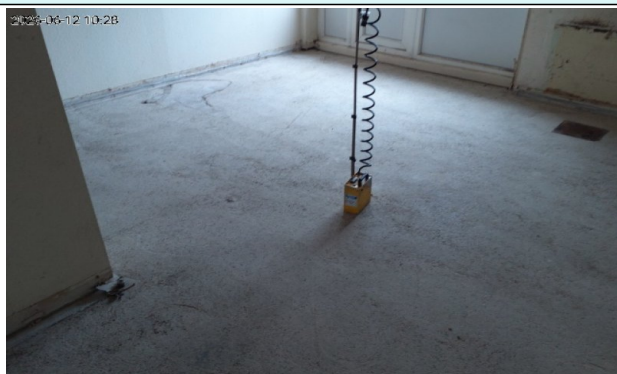
#### Sampling pump (sample ref: 26/6/A/12/MH3)

| 26/6/A/12/MH3 | HFNE 21 | 6C | N/A | N/A | 8.5 | 10:23 | - | --:-- | 8.5 | 11:24 |

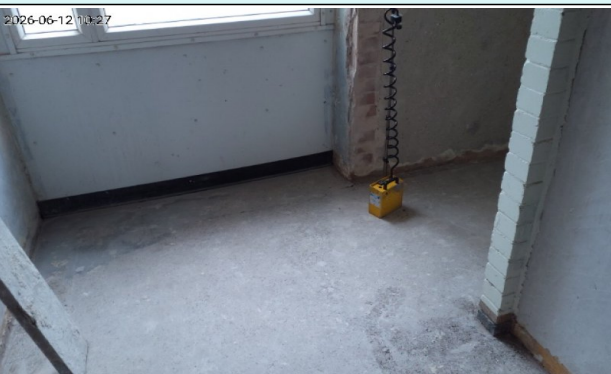
#### Sampling pump (sample ref: 26/6/A/12/MH4)

| 26/6/A/12/MH4 | HFNE 23 | 6D | N/A | N/A | 8.5 | 10:24 | - | --:-- | 8.5 | 11:25 |

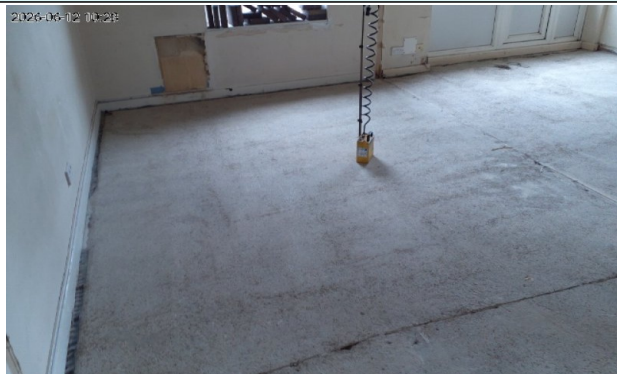
Sampling pump (sample ref: 26/6/A/12/MH5)

| 26/6/A/12/MH5 | HFNE 25 | 6E | N/A | N/A | 8.5 | 10:25 | - | --:-- | 8.5 | 11:26 |

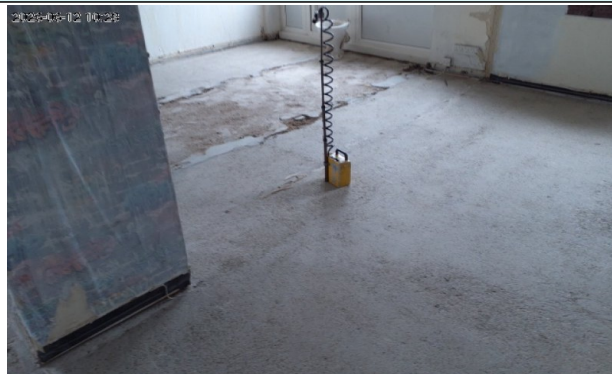
Sampling pump (sample ref: 26/6/A/12/MH6)

| 26/6/A/12/MH6 | HFNE 26 | 6F | N/A | N/A | 8.5 | 10:26 | - | --:-- | 8.5 | 11:27 |
