| Site Air Test Certificate Ref: | ST/26/8/19/MH2 | Date of Issue: | 19/08/2026 | Page 1 of 5 |

### Air Testing

| | <b>Area Assessed:</b> | Stairwell to Sixteen Floor Block of Flats | | |
| | <b>Description of reason for test (including the nature and extent of ACMs removed):</b> | Reassurance Air Test following removal of Bitumen Adhesive to Floor and Textured Coating to Concrete Ceilings and Walls | | |

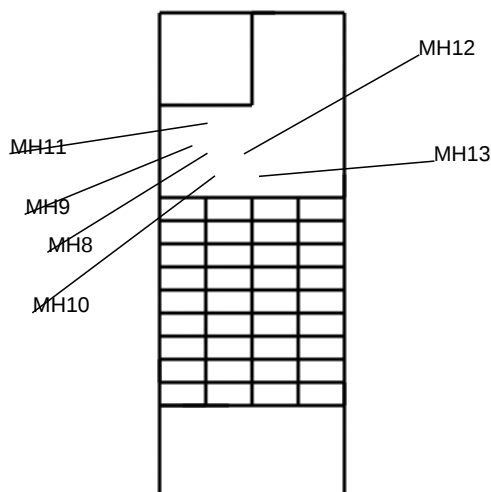
### Sample Area Layout Plan

Typical Floor Stairwell

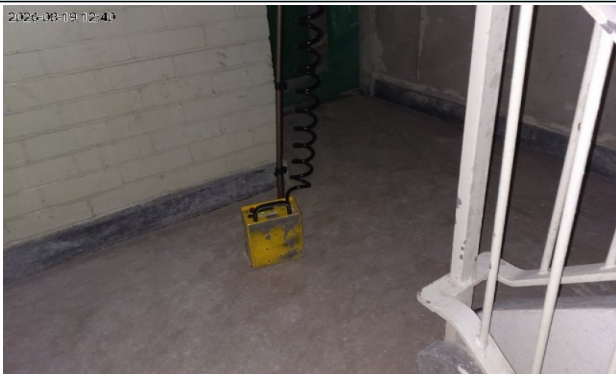
| <b>Sampling pump (sample ref: 26/8/A/19/MH8)</b><br> | <b>Sampling pump (sample ref: 26/8/A/19/MH9)</b><br> |

| 26/8/A/19/MH8 | HFNE 11 | 6A | N/A | N/A | 8.5 | 12:28 | - | --:-- | 8.5 | 13:29 |

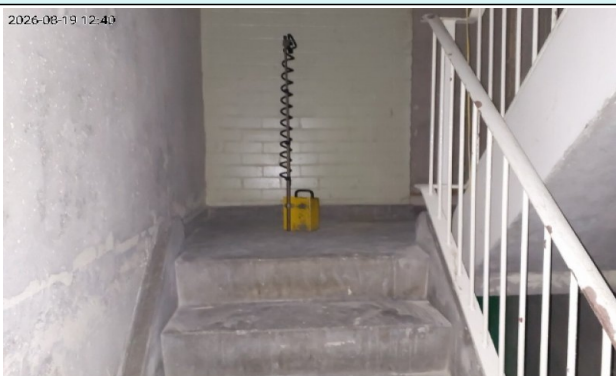
| <b>Sampling pump (sample ref: 26/8/A/19/MH10)</b><br> | <b>Sampling pump (sample ref: 26/8/A/19/MH11)</b><br> |

| 26/8/A/19/MH10 | HFNE 18 | 6C | N/A | N/A | 8.5 | 12:32 | - | --:-- | 8.5 | 13:33 |

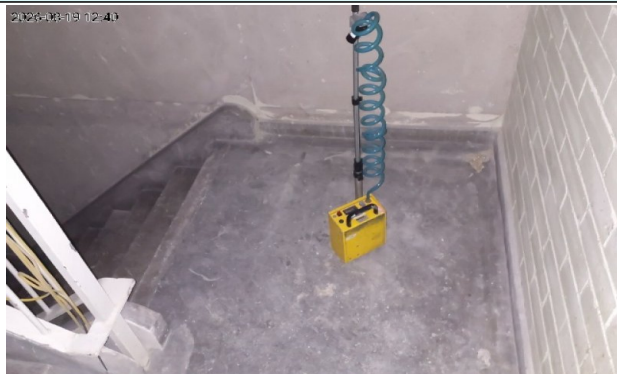
Sampling pump (sample ref: 26/8/A/19/MH12)

| 26/8/A/19/MH12 | HFNE 33 | 6E | N/A | N/A | 8.5 | 12:36 | - | --:-- | 8.5 | 13:37 |

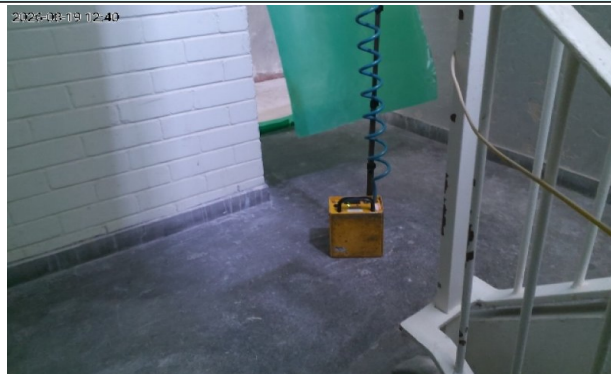
Sampling pump (sample ref: 26/8/A/19/MH13)

| 26/8/A/19/MH13 | HFNE JD03926 | 6F | N/A | N/A | 8.5 | 12:38 | - | --:-- | 8.5 | 13:39 |
