| Site Air Test Certificate Ref: | ST/26/7/15/MH1 | Date of Issue: | 15/07/2026 | Page 1 of 5 |

| | <b>Area Assessed:</b> | Tenth Floor of Block of Flats | | | |
| | <b>Description of reason for test (including the nature and extent of ACMs removed):</b> | Reassurance Air Test following removal of Bitumen Adhesive to Floor and Textured Coating from Ceilings (Concrete) and Textured Coating to Concrete Walls and Ceiling to Corridors | | | |

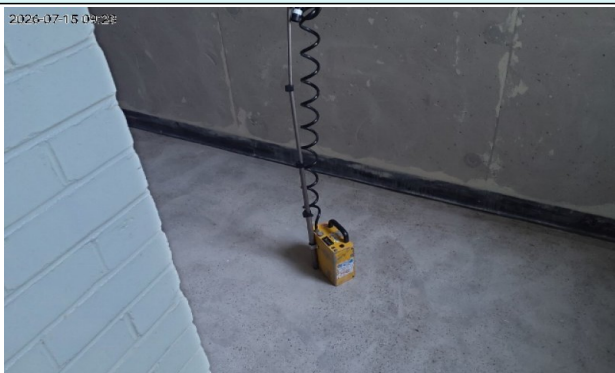
#### Sampling pump (sample ref: 26/7/A/15/MH1)

| 26/7/A/15/MH1 | HFNE 03 | 6A | N/A | N/A | 8.5 | 09:21 | - | --:-- | 8.5 | 10:22 |

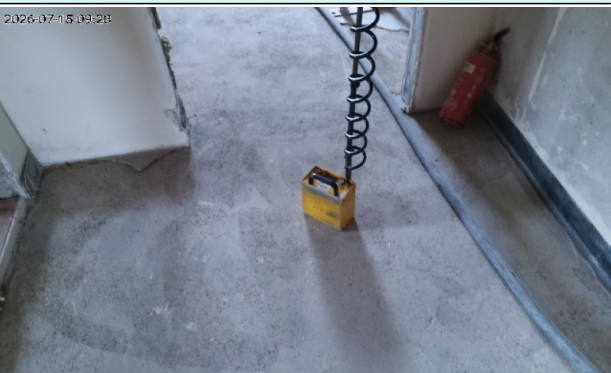
#### Sampling pump (sample ref: 26/7/A/15/MH2)

| 26/7/A/15/MH2 | HFNE 13 | 6B | N/A | N/A | 8.5 | 09:22 | - | --:-- | 8.5 | 10:23 |

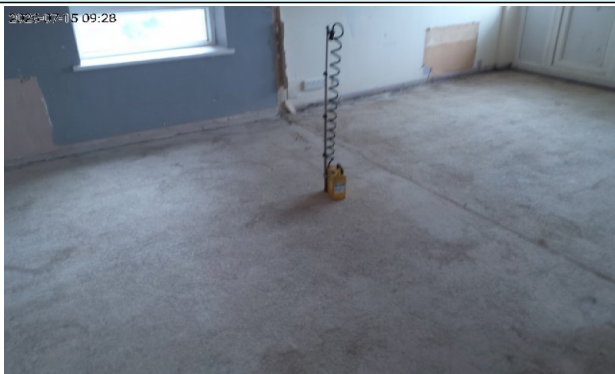
#### Sampling pump (sample ref: 26/7/A/15/MH3)

| 26/7/A/15/MH3 | HFNE 21 | 6C | N/A | N/A | 8.5 | 09:23 | - | --:-- | 8.5 | 10:24 |

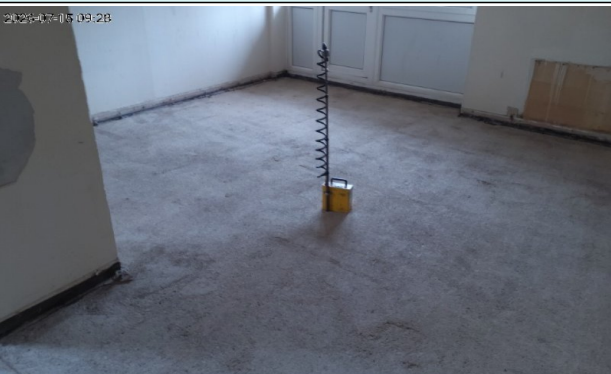
#### Sampling pump (sample ref: 26/7/A/15/MH4)

| 26/7/A/15/MH4 | HFNE 22 | 6D | N/A | N/A | 8.5 | 09:24 | - | --:-- | 8.5 | 10:25 |

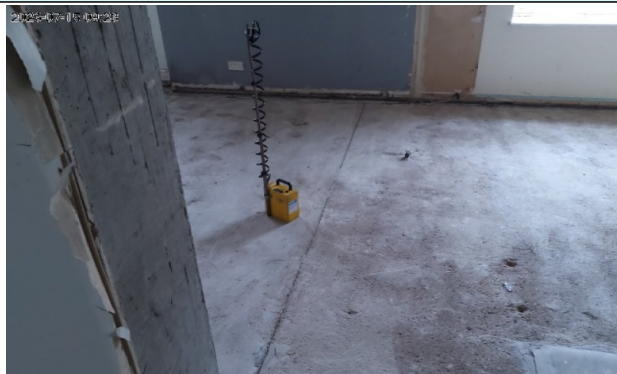
Sampling pump (sample ref: 26/7/A/15/MH5)

| 26/7/A/15/MH5 | HFNE 25 | 6E | N/A | N/A | 8.5 | 09:25 | - | --:-- | 8.5 | 10:26 |

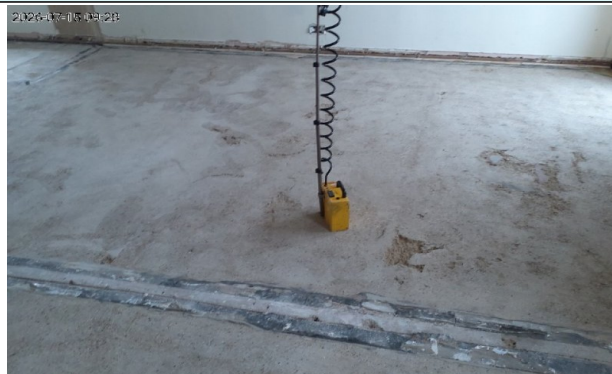
Sampling pump (sample ref: 26/7/A/15/MH6)

| 26/7/A/15/MH6 | HFNE 26 | 6F | N/A | N/A | 8.5 | 09:26 | - | --:-- | 8.5 | 10:27 |
